INFLUENCE OF GEOTECHNICAL CONDITIONS ON DAMAGE STATES OF GDANSK BAY COAST CLIFF FORMATIONS

Eligiusz Mieloszyk¹

Mariusz Wyroślak²

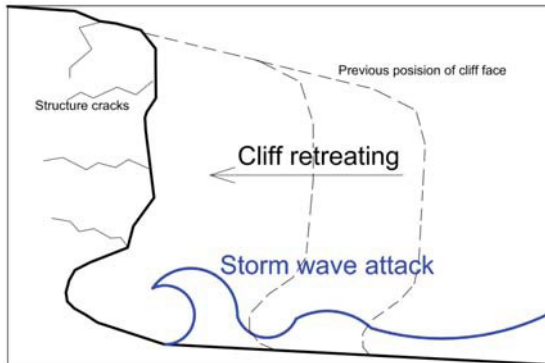
- permanent or periodical attacks of storm sea waves against cliff base [4], as a result of which cliff slope retreats step by step back into the land (Fig. 1),

Fig. 1. Erosion of cliff resulting from storm wave attack

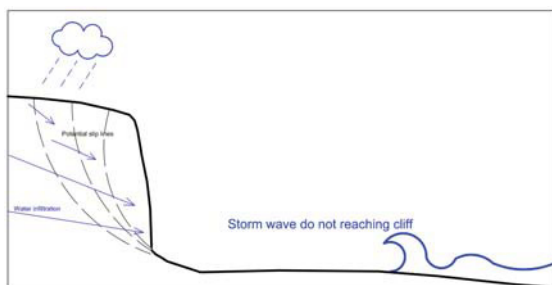
- effects of ground mass forces onto sheer slopes, that results in loss of stability and landslides,
- infiltration and flow of underground water from the side of land towards sea, which liquefies the ground and changes its state (Fig. 2).

Fig. 2. Cliff erosion due to geotechnical effects from the side of land

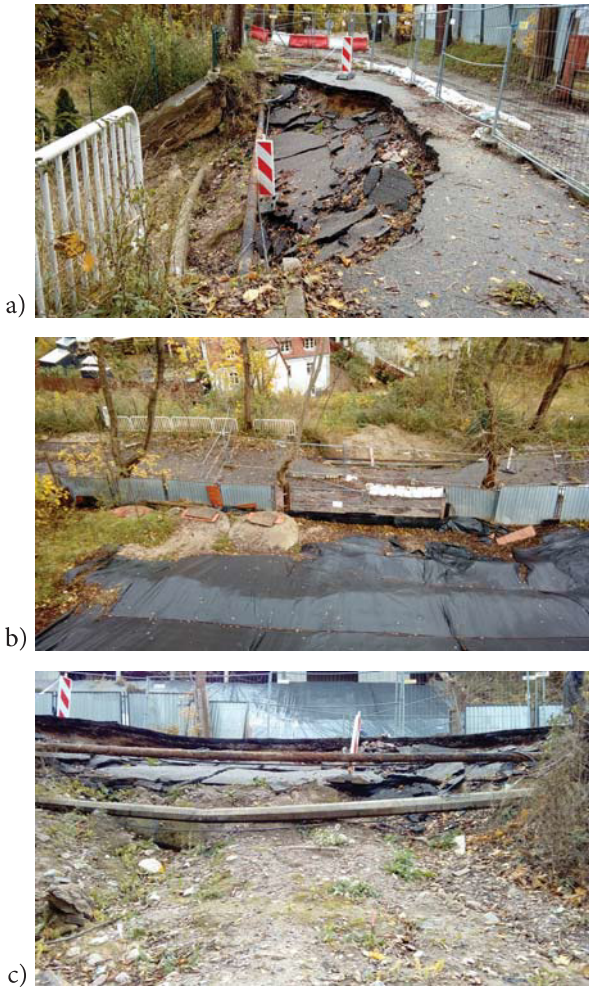
In the night from 23rd to 24th February 2017, in Gdynia, below Sienkiewicz Street, a sudden landslide and run-off of ground-water mass occurred from the escarpment. The slid-down and watered ground mass displaced forming a precipice. Simultaneously, the active tongue of the landslide locally deformed the lie of the land, rising the terrain level by 1,5 m in some places.

A 7 m fragment of the street pavement and roadway was damaged. A geotechnical consequence of the occurred situation is a new state of force equilibrium spontaneously settled in the ground. The geotechnical investigations of the terrain in question show [10] that this state is not stable and may be changed after subsequent intensive watering the ground. A week after the reported event some water flow sources and symptoms of the significant ground watering were found in the site of the landslide.

Fig. 5. State of the landslide 8 months after the damage

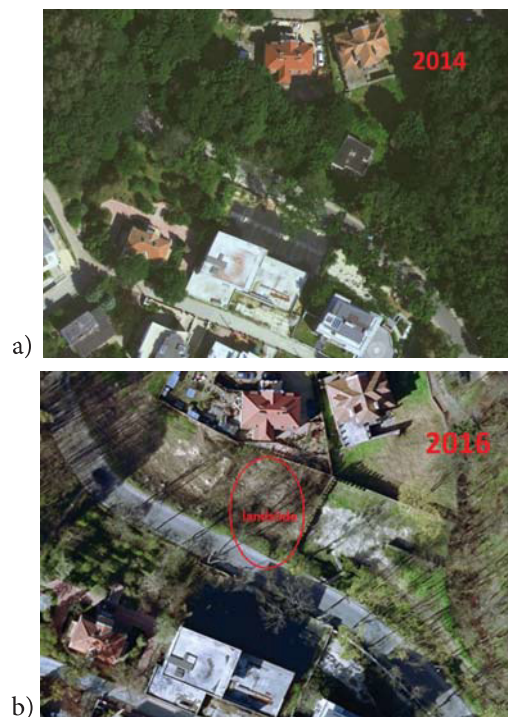
For several years before the landslide event, a devastation of the existing stand of trees has been observed. As a result, a lack of the natural factor holding the ground on the slope has been introduced. The attached photographs reveal a wastage of the stand of trees in this area (Fig. 7a, Fig. 7b).

Fig. 7. Changes in the stand of trees within the landslide, which occurred between the years 2014 and 2016, (Aerial photographs shot by MGGP AERO)

The removal of flora from the escarpment area of the plot in question and neighbouring plots exposed the terrain to intensive surface erosion and increased infiltration of rainfall water into the ground, that resulted in the ground strength lowering. Additionally, a lack of transpiration causes that water is not taken up by the plant root system and in the surrounding ground there do not exist respective compression stresses resulting from sucking the water by plants.
