INFLUENCE OF GEOTECHNICAL CONDITIONS ON DAMAGE STATES OF GDANSK BAY COAST CLIFF FORMATIONS

ABSTRACT

A geotechnical aspect of destruction processes of seashores was identified based on the case of erosion of Gdansk Bay Coast cliff formations. Causative factors of landslide were described in the context of natural phenomena, land development and its anthropogenic transformations. Possible directions of theoretical analysis of changes in ground-water relations were indicated.

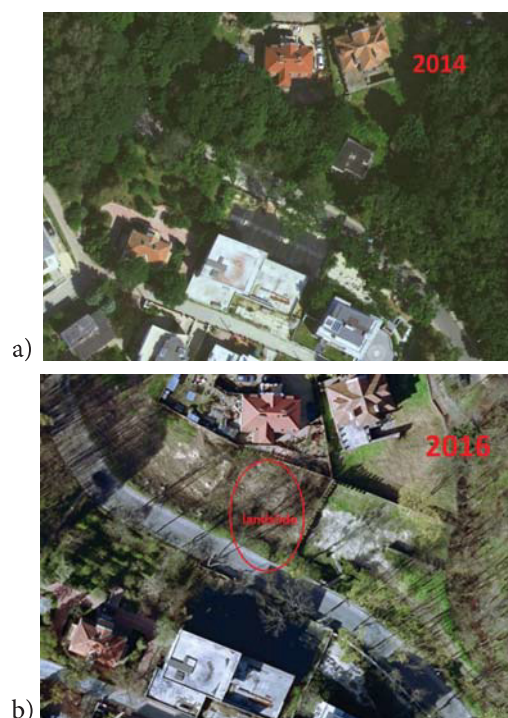
For several years before the landslide event, a devastation of the existing stand of trees has been observed. As a result, a lack of the natural factor holding the ground on the slope has been introduced. The attached photographs reveal a wastage of the stand of trees in this area (Fig. 7a, Fig. 7b).

Fig. 7. Changes in the stand of trees within the landslide, which occurred between the years 2014 and 2016, (Aerial photographs shot by MGGP AERO)
