## DEGRADATION OF THE CONCRETE RAILWAY TRACK BED LOCATED IN THE VICINITY OF THE LOADING WHARF

Maciej Niedostatkiewicz

Gdańsk University of Technology, Faculty of Civil and Environmental Engineering, Poland

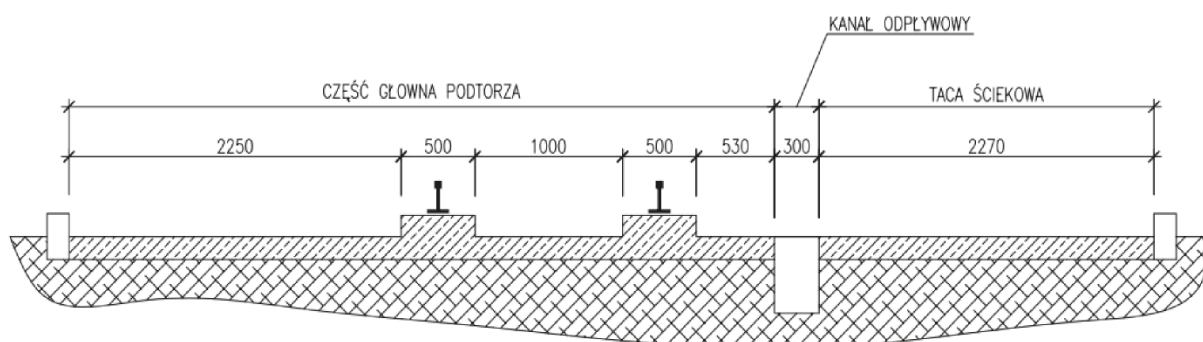
The 100 m long reinforced concrete track bed was located in the vicinity of the wharf and used for loading and unloading petroleum materials for rail tankers. The railway track was laid on a reinforced concrete track bed. The plate consists of three elements: the main part of the track bed, the drainage channel and the sewage tray (Fig.1 and Fig.2).

Fig. 2. Diagram of the concrete structure of the railway subgrade-stocktaking

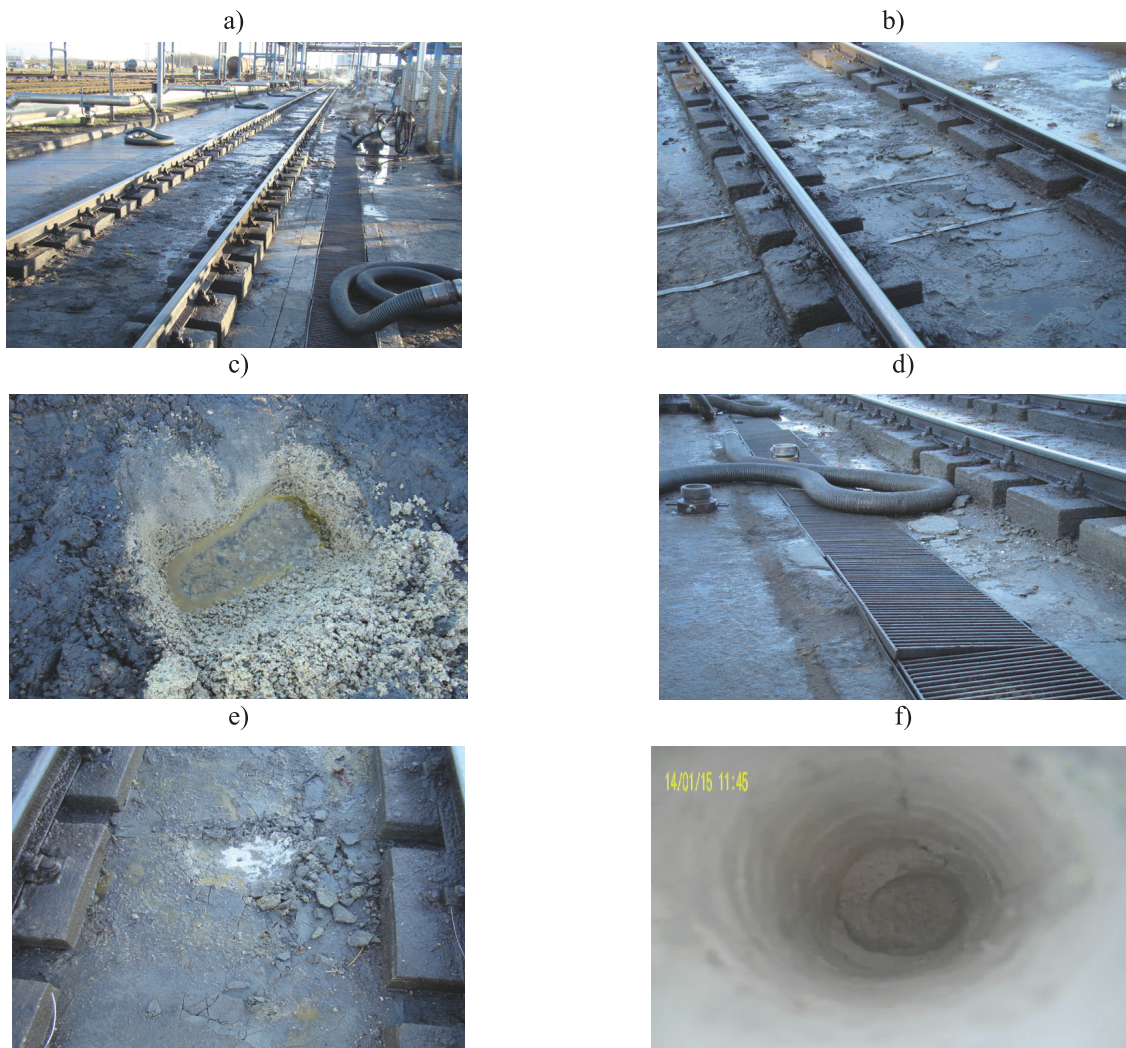
The most intense damage occurred at the length of the middle part of the track bed with a length of about 40 m. In this part the most damaged element was the middle section of the plate located between the rail heads (Fig.3a and Fig.3b). In the main part of the track bed the following damage to the upper surface of the board was found: separation of the PCC layer from the cracking ground, scratches and oil saturation of the concrete slab and PCC. Made in the past (~ 2 years ago), the layer was intensely fractured and carried traces of freezing (frosty scratches). Open pits ascertained that oil-based liquids gathered (by inflowing) from the sub-surface of the subgrade due to unloading of railway tanks (Fig. 3c). The depth of damage to the concrete layer was up to 6 cm, and structural reinforcement bars were visible. The drainage channel located along the road, located between the main part of the track bed and the drainage tray (Fig.2) was

deformed in an intensive manner. The concrete had extensive damage along drainage grates - a sectional drainage channel was replaced ~ 2 years ago as part of the works related to the reprofiling of the substrate. Despite the application of systemic repair solutions (built-in reinforced concrete, prefabricated elements of linear drainage) along the channel, the joints of the channel profiles were found to be broken and the surface layer of the concrete damaged (Fig.3d).

Fig. 3. Track with track bed: a) general view, b) damage to the main part of the track bed, c) open pit in the middle of the track between the rails, d) damage to the drainage channel, e) open pit - control hole, f) the interior of the control hole

In the described case of a concrete railway subgrade, soil saturation with petroleum products was found, based on the conducted ground tests. The soil did not soften despite the contamination. The homogeneity of concrete in the made-out pits was sufficient for surface repairs - the concrete had a compact structure [2], [5]-[6]. Also on the concrete surface, after removing the damaged PCC trip layer, no crayfish or caverns were found (Fig.3e and Fig.3f). The maximum depth of damaged concrete was 6 cm.

The direct cause of damage to the concrete substructure structure, including the PCC repair mortar layer, was the poor quality of the works performed and the use of materials not intended for use in the aggressive operating environment (with agents negatively affecting the concrete). The repair materials used did not provide the designed durability and resistance of the concrete railway sub-floor.

STAGE 1 (for urgent implementation) included:

I) ad hoc removal of loose fragments of the PCC and concrete,

II) initial geodetic surveying of rectilinearity and inclination of the track rails as well as running control measurements of the subgrade at regular intervals. It was recommended to perform geodetic measurements at intervals of 4 weeks in winter and at intervals of 2 weeks in the spring and summer. During the measurements, particular attention should be paid to the measurement of linearity, verticality and inclination of the heads of the rails with respect to each other,

III) sub-division of the subgrade to working plots and execution of works including:

- a) pressure washing with water and detergents,
- b) priming washed concrete surface: for matt-damp concrete applying a protective layer of epoxy resin for oily floors and sprinkling it with quartz sand (annealed with fire),
- c) making buffer layer of epoxy resin and sprinkling it with quartz sand,
- d) reprofiling the upper surface a mortar based on epoxy resin mixed with quartz aggregate,
- e) applying a support layer of resin resistant to petroleum products.

STAGE 2 (for the final implementation during the overhaul) included reconstruction of the main part of the track bed and the sewage tray based on systemic prefabricates made of polymer concrete resistant to oil-based liquids - in the newly designed subgrade layer system horizontal damp insulation was to be designed, also fulfilling the role of anti-oil insulation laid on the foundation layer of lean concrete B15 (C12 / 15). As insulation material, it has been recommended to use, for example, oil and bitumen protective foil with a minimum thickness of 2 mm..

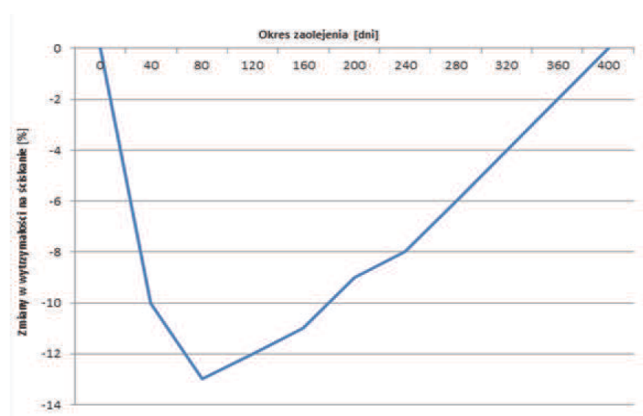
In oily concrete, bacteria (aerobic and anaerobic) develop in the presence of water, while organic acids, hydrogen sulphide are produced and the pH of the water decreases. In oiled concrete durability decreases compared to the condition before oil formation - there is the phenomenon called concrete softening, and the long-term impact of organic acids results in a decrease in the mass of concrete, as a result of the dissolution of the cement binder and increase in its porosity. As a result of the dissolution of the binder, the durability of the concrete decreases significantly. The drop in concrete strength depends on the type of oil and the time of exposure of the concrete to oiling [3-4] (Fig.4).

Fig. 4. Change in compressive strength of concrete (vertical axis-%) contaminated with diesel oil versus (horizontal axis-time (days)) (Błaszczczyński 1995)
