DEGRADATION OF THE CONCRETE RAILWAY TRACK BED LOCATED IN THE VICINITY OF THE LOADING WHARF

Maciej Niedostatkiewicz

Gdańsk University of Technology, Faculty of Civil and Environmental Engineering, Poland

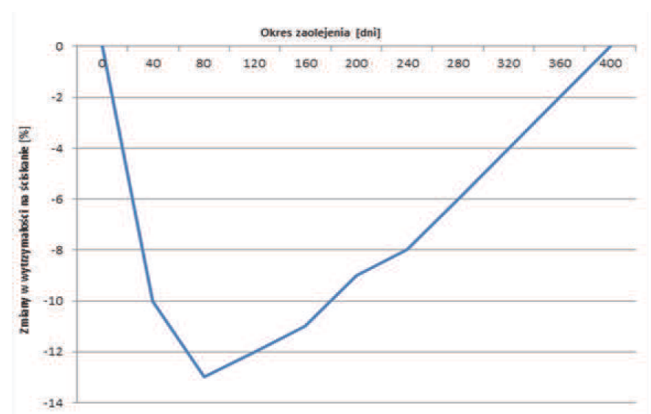
In oily concrete, bacteria (aerobic and anaerobic) develop in the presence of water, while organic acids, hydrogen sulphide are produced and the pH of the water decreases. In oiled concrete durability decreases compared to the condition before oil formation - there is the phenomenon called concrete softening, and the long-term impact of organic acids results in a decrease in the mass of concrete, as a result of the dissolution of the cement binder and increase in its porosity. As a result of the dissolution of the binder, the durability of the concrete decreases significantly. The drop in concrete strength depends on the type of oil and the time of exposure of the concrete to oiling [3-4] (Fig.4).

Fig. 4. Change in compressive strength of concrete (vertical axis-%) contaminated with diesel oil versus (horizontal axis-time (days)) (Błaszczczyński 1995)
