## **On the current state of dovetail wall-corner joints in wooden Greek Catholic churches in Polish Subcarpathia with structural and sensitivity analyses**

Izabela Lubowiecka<sup>1</sup>, Tomasz Zybała<sup>1</sup>, Grzegorz Bukal<sup>2</sup>, Marcin Krajewski<sup>1</sup>, Marcin Kujawa<sup>1</sup>, Paweł Kłosowski<sup>1</sup>

*1) Department of Structural Mechanics, Faculty of Civil and Environmental Engineering, Gdańsk University of Technology, Gdańsk, Poland*

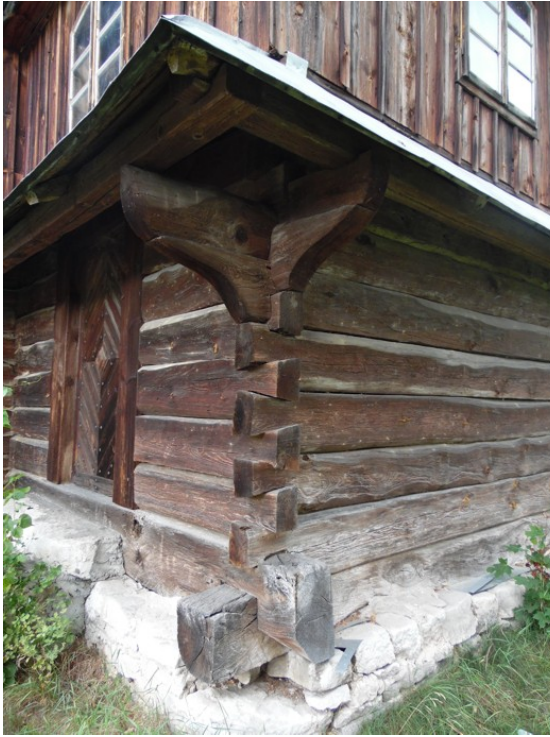
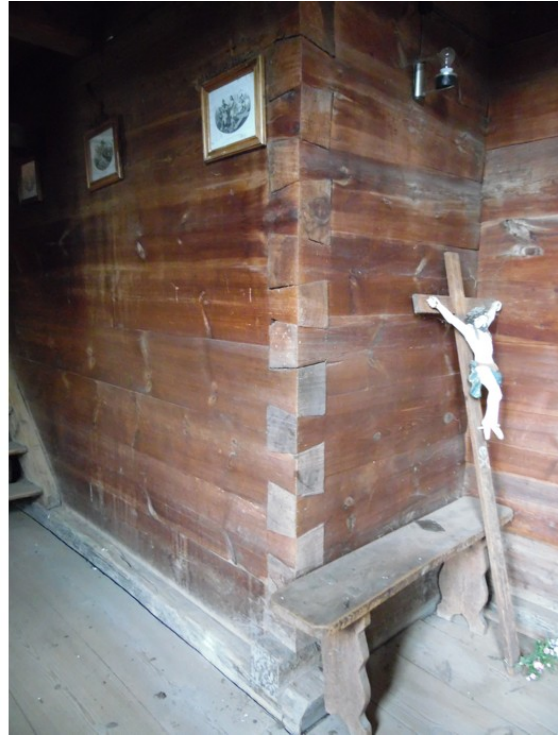
The current condition of the walls is good. The church has log walls with dovetail notches (Figure 9, 10). The walls are made of wood beams with a rectangular cross-section of 15 x 21 cm. No significant moisture has been found and the humidity level of the corners remains at 12.5% on the south side and 17.8% on the north side (Figure 11). The horizontal damp proof course in the foundations is not broken and the roof covering is rain-tight. There are some visible longitudinal cracks (Figure 10) and a few transverse cracks in the beams. There are also some signs of damage caused by insects and some

Figure 9. Current condition of log walls with dovetail notches in Chotylub outside and inside.

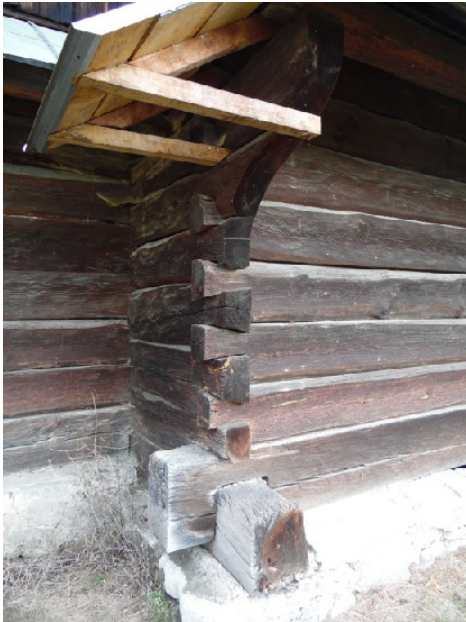
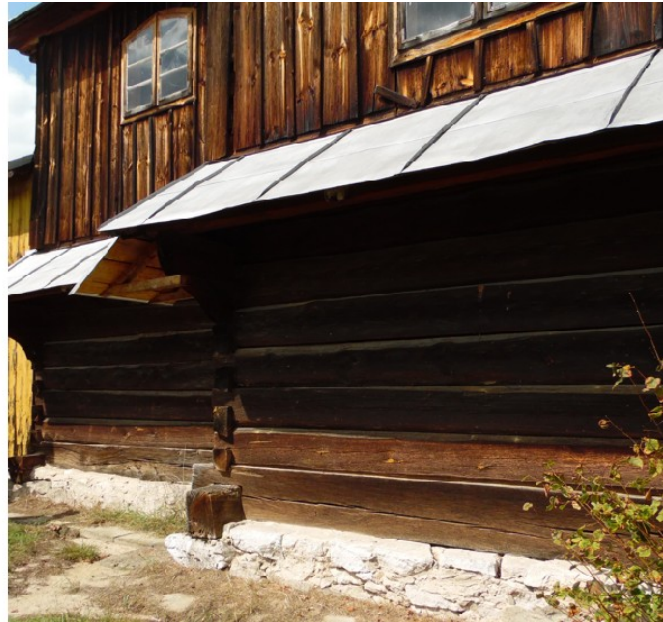
minor local cavities of the structure. The out-of- plane vertical deviations of the walls are relatively small - from 0.15 cm to 1.2 cm. The internal angles have not changed since the church assembly - deformations inside and outside the building range from 88.9° to 90.5°. The same is true for the construction as a whole which has never been rebuilt and hence there are no additional loads on the walls. Moreover, the gravity ventilation of the object is intact. At present the church is not in use but local authorities have designated a person responsible for taking care of it. Owing to this the building is closed and protected against vandalism and the area around it is well kept.

Figure 10. Current condition of log walls with dovetail notches in Chotylub: cracks in log walls in and contemporary repairs of the eaves roof.
