Causes of damage and methods of repairing floor made on polystyrene concrete

Abstract. The paper describes damages, tests and repair of the floor made on existing ceiling and expanded polystyrene concrete underlay. The floor was built on a reinforced concrete ceiling with an area of about 1050 m². Significant damage in the form of cracks, detachments and unevenness was found in the floor. In order to determine the causes of damage, in situ tests and laboratory tests were carried out. It was found that the damage was caused by numerous performance errors. A test repair of the damage (4.7x6.0 m) was carried out, and then the repair method was applied on the entire floor surface.

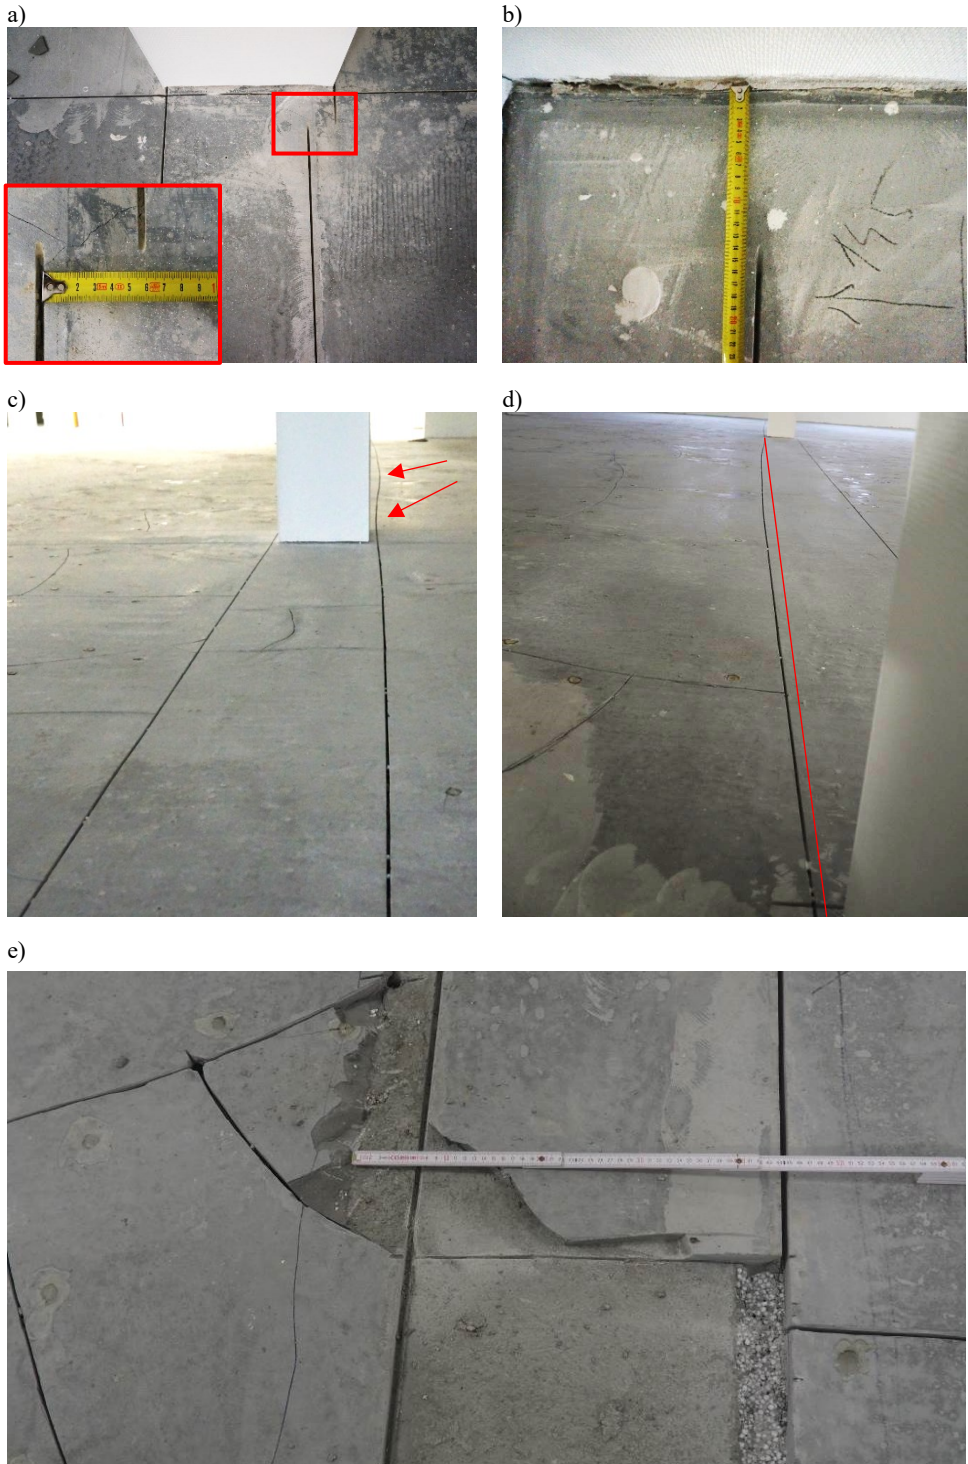
Visual inspection determined several performance errors, including uneven thickness of screed and EPSC, lack of precision in the execution of expansion joints and stratification of the concrete (up to three layers). The floor was clearly uneven - the slope of several slabs reached up to 16 mm/m, while spacing under two-metre-level and floor was up to 7 mm. It was observed that floor cracks protruded beyond expansion joints, which proves that the cuts were made too late.

Fig. 5. Imprecise expansion joints: a) lack of continuity, b) improper cut near the wall, c), d) uneven cuts e) inverted beam exposure. Expansion joints are at the distance of 7 cm.

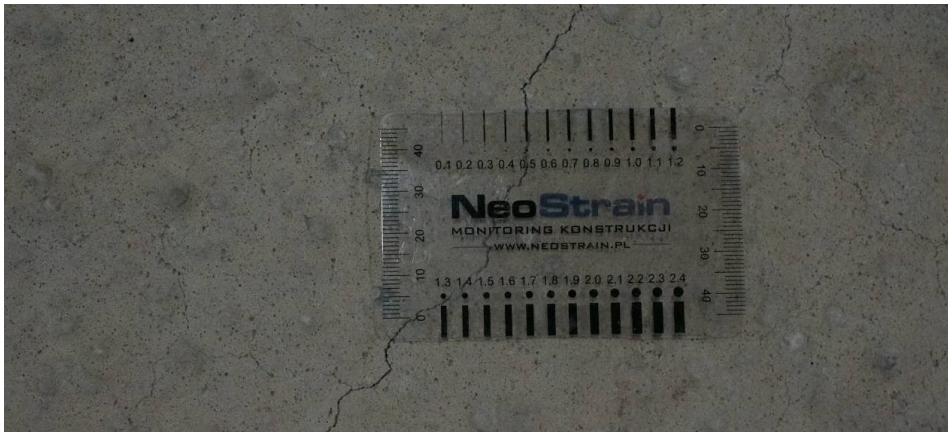
The visual evaluation of the samples was being conducted for over 2 months. The observations lasted over 2,5 times longer than the time in which the cracks occurred in analyzed floor. After 49 days first three samples did not exhibit any signs of cracking. The last sample exhibited small shrinkage cracks. Local width of the crack reached between $0.1 \div 0.5$ mm. The cracks on the surface of the EPSC occurred after two weeks due to lack of curing. The cracks are shown in Fig. 10.

Fig. 10. Measurement of the cracks in sample no. 4.

Comparative tests have shown that it is possible to make a self-levelling screed for the designed floor. Lack of curing resulted in the occurrence of cracks in the EPS concrete.
