Integrated Application of GPR and Ultrasonic Testing in the Diagnostics of a Historical Floor

Abstract: The paper presents the results of integrated ground penetrating radar (GPR) and ultrasonic testing (UT) measurements conducted on a historical floor in St. Nicholas' Church, Gdańsk, Poland. The described inspection was the first stage of the technical state assessment of the building. The aim of the study was the detection of underfloor air gaps, which were observed in a few trial pits. The condition of the ground under the floor was determined by localizing other inclusions such as rubble, human remains, brick walls and pipes. To identify the phenomenon of electromagnetic and ultrasonic wave propagation within the air gap, laboratory tests were conducted on physical models consisting of two concrete slabs stacked on top of each other and gradually moved apart to simulate a slot of varying thickness. The conducted research was supported by the numerical models of electromagnetic wave propagation. The obtained results showed that the integration of the GPR and UT methods provided an effective imaging of the floor and the area under it. Ultrasonic testing was proved to be a good t

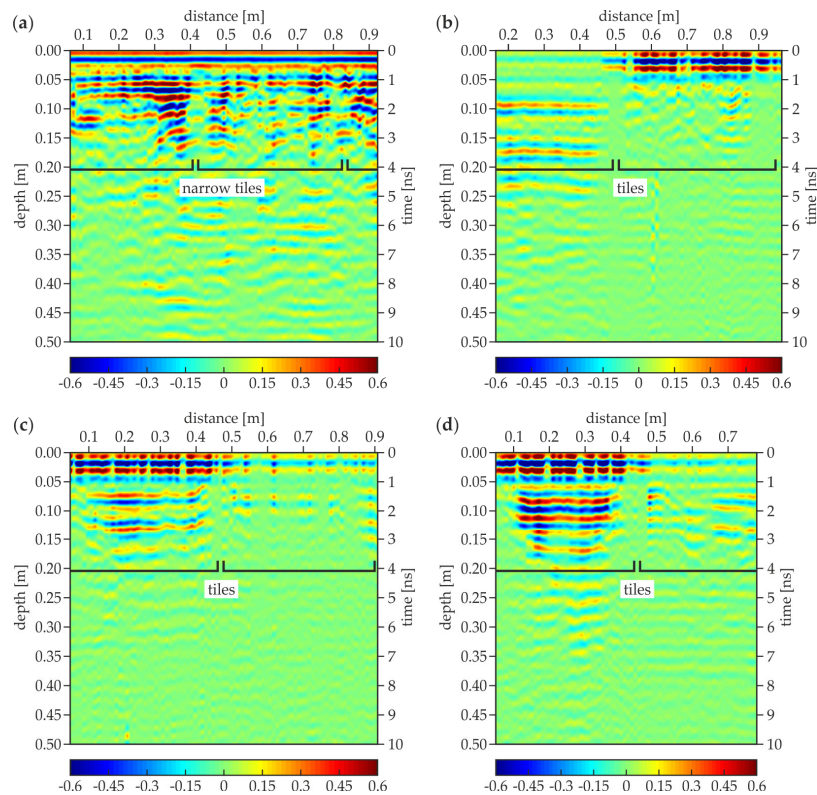
Figure 16 contains the UT B-scans corresponding to the above-discussed GPR B-scans. The C-1 scan (Figure 16a) was performed through the narrow tiles, as can be seen in Figure 7a, thus the joints of the standard tiles were not observed. In the top part of the scan (at the depth of about 0.03 m), there was a straight line denoting the regular bottom face of the narrow tiles. However, there was no regularity in the lower part of the scan, where many multiple reflections occurred. Compared with the results for the concrete slabs, it might be stated that the air gap with an irregular shape was present in this area. The non-uniform settlement of the original ground probably led to the appearance of the air gap. The C-2 scan (Figure 16b) shows the image of two different tiles. The right tile, unlike the left one, was clearly visible at the top of the scan; it was possibly removed and then placed again with the use of a different (stronger) mortar. The multiple reflections appeared under the left tile, indicating the presence of the air gap (this tile laid on the original ground). On the contrary, there were no reflections under the right tile. The pipe detected in the GPR scans was not visible, which stays in agreement with the results for the concrete slabs where the UT scans did not reveal the table tennis ball. This observation allowed concluding that concentrated inclusions could not be detected by the UT scanning. It also should be mentioned that, according to the UT antenna instruction, the diameter of the pipe did not exceed 30 mm. In the C-3 scan (Figure 16c), two tiles were also visible. The left one was much more pronounced: it could have been replaced during some renovation works. Additionally, there were multiple reflections under both tiles, indicating the presence of the air gaps (resulting from the ground settlement). However, it needs to be noted that the reflections were less intensive under the right tile because it was weakly identified itself. The possibility of detecting the tiles in the C-4 scan (Figure 16d) was also distinguished: the left one was much better imaged. Although the ground below the left tile was replaced, the multiple reflections indicating the presence of an air gap were visible under both tiles. Like in the C-3 scan, the reflections under the right tile were weaker because it was weakly imaged itself. It also needs to be added that the pipe was not observed like in the C-2 scan.

Figure 16. Ultrasonic B-scans for the trial pit: (a) edge 1 (trace C-1); (b) edge 2 (trace C-2); (c) edge 3 (trace C-3); (d) edge 4 (trace C-4).

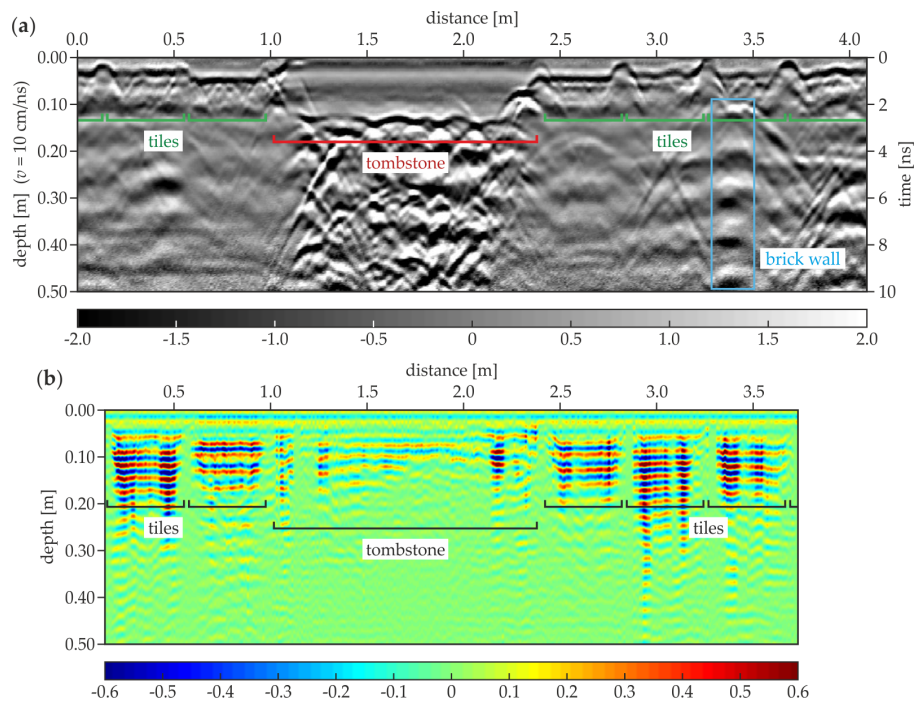
The next two GPR B-scans from the south aisle are presented together with the corresponding results of the UT scanning. In the A-121 GPR B-scan (Figure 18a), the tiles with different thicknesses (in the range of 0.02–0.04 m) were visible, and also a tombstone with the thickness of about 0.12 m was identified. The ground below the tombstone contained some concentrated inclusions (probably rubble or human remains). The brick wall was present at a distance of about 3.4 m. The UT scan (Figure 18b) clearly revealed the tile pattern, and also the tombstone was observed. The presence of the multiple reflections under each tile allowed stating that there were many air gaps below them, which agreed with the fact that the floor of the south aisle experienced significant settlement. The reflections denoting the air gaps generally did not appear below the tombstone, probably because of

its weight. What is also worth noting is that no additional reflections from the ground heterogeneities could be identified. The UT scanning did not detect concentrated inclusions, which were already observed for the pipe in the area of the trial pit and the table tennis ball in the concrete slab. The GPR B-scan for the trace A-129 is presented in Figure 19a. The tiles with different thicknesses (varying between 0.02 and 0.06 m) are clearly detectable. Two tombstones with a thickness of approximately 0.12 m and irregular shape of the bottom face were also present. The ground under both tombstones had many concentrated inclusions unlike aside from this area. The brick wall could be visible at the distance of about 4.3 m; however, the intensity of the reflections from the bricks was not as strong as in the A-121 scan. In the UT scan (Figure 19b), the tiles and the tombstones could be localized. There were no significant reflections under the tombstones, thus the air gaps were not likely to be there, unlike under the most of the tiles, where multiple reflections appeared. This observation corresponded with the settlement of the floor in the area of the south aisle.

Figure 18. GPR and UT B-scans for trace A-121 (south aisle): (a) GPR scan; (b) UT scan.

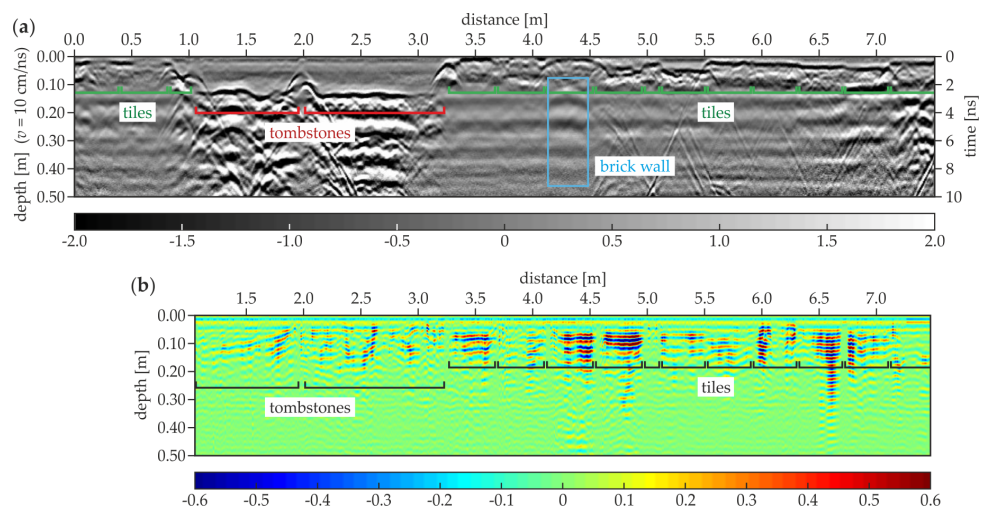
Figure 19. GPR and UT B-scans for trace A-129 (south aisle): (a) GPR scan; (b) UT scan.

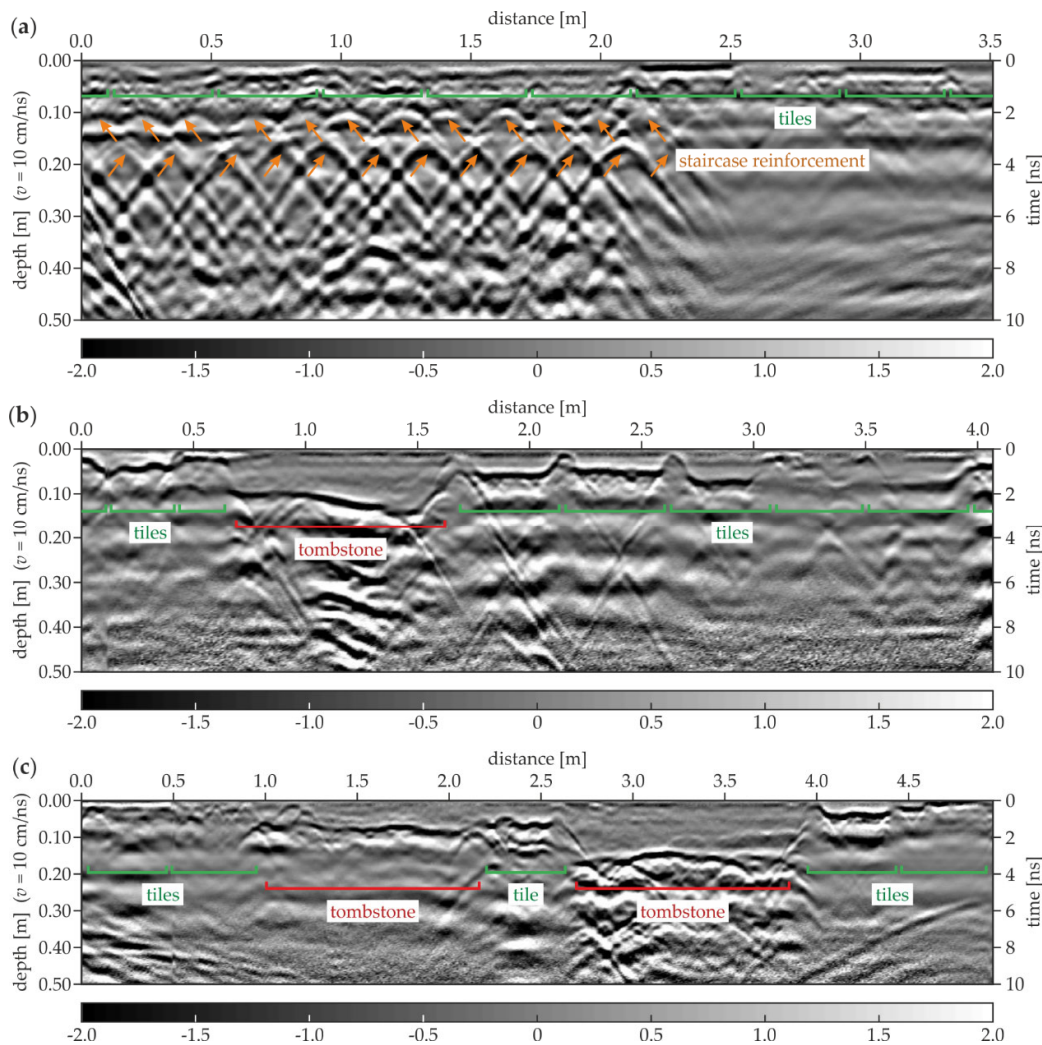
Figure 20 shows the examples of the GPR B-scans for the north aisle. The B-5 scan (Figure 20a) shows the regular pattern of tiles with a constant thickness of 0.03 m. Several evenly spaced hyperbolas were visible at two levels (the depth of 0.11 and 0.18 m) and the distance of 0.0–2.1 m. These reflections represented the reinforcement of the staircase located under the floor. The ground below the tiles aside of the staircase seemed to be devoid of significant heterogeneity. In the B-35 scan (Figure 20b), the tiles had different thicknesses in the range of 0.02–0.06 m. The tombstone had a thickness varying between 0.10 and 0.15 m and the skew shape of the bottom face. The ground below the tombstone had some concentrated inclusions. The B-143 scan (Figure 20c) presents the tiles with the thicknesses between 0.02 and 0.05 m. Two tombstones were also visible, the left one with the thickness of about 0.09 m and the right with the thickness of approximately 0.16 m. The ground under the thinner tombstone did not have inhomogeneities, unlike the ground under the second one, where multiple reflections from the concentrated inclusions occurred. This observation confirms the fact that some of the tombstones were placed aside from the area of the original crypts.

Figure 20. GPR B-scans for the north aisle (survey B): (a) B-5; (b) B-35; (c) B-143.

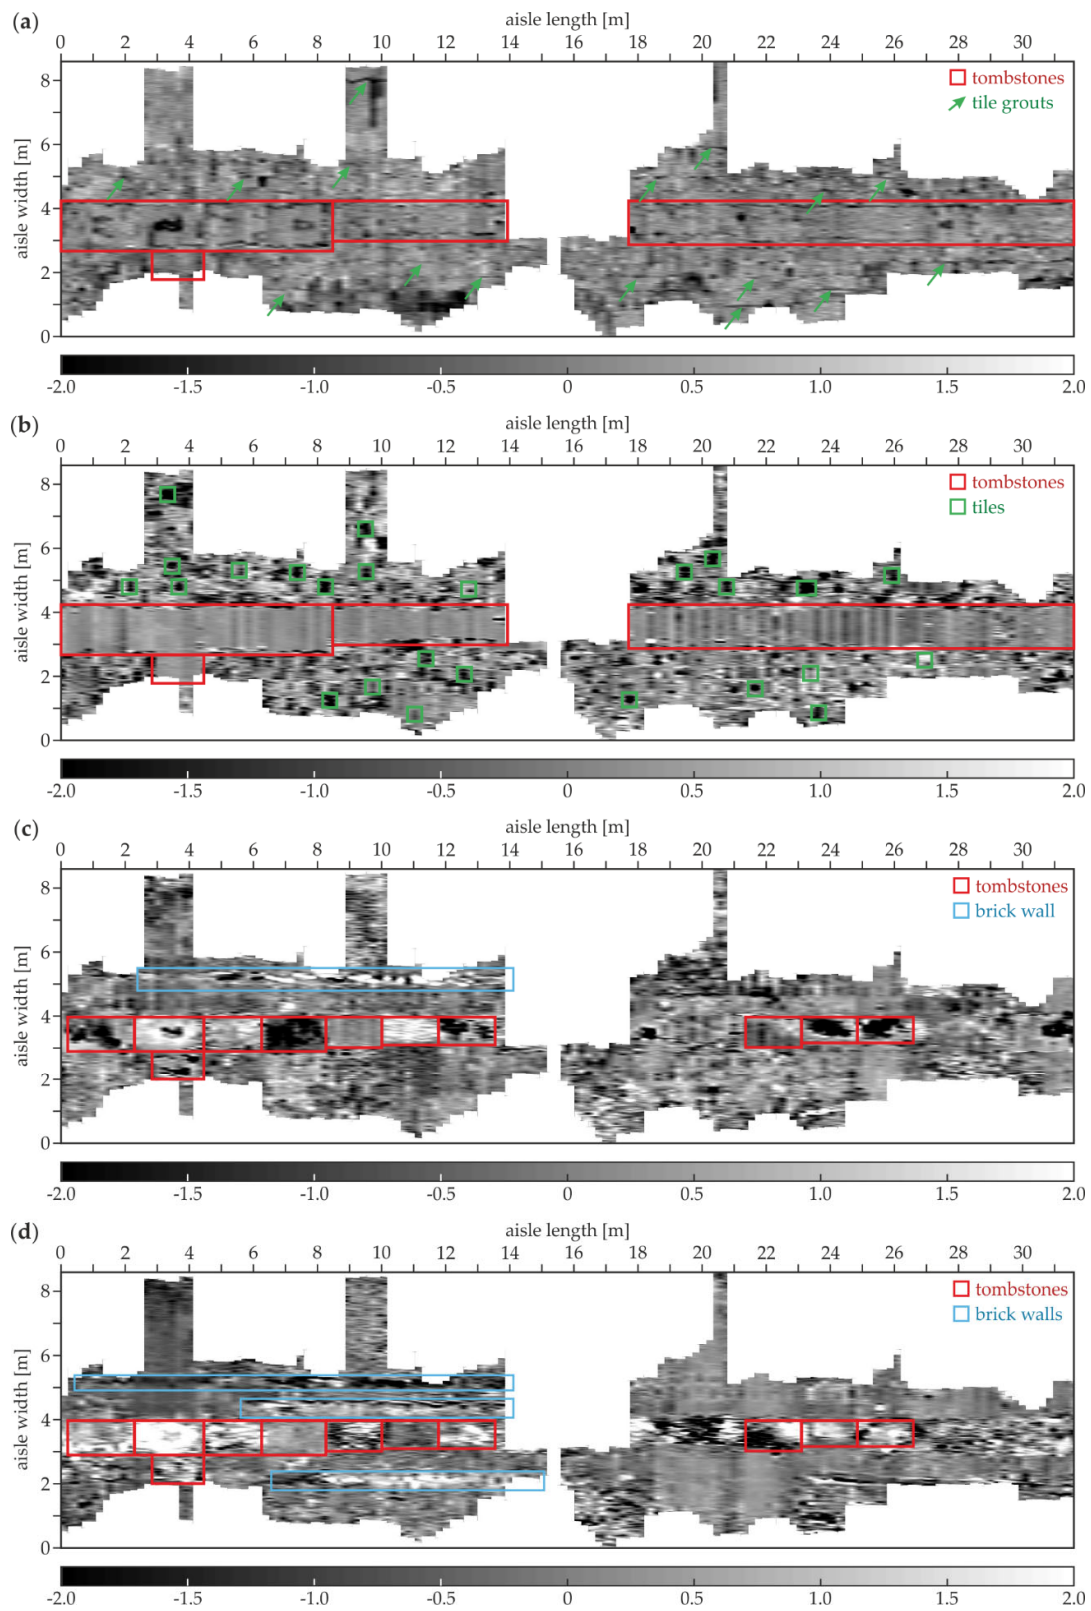
Figure 21 presents the tomographic images of the south aisle. At the depth of 0.16 m (Figure 21a), the tombstones identified in the above-discussed B-scans of the south aisle were detected. The elements were laid in a straight line along the whole aisle at the width between about 2.75 and 4.25 m. Additionally, the single tombstone was located aside from the main row at the length between 2.5

and 4.5 m (it was seen in the A-129 scan, Figure 19). The distinction of singular tombstones from the main row was not possible; the scanning was performed along the tombstone grouts, thus they could not be imaged. The singular tiles were not detected due to a single direction profiling. The tile grouts in the lengthwise direction (perpendicular to the measurement traces) were identified, unlike the crosswise grouts (oriented in the same direction as the scan traces). At the depth of 4.06 cm (Figure 21b), the imaging of the tombstones was far clearer; however, there was still no possibility to distinguish the singular elements. On the contrary, the individual tiles could be detected; the chosen tomography depth was between the minimum and the maximum thickness of the tiles, thus some of them were visible, whereas other ones could not be observed. At the depth of 12.19 cm (Figure 21c), most of the tombstones were clearly visible. The lower faces of some thicker tombstones were below the tomography depth, unlike the thinner ones, which were not detected at this level. The adornment was detected on the second tombstone from the left. The tiles could not be identified because their bottom faces were located certainly above the actual tomography level. What is more, the brick wall was moderately imaged at the width of about 5.2 m and the length between 2.2 and 13.8 m. The tombstones were still distinguishable at the depth of 23.75 cm (Figure 21d). The inhomogeneities in the ground under certain tombstones were visible, especially on the right side of the tomography. The brick wall discovered at the depth of 12.19 cm was still detectable and seemed to be longer. What is more, another two brick walls were identified: the first one at the width of 4.5 m and the length between 5.5 and 14.0 m, the second at the width of 2.2 m and the length between 6.5 and 15.0 m. All of the three walls were clearly imaged in the A-117 B-scan (see Figure 17b).

Figure 21. GPR tomographic images of the south aisle (survey A) at different depths: (a) 0.16 cm; (b) 4.06 cm; (c) 12.19 cm; (d) 23.75 cm.
