# Integrated Application of GPR and Ultrasonic Testing in the Diagnostics of a Historical Floor

**Abstract:** The paper presents the results of integrated ground penetrating radar (GPR) and ultrasonic testing (UT) measurements conducted on a historical floor in St. Nicholas' Church, Gdańsk, Poland. The described inspection was the first stage of the technical state assessment of the building. The aim of the study was the detection of underfloor air gaps, which were observed in a few trial pits. The condition of the ground under the floor was determined by localizing other inclusions such as rubble, human remains, brick walls and pipes. To identify the phenomenon of electromagnetic and ultrasonic wave propagation within the air gap, laboratory tests were conducted on physical models consisting of two concrete slabs stacked on top of each other and gradually moved apart to simulate a slot of varying thickness. The conducted research was supported by the numerical models of electromagnetic wave propagation. The obtained results showed that the integration of the GPR and UT methods provided an effective imaging of the floor and the area under it. Ultrasonic testing was proved to be a

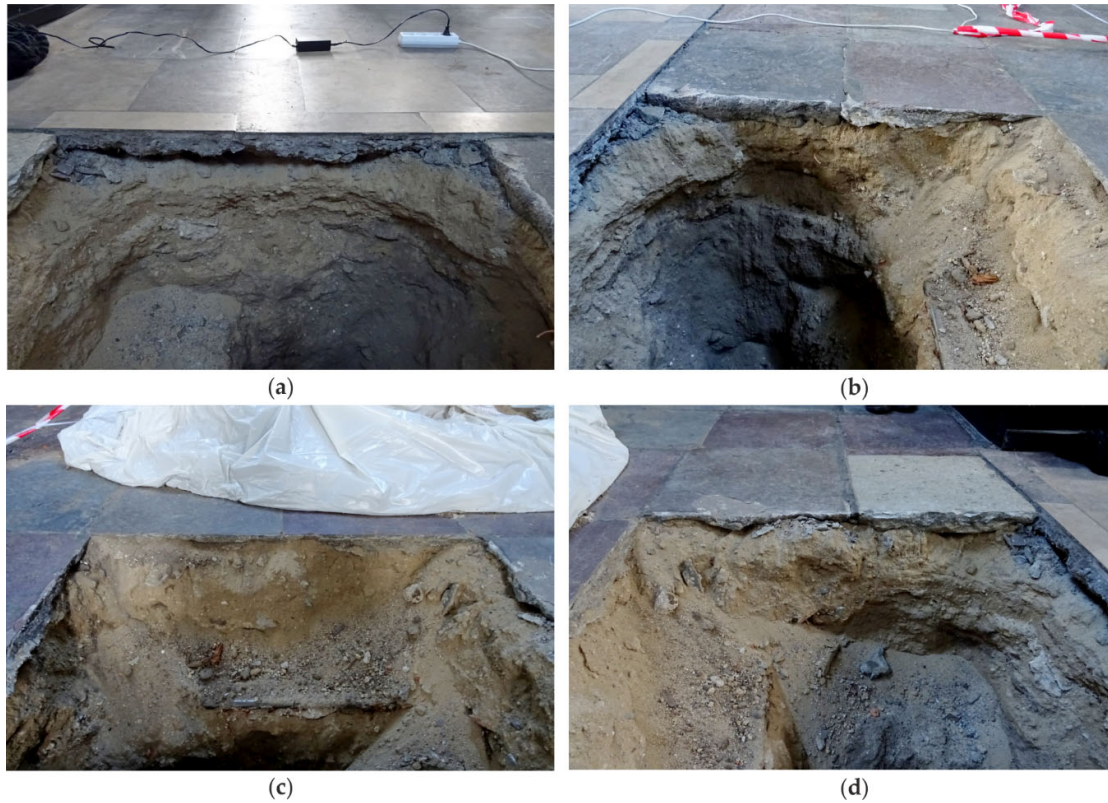
The conducted floor inspection reported in this paper was the first stage of investigations directed to assess the technical state of the church. NDT tests were performed on the floor of two aisles, south and north, as shown in Figure 1. In both aisles, the top floor layer was made of stone tiles measuring approximately 43 cm × 43 cm. In the central part of each aisle, tombstones were laid. The cross-section layers of the floor were identified in a few trial pits. One of the pits located in the north aisle is shown in Figure 2. Based on a visual inspection of the cross-section visible in the trial pit, particular layers in the floor were identified (Figure 3). It was found that the stone tiles laid on the cement mortar layer had a thickness of approximately 2–6 cm. Below was a layer of sand and ground backfill. It was also identified that at some edges, an air gap with a thickness of approximately 1–2 cm was visible below the cement mortar.

**Figure 2.** Photographs of the trial pit in the floor: (a) edge 1; (b) edge 2; (c) edge 3; (d) edge 4.

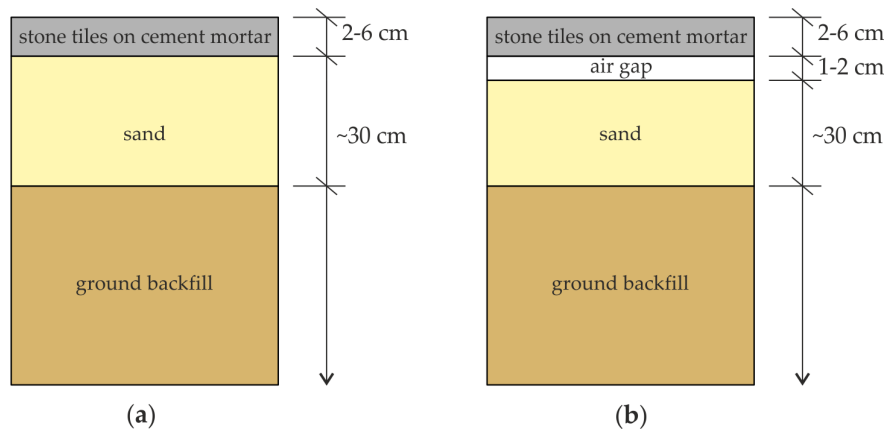
**Figure 3.** Schematic sketch of floor layers in the trial pit: (a) appropriate cross-section (without air gap); (b) cross-section with damage (air gap).
