1 Thermal failure of a second rotor stage in heavy duty gas turbine

10 11 Abstract

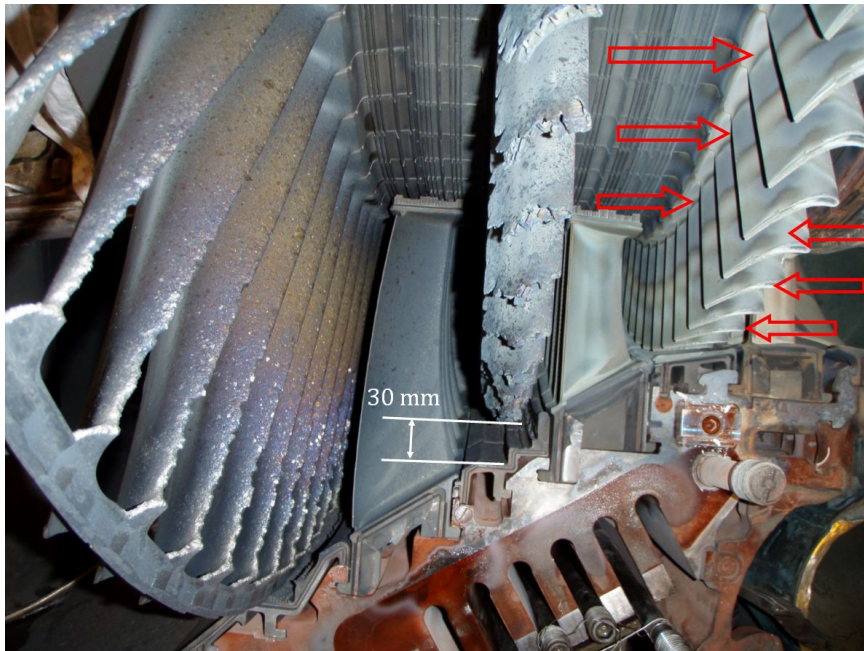
37 The gas turbine blade was broken in the upper part of the blade, near the bandage. The even
38 melting of all blades of the rotor stage and the jagged nature of the damage proves that we
39 are dealing with failure resulting from the presence of a large heat source. This source was,

1 most likely, (Fig. 1) the friction of the rotating blade bandages against the seals separating the
2 body case. The specific stepped shape of this seal, which has no equivalent in subject
3 literature, is also not without significance here.

4
5 Figure 1 View of the 2nd stage following the failure with a characteristic even melting
6 of the upper parts of the blades.

7 The melting occurred evenly, stopping at a distance of 30 mm from the internal walls of the
8 body case. An additional argument in favour of thermal damage to the blades are tarnish
9 indicated by arrows, clearly visible on the first stage of the turbine. These stains are the result
10 of high temperatures, and their formation is primary in its nature, resulting from too high a
11 temperature of the flowing exhaust gas. In an interview with the power plant operator, we
12 determined that the failure was preceded by a change in the fuel supplied to the turbine.

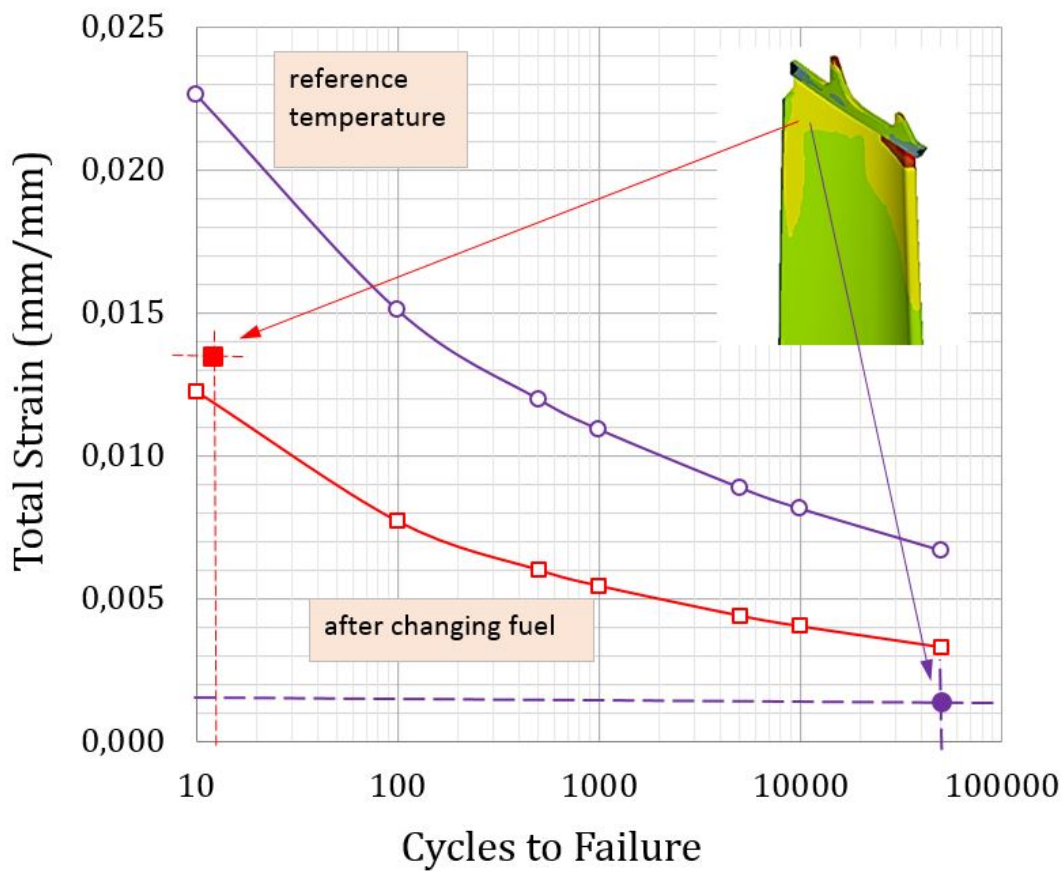
1 Two curves were drafted, presenting the relationship of the amount of deformation to the
 2 number of cycles required to destroy the material. The first (upper) curve presents the
 3 relationships for the nominal operating conditions of the stage powered by reference fuel.
 4 The calculated point is located at the bottom of the graph, indicating some 50 000 cycles to
 5 failure. This value is close to the design value, which for heavy duty stages equals 100 000
 6 cycles. The magnitude of deformations also falls below the critical line.
 7 After changing the fuel and increasing the stage temperature, the read size of deformations
 8 increases drastically, adopting the location of the critical curve drafted for the changed fuel.
 9 Now the number of cycles to failure reads about 20.

Fig. 10 Estimated number of cycles to failure by using Manson's criteria

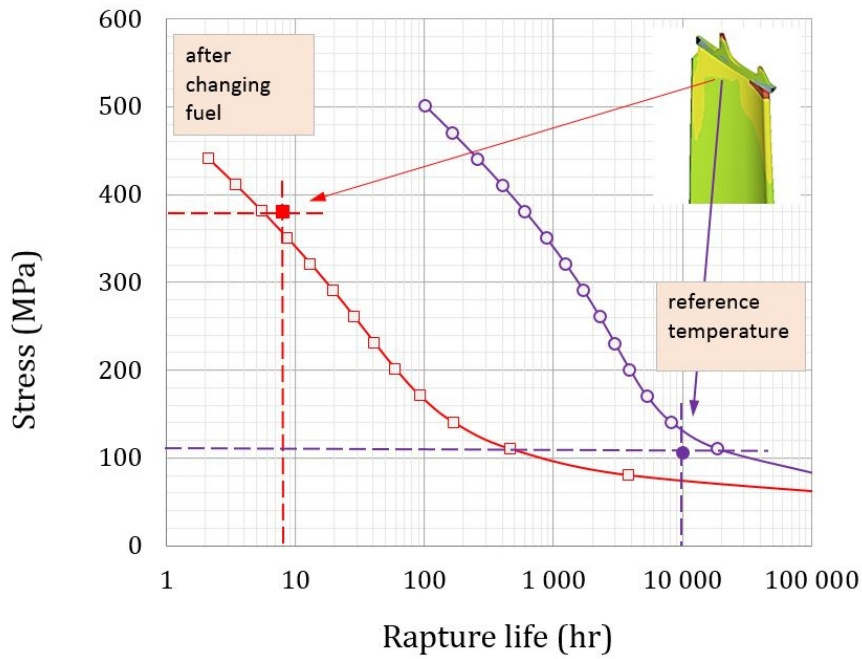
10 A similar relationship was observed when plotting the relation of service life to the magnitude
 11 of stress generated in the blade. The results are presented in Fig.11. Stresses generated in the
 12 blade during nominal operation are below the critical line indicating an estimated service life
 13 of approximately 10 000 hr. The resulting value is also acceptable in terms of design criteria.
 14 After changing the fuel, the increasing stress caused the crossing of critical line, thus
 15 determining the value of service life at just 10 hr. This change in available service life is drastic
 16 and should not be left unnoticed.

Fig. 11 Estimated time to failure using the first technique of data description.

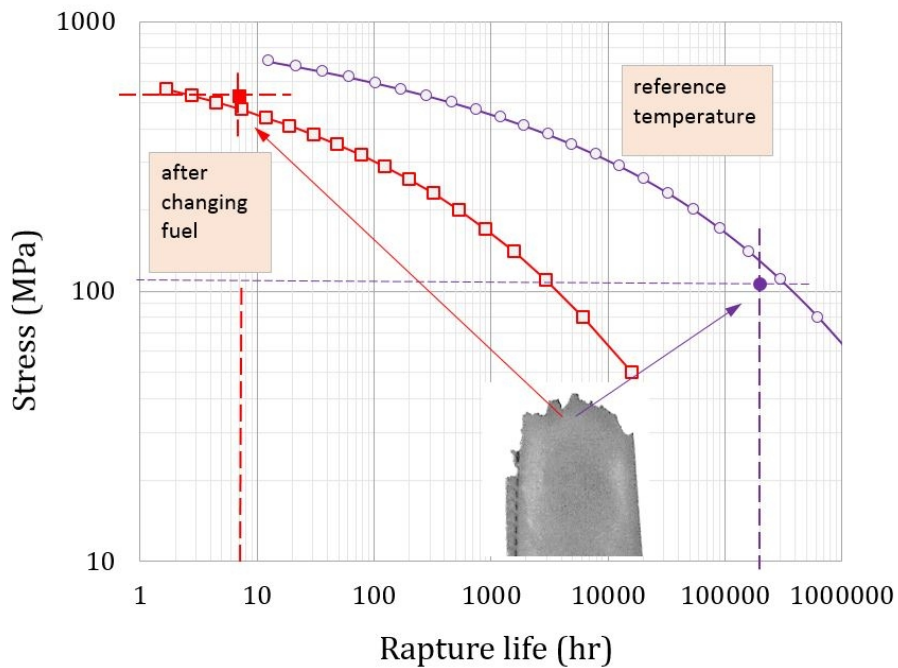
Fig. 12 Estimated time to failure using the second technique of data description.

The results presented in Fig. 12, confirm the existing rule. Stresses read in the blade material in the FEM analysis indicated the possibility of seamless blade operation of up to 200 000 hr. Changing the fuel, and thus the working conditions of the stage and stress of materials reduced the permissible operating time to 8 hr. These results are consistent with previous observations.
