1 Thermal failure of a second rotor stage in heavy duty gas turbine

12 The impulse mode of operation and the supply of various types of fuels causes frequent
13 failures even in the heavy duty gas turbines. The paper presents the ravages of second rotor
14 stage failure in a gas turbine. The excessive thermal elongation rise caused by fuel change
15 was indicated as the main cause. We applied nonlinear numerical analysis, preceded by
16 thermodynamic calculations of the turbine and visual inspection of the effects of failure.
17 Simulations were performed on undamaged blade geometry under load resulting from
18 combustion: nominal fuel and the changed fuel. Thermodynamic calculations demonstrated
19 a 70°C increase in temperature using the changed fuel. The blade tip displacements
20 demonstrated the possibility of abrasion. The amount of displacement of the tip of the turbine
21 blade with increasing pressure or increasing rotational speed do not pose as great a threat, as

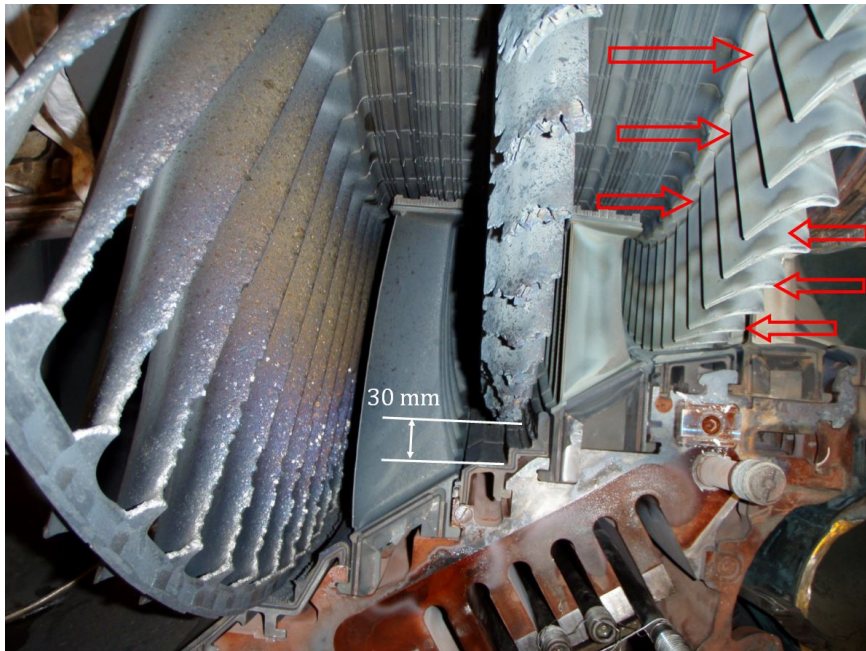
37 The gas turbine blade was broken in the upper part of the blade, near the bandage. The even
38 melting of all blades of the rotor stage and the jagged nature of the damage proves that we
39 are dealing with failure resulting from the presence of a large heat source. This source was,

1 most likely, (Fig. 1) the friction of the rotating blade bandages against the seals separating the
2 body case. The specific stepped shape of this seal, which has no equivalent in subject
3 literature, is also not without significance here.

4
5 Figure 1 View of the 2nd stage following the failure with a characteristic even melting
6 of the upper parts of the blades.

7 The melting occurred evenly, stopping at a distance of 30 mm from the internal walls of the
8 body case. An additional argument in favour of thermal damage to the blades are tarnish
9 indicated by arrows, clearly visible on the first stage of the turbine. These stains are the result
10 of high temperatures, and their formation is primary in its nature, resulting from too high a
11 temperature of the flowing exhaust gas. In an interview with the power plant operator, we
12 determined that the failure was preceded by a change in the fuel supplied to the turbine.
