The Impact of Material Selection on Durability of Exhaust Valve Faces of a Ship Engine – A Case Study

Hanna Smoleńska¹, Włodzimierz Kończewicz², Sylwia Bazychowska^{2*}

ABSTRACT

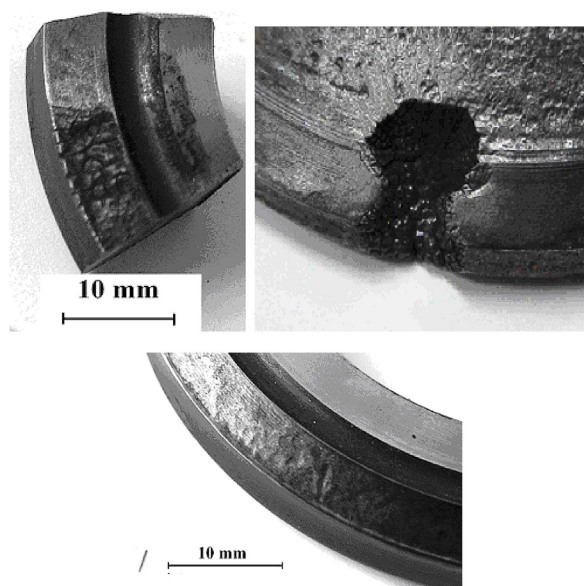
- loss of tightness caused by corrosion pits resulting from erosive exhaust fumes (Fig. 1b),
- over burning of the valve head edges caused by the flow of extremely hot gases through the leaks (Fig. 1a),
- cracks, scratches and splinters caused by fatigue of the face layer (Fig. 1c).

Fig. 1. Examples of damaged exhaust valve of the marine engine: (a) corrosion of the face – “pavement”; (b) destruction of the face and substrate due to valve leaks – irreparable; (c) face wear – repairable

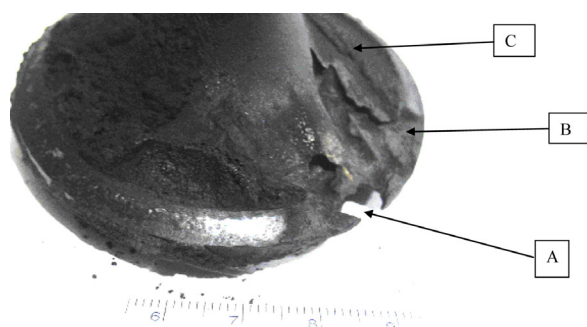
After 2000 hours of service valve L12 was still intact without of any traces of serious failure but valve N was completely destroyed. Figure 2 presented the state of the valve N after operation. On the right side of the figure there is visible broken (A) part of the valve and the layer of surfacing (B) has practically disappeared. The damage also applies to the valve plug (C). The L12 valve

Fig. 2. N valve after 2000 hours of operation

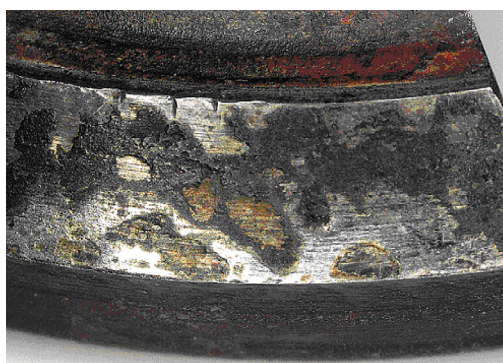
Fig. 3. L12 valve after 3000 hours of operation. Magnification 10x

after 3000 hours of operation did not show any significant signs of wear or damage (Fig. 3).

The L12 valve shows little signs of degradation after a longer operating time. Some regions of the scale are visible however some of the face is still shiny and smooth. Detailed investigations were carried out on the face surfaces of both valves and microstructures on the cross-section of the analyzed valves. In addition, hardness measurements were carried out to assess the degree of material degradation. During the operation and heat interaction, diffusion processes occur in the surfacing material leading to changes in the structure. Mainly the formation of oxides on the surface causes the decomposition of carbides and a decrease in the hardness of the material. Microhardness tests are very sensitive to microstructure changes.

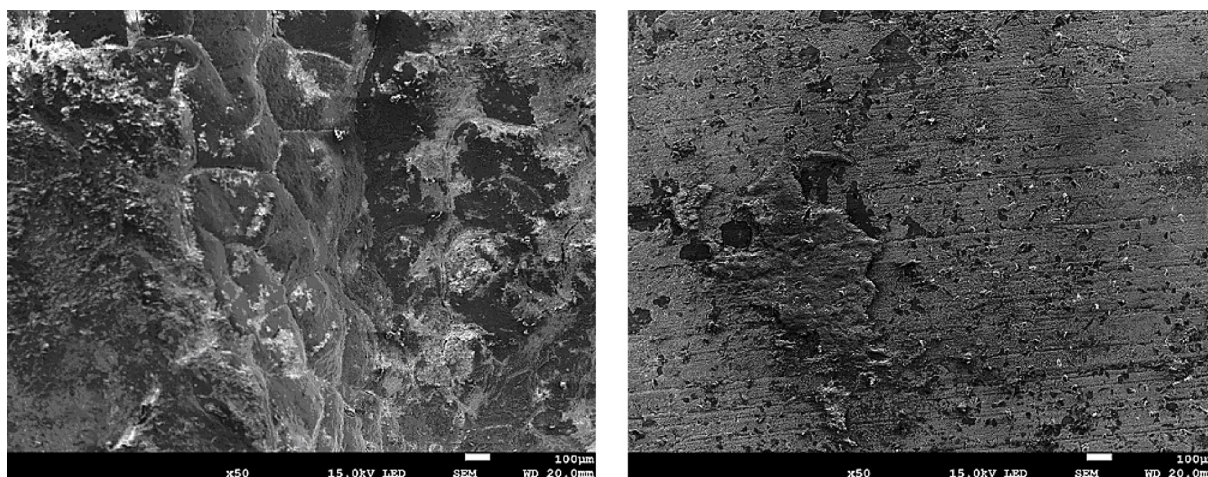
Fig. 4. N valve destroyed during operation – face surface (a), face surface in a different area (b)

condition of the N valve after service. Significant differences of the appearance of the valve face surface were observed. It also indicates different properties of the material in different area of the face which is not acceptable.

Observed destruction of the face can be caused by various factors. It may be the result of incorrect selection of padding materials, improper parameters of the padding process, but also mechanical causes of damage, i.e. overloading or improper valve grinding should be taken into account. In this work only chemical composition of the clad and changes in mikrostrusture were analyzed.

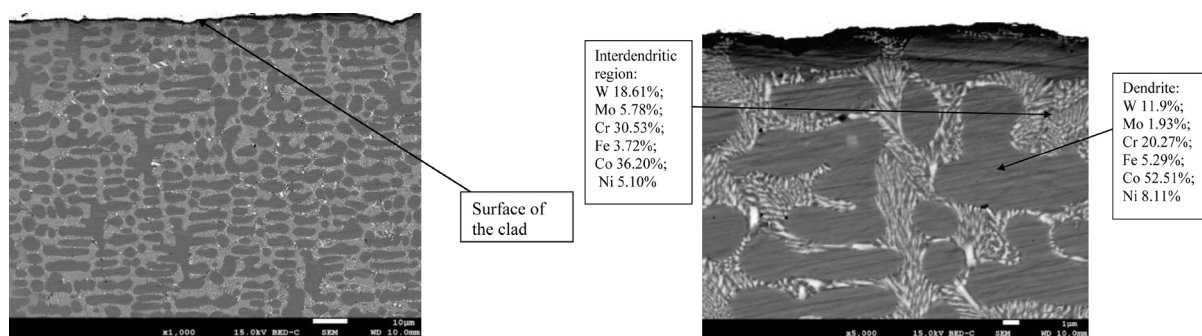
Fig. 5. N valve destroyed during operation – microstructure on the cross-section, close to the face surface; it is visible dendritic structure characteristic for free solidification of melted metal during surfacing (a); microstructure on the cross-section, near the top surface; EDS results for dendritic and interdendritic region (point analysis) (b)

The valve was cut into samples, included and a specimen prepared, which was observed on a scanning electron microscope (SEM). On Figure 5 is presented mikrostruktue of destroyed valve N. Mikrostruktue is typical for cladding

technology [3, 4, 10, 26]; visible dendritic structure (dark) and interdendritic regions (light under low magnification). Dendritic region are a solution of alloying additives in cobalt, mainly nickel, iron, chromium, tungsten and molybdenum. The interdendritic region consist of mixture of carbides end eutectics (Fig. 5a). During previous tests of welds made of the same powder as designated L12, occurrence was found was found by XRD analysis presence of carbides were identified as mainly $M_{12}C$ (Co_6W_6C), M_7C_3 and $M_{23}C_6$ ($Cr_{23}C_6$). EDS analysis shows a significant presence of tungsten, chromium and molybdenum

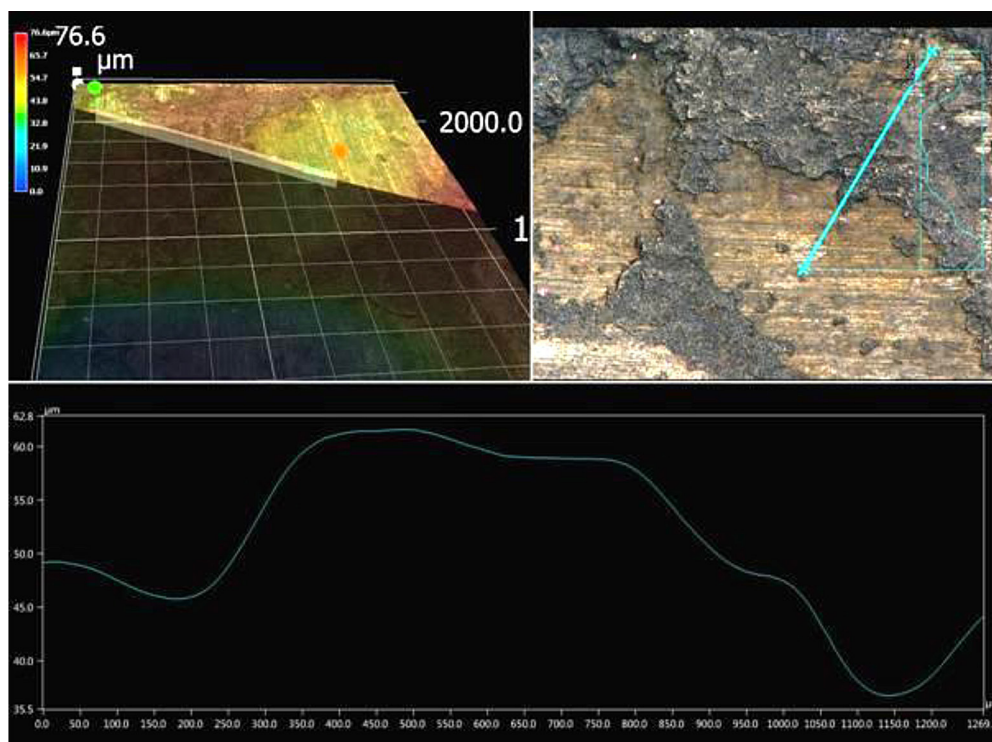
Fig. 6. Surface profile of L12 valve face after operation –visible regions of existing scale. Analyse made by laser profiler KEYENCE

surface of the outlet valve face has been slightly degraded. Keyence equipment was used for surface analysis. This equipment is a microscope coupled with a profilograph and allows measure the surface profile of targets in X and Z directions. The height, width or gap on a surface profile can be measured. Observation of the face surface showed the presence of crumbling scale and areas of the exposed metal surface. In

Figure 6 a multilayer scale with a tendency to crack and delaminate is visible. However, the largest layer thickness did not exceed 60 μm. SEM analysis of the valve face marked L12 showed the slight plastic deformation of the surface was observed, which can be interpreted as the effects of plastic deformation during work, this is illustrated in Figure 7.

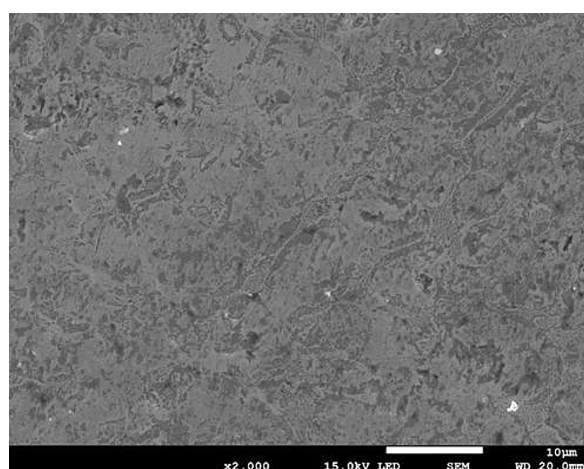
Fig. 7. L12 valve face after operation – plastic deformation

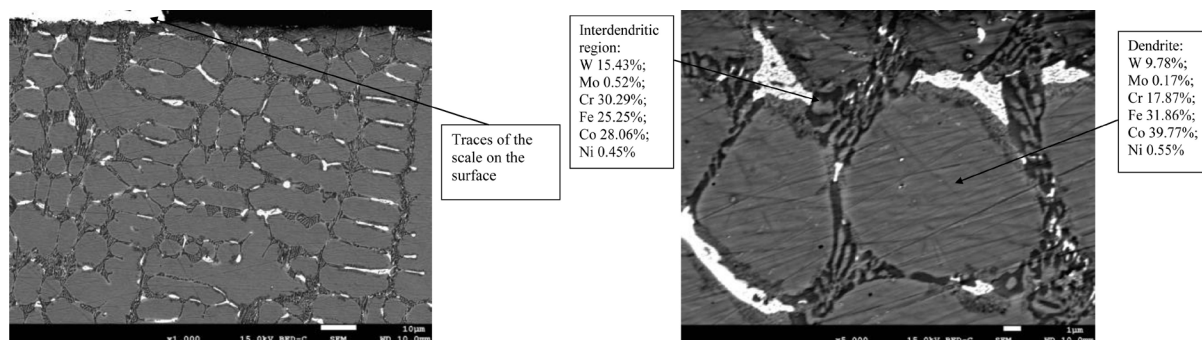
SEM observation of the cladding layer cross-section does not show any significant changes in relation to the typical microstructure of the clad layer. However, the presence of the scale on the face surface indicates changes in chemical composition resulting from diffusion processes. The EDS analysis results for the padding area just below the scale was as follows: Si-2.49%; Cr-23.12%; Fe-31.83%; Co-35.30%; Ni-0.60%; W-5.79%; Mo-0.86%. It may cause changes in material hardness because the scale is mainly composed of chromium oxide, which has protective properties. This is also the reason for using alloys with such high chromium content. Chromium is mainly contained in carbide secretions and they are also the main source of diffusion to the surface. Degradation of carbides decreases the hardness of the material [10, 24, 25].

Fig. 8. (a) L12 after operation - microstructure on the cross-section, near the top surface. No visible changes in dendritic microstructure under the scale (b) L12 after operation - microstructure on the cross-section, near the top surface. EDS results for dendritic and interdendritic region (point analysis)

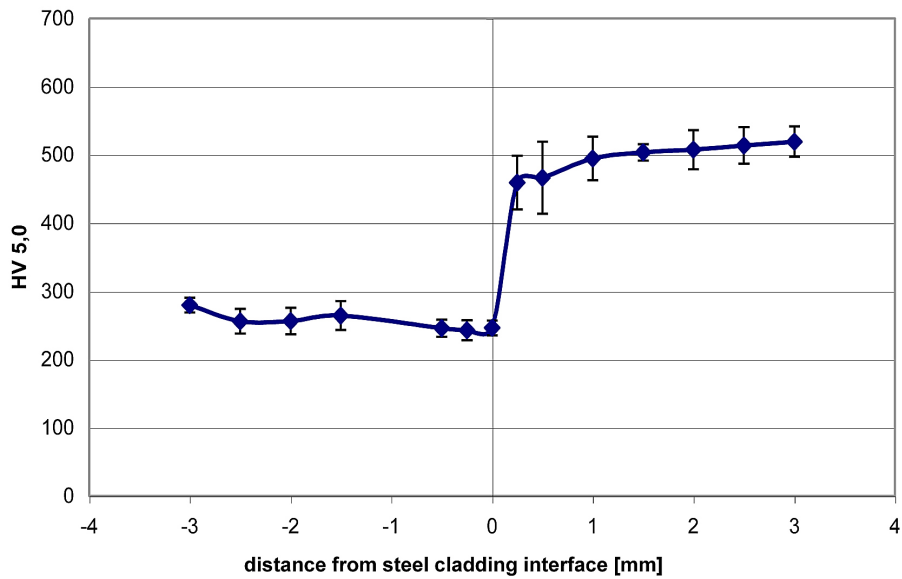
Fig. 10. Statistical analysis of the hardness measurements for the L12 valve after 3000 hours of operation

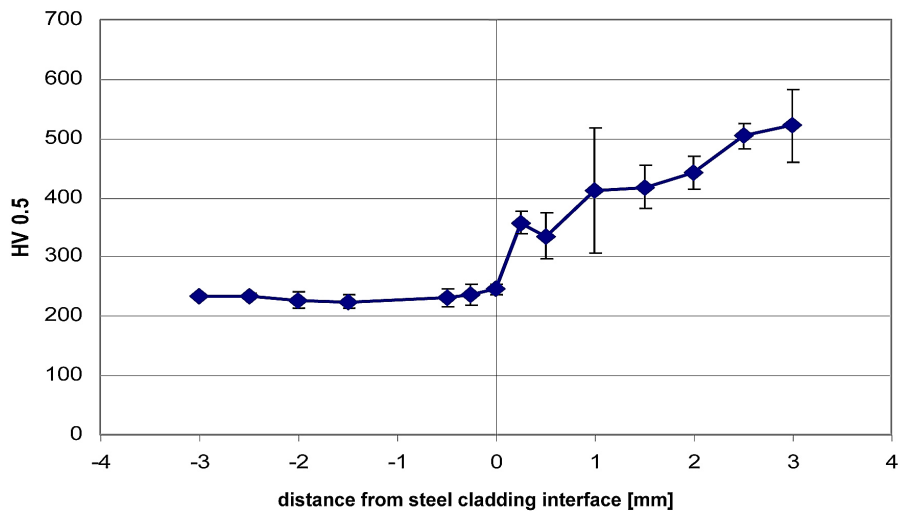
Fig. 11. Statistical analysis of the hardness measurements for N valve after 2000 hours of operation

found in the range 480 to 581 HV5.0 at distance 3mm from the steel-clad interface (close to clad top surface) – similar to L12, but in the deep of the clad hardness decreases up to 195-447 HV5.0. In means large changes in hardness on the cross-section. In both cases no significant decrease in hardness was observed close to the top surface, which indicates that despite the formation of the oxide layer, no degradation of the material will occur.

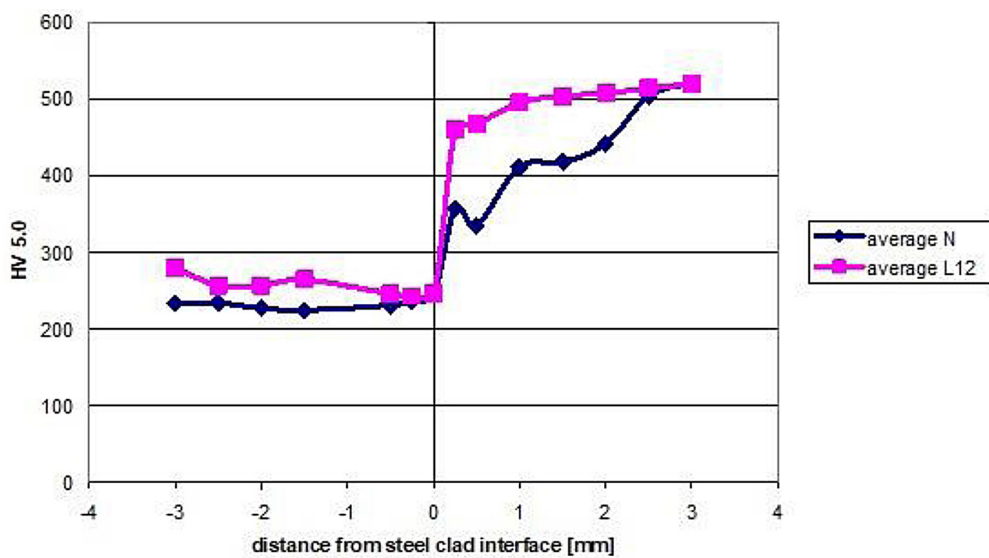
Fig. 12. Comparison of average values of hardness of the N and L12 faces claddings

3. Hardness measurements showed stable hardness of the L12 surfacing weld, higher than the hardness of the substrate. While a constant decrease in the hardness of the N-weld surfacing across the thickness is observed which could affect its durability.
