The Impact of Material Selection on Durability of Exhaust Valve Faces of a Ship Engine – A Case Study

Two alloys were used in order to extend the service life of marine engine exhaust valve head. Layers of cobalt base alloys were made of the powders with chemical composition as follow: the layer marked L12; C-1.55%; Si-1.21%; Cr-29.7%; W-9%; Ni-2%; Mo<0.01%; Fe-1.7%; Co-54.83% and the layer marked N; C-1.45%; Co-38.9%; Cr-24.13%; Ni-10.43%; W-8.75%; Fe-7.64%; Mo-7.56%; Si-2.59%. Base metal was valve steel after heat treatment. It was consisted of: C-0.374%; Cr-9.34%; Mn-0.402%; Ni-0.344%; Si-2.46%; Mo-0.822%; P-0.0162%; S-0.001%. Layers on the valve faces were produced by laser cladding using the HPDL ROFIN DL020 laser. Grinding treatment is a very popular form of regeneration of seat and valve plug adhesions. Properly performed grinding operation ensures dimensional and shape accuracy of the surface from 7 to 5 accuracy class and surface roughness Ra not less than 0.16 μm, depending on the object and method of grinding. The 75H and 150S types are a significantly simplified form of valve plug face grinders. Finishing treatment was carried out with a Chris-Marine AB75H sander on a

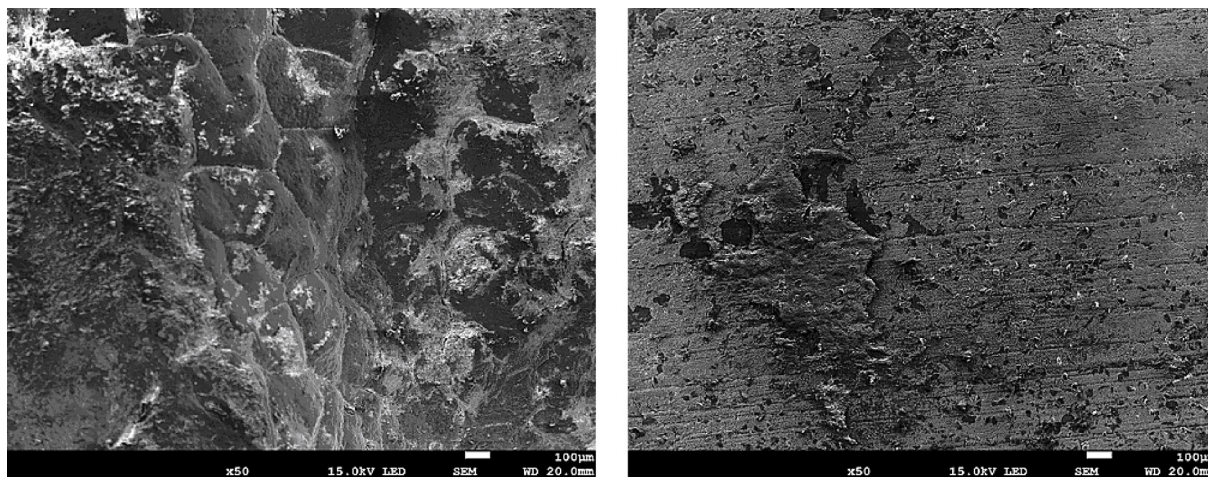
Fig. 4. N valve destroyed during operation – face surface (a), face surface in a different area (b)

condition of the N valve after service. Significant differences of the appearance of the valve face surface were observed. It also indicates different properties of the material in different area of the face which is not acceptable.

Observed destruction of the face can be caused by various factors. It may be the result of incorrect selection of padding materials, improper parameters of the padding process, but also mechanical causes of damage, i.e. overloading or improper valve grinding should be taken into account. In this work only chemical composition of the clad and changes in mikrostrusture were analyzed.

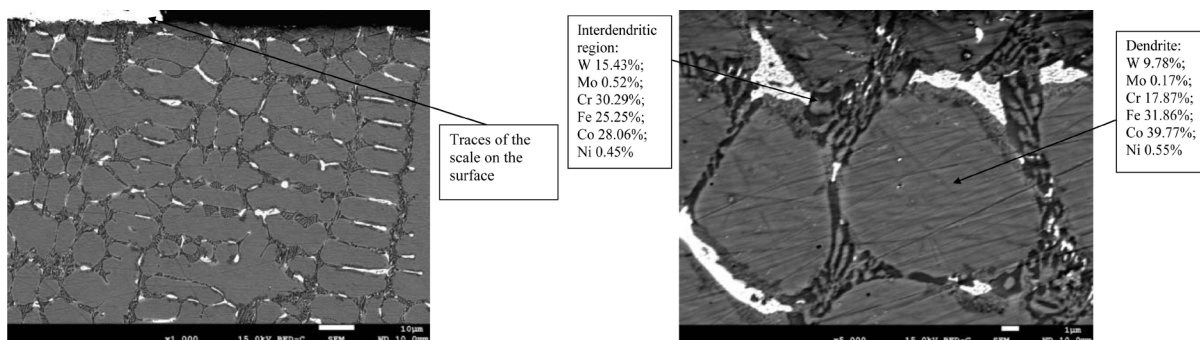
SEM observation of the cladding layer cross-section does not show any significant changes in relation to the typical microstructure of the clad layer. However, the presence of the scale on the face surface indicates changes in chemical composition resulting from diffusion processes. The EDS analysis results for the padding area just below the scale was as follows: Si-2.49%; Cr-23.12%; Fe-31.83%; Co-35.30%; Ni-0.60%; W-5.79%; Mo-0.86%. It may cause changes in material hardness because the scale is mainly composed of chromium oxide, which has protective properties. This is also the reason for using alloys with such high chromium content. Chromium is mainly contained in carbide secretions and they are also the main source of diffusion to the surface. Degradation of carbides decreases the hardness of the material [10, 24, 25].

Fig. 8. (a) L12 after operation - microstructure on the cross-section, near the top surface. No visible changes in dendritic microstructure under the scale (b) L12 after operation - microstructure on the cross-section, near the top surface. EDS results for dendritic and interdendritic region (point analysis)

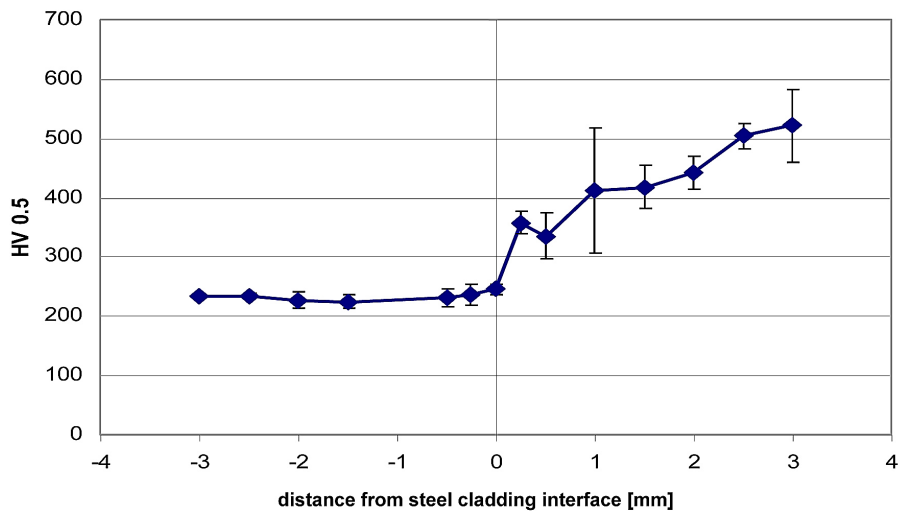
Fig. 11. Statistical analysis of the hardness measurements for N valve after 2000 hours of operation

found in the range 480 to 581 HV5.0 at distance 3mm from the steel-clad interface (close to clad top surface) – similar to L12, but in the deep of the clad hardness decreases up to 195-447 HV5.0. In means large changes in hardness on the cross-section. In both cases no significant decrease in hardness was observed close to the top surface, which indicates that despite the formation of the oxide layer, no degradation of the material will occur.

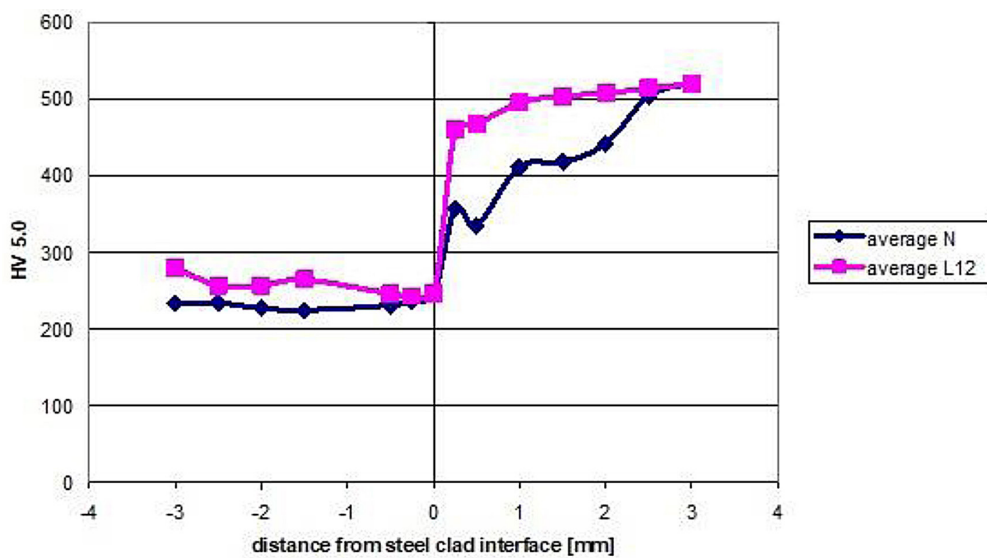
Fig. 12. Comparison of average values of hardness of the N and L12 faces claddings

3. Hardness measurements showed stable hardness of the L12 surfacing weld, higher than the hardness of the substrate. While a constant decrease in the hardness of the N-weld surfacing across the thickness is observed which could affect its durability.
