Corrosion hazards and inhibitor protection in the seawater injection system on the Baltic sea rig

Abstract

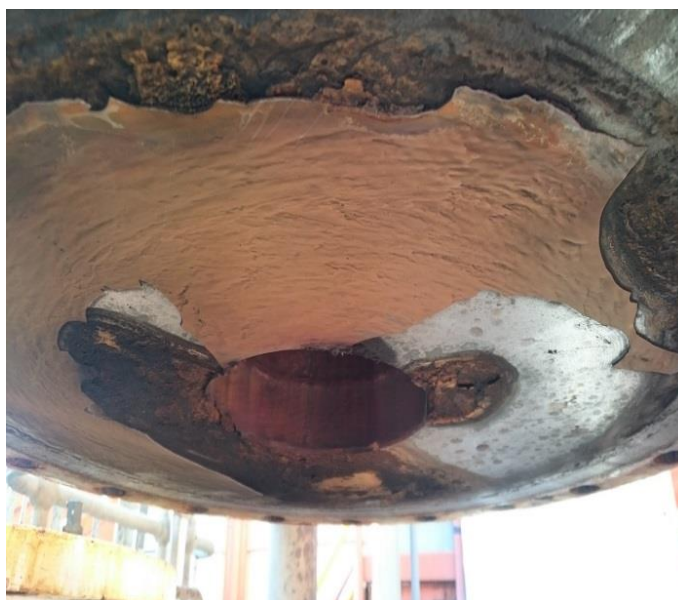
The operational experience of the Baltic Beta rig has shown a significant degree of corrosion aggressiveness of water, which necessitates frequent repairs of the installation, especially downstream of the dual media filters. Such a poor condition of the installation had a negative impact on the injected water quality. The average content of total suspended solids content in the last year was 2.25 mg/l and total iron content was 1.19 mg/l. These values exceed the permissible quality indices for injected water. Figure 2 presents the actual state of the hatches of the dual media filters.

Figure 2. Surface of the inner parts of the dual media filter.

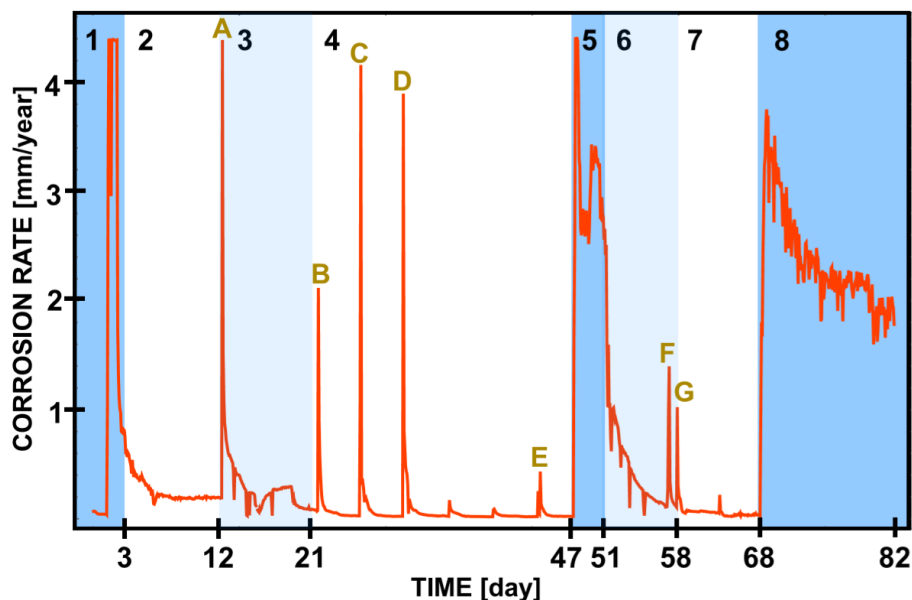
The average rate of corrosion affecting the S236JR non-alloy steel remained at the level of 1 mm/year, which is ten times higher than the safe level of 0.1 mm/year.

Figure 3. Corrosion rate measured at a point downstream of the deaerator tower (sensor 2).

In the periods 1, 5 and 8 (dark blue area), when the internal circuit was in use, the water flow through the installation amounted to $80 \text{ m}^3/\text{h}$, no deoxidization was performed, and the water chlorination process was carried out only to the point at which the free chlorine content reached the level of 0.2 ppm. Corrosion inhibitor was switched off. The average corrosion rates noted in these periods of time were, respectively, 1.68, 2.66 and 2.38 mm/year. Such high levels were associated with high water expenditures (erosion, corrosion), the presence of oxygen at the level of 12.5 ppm, free chlorine at the level of 0.2 ppm, and chlorides. In each of these periods the corrosion rate was decreasing gradually, indicating that some corrosion products might have developed on the metal surface.

In the periods 3 and 6 (light blue area), the process of water injections into the oil formation was being performed. The installation operated at the flow rate of $40 \text{ m}^3/\text{h}$, while water was being deoxygenated and corrosion inhibitor was added. The average levels of corrosion rate recorded in these periods were, respectively, 0.26 and 0.36 mm/year. The low oxygen content, lack of free chlorine, lower water flow rate and dosage of corrosion inhibitor brought the corrosion rate down significantly. Despite this fact, its level was still too high. This might prove the occurrence of MIC or low efficiency of the corrosion inhibitor. These periods were characterized also by a gradual decrease in the corrosion rate. However, the corrosion rate drops occurred faster here than in the periods when the internal water circuit was switched on. This is due to the lower water flow rate, which does not wash the corrosion products off from the inner surface of the pipes and an addition of a corrosion inhibitor. Peak A in the area 3 shows when the water flow in the system was switched on and the corrosion products became detached. Peaks F and G in the area 6 result from temporary adjustments of the water flow rate.

Very interesting results were recorded in the periods marked 2, 4 and 7 (in white), when the water flow through the installation was entirely shut off. In the first period (2), the installation was filled with water without a corrosion inhibitor. The average corrosion rate was 0.33 mm/year at the time. In the periods 4 and 7 the water flow was turned on every five days for a period of one hour in order to flush the equipment with water containing the corrosion inhibitor. The average corrosion rate in this period equaled 0.129 and 0.075 mm/year, which shows that the inhibitor used is highly effective under stationary conditions, when there is no water flow through the installation. Peaks *B*, *C*, *D* and *E* occurred when large flows of water treated with corrosion inhibitor were turned on, while the smaller peaks correspond to turning the installation on with less expenditure.

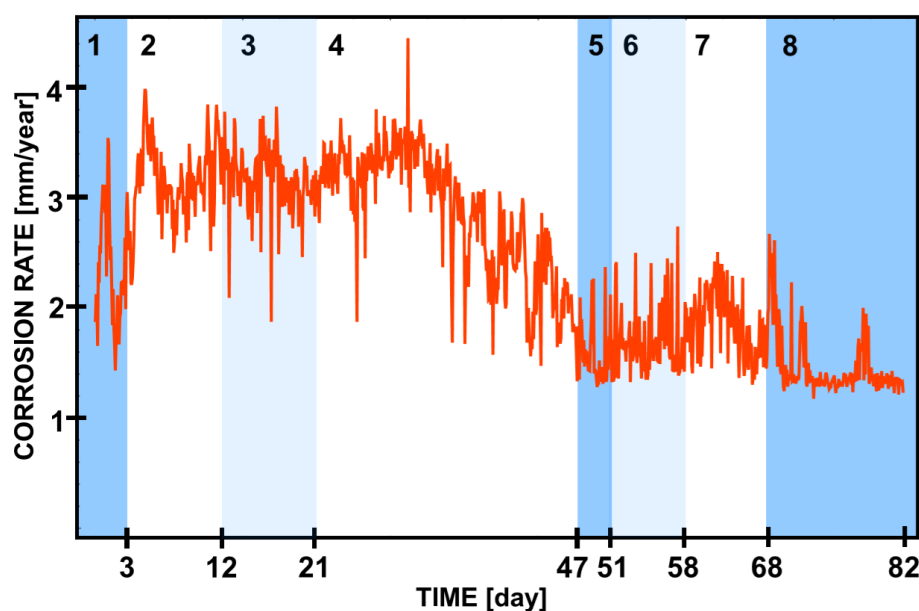
Figure 4. The corrosion rate measured at a point downstream of the dual media filters (sensor 1).

The average corrosion rate in non-alloy steel measured at a point before introduction of an inhibitor totaled 2 mm/year (which is twenty times higher than the safe level). The measured corrosion rates tended to oscillate. It was related to the fact that the installation was functioning on a periodic basis at the time. The noticeable oscillations match the devices operation schedule.

In the periods marked 1, 5 and 8 (dark blue area), when the internal circuit was on, the average corrosion rates dropped down (~2.28, 1.52, 1.4 mm/year). When the water was being injected (light blue area, marked 3 and 6) and flow rate was 40 m³/h, the corrosion rate was higher (3.07, 1.65 mm/year). Hence, it can be noted that at this point the changes in the installation's operating mode did not have a significant impact on the corrosion rate measurements. The drop in the water flow velocity was not mirrored by a drop in the

corrosion rate. It must be also noted that at times when water was not flowing through the installation, no significant drop in the corrosion rate could be recorded. At the time when the installation remained filled with water not treated with the corrosion inhibitor (white area marked 2), the corrosion rate was 3.05 mm/year, and in the periods marked 4 and 7, when the filters were poured with water containing the corrosion inhibitor, the sensor recorded the corrosion rate of 2.74 and 1.78 mm/year. This may be a proof that chlorination of water in this part of the installation does not prevent biofilm development, and that MIC is the dominant corrosion mechanism here, which is why the corrosion inhibitor does not work properly.

We can also notice a decrease in the corrosion rate starting in the middle of period 4. Presumably, turning on a heavy water flow several times in period made some of the biofilm detach, thus slowing the microbiological corrosion rate.

A comparison of the measured corrosion rates with the contents of SRB and GHB showed only a partial correlation between these parameters. However, it must be underlined that only bacteria swimming freely in the water were analyzed. This indicator demonstrates only the potential of water to develop a biofilm. In the future, the number of bacteria in the biofilm will have to be determined to assess the possibility of MIC occurrence, as activity of bacteria proliferating in the biofilm is the main factor behind corrosion of this type. There will have to be performed a mechanical cleaning of the installation and find a new inhibitor

preventing microbiological corrosion more successfully (which may prove difficult). It is particularly important to develop a means of biological protection for the section of the installation upstream of the deaeration tower for the times when only the internal circuit is used.

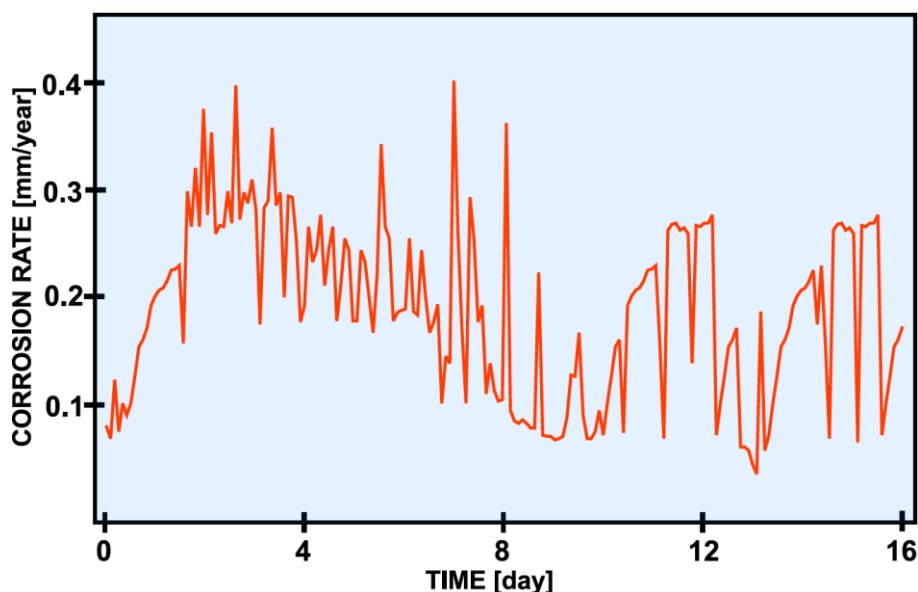
Figure 5. The corrosion rate measured downstream of the deaerator during the second inhibitor test.

The average corrosion rate during the test was 0.2 mm/year. This value is still too high, so the effectiveness of the tested inhibitor was poor. Similar to the corrosion inhibitor used previously.
