Investigation of the 0.4C-35Cr-45Ni-Nb Alloy after Service in High-Temperature Steam and Hydrocarbons Environment

Abstract: The paper presents the results of investigation of the 0.4C-35Cr-45Ni-Nb alloy, which operated in the cracked hydrocarbon feeds and dilution steam at 1125 °C. The material originated from the pyrolytic furnace coil tubes, of which internal walls were in contact with the aforementioned medium, whereas the external walls were in contact with the flue gases. The examination included metallographic and mechanical tests on the material after service exposure, the results of which were compared with the ones obtained for the as-received non-exposed specimens. The metallographic tests revealed changes in the alloy's structure manifested by formation of significant amount of the carbides due to carburization of the alloy from the steam and cracked hydrocarbon feeds side. The central and external parts of the alloy samples (having no contact with the process medium) underwent substantial degradation but within a relatively narrow zone of the material. The investigations of hydrogen and methane content in the alloy showed a high amount of these gases, resulting from hi

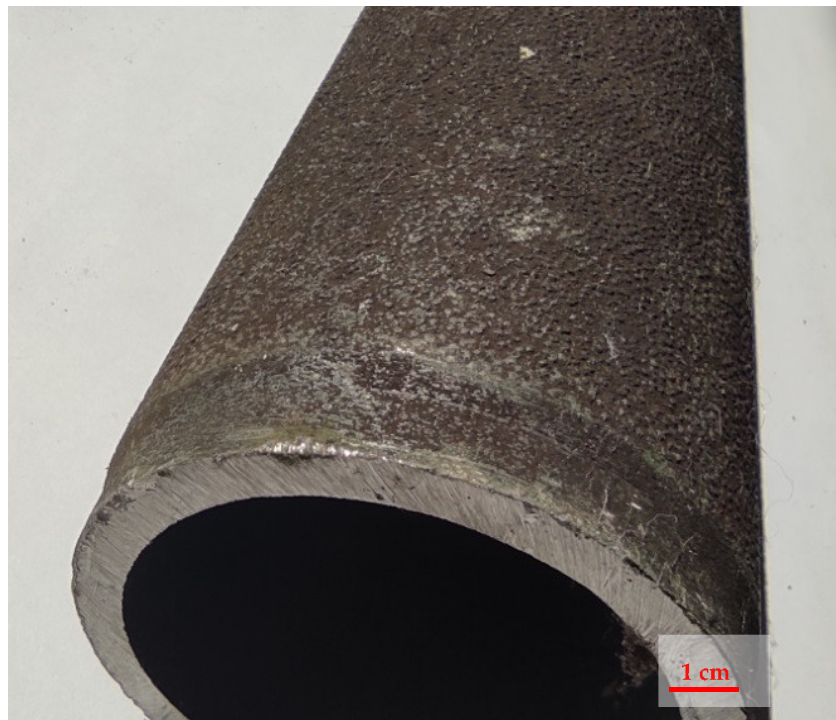
Figure 2. Pyrolytic furnace's coil tube subjected to investigation.

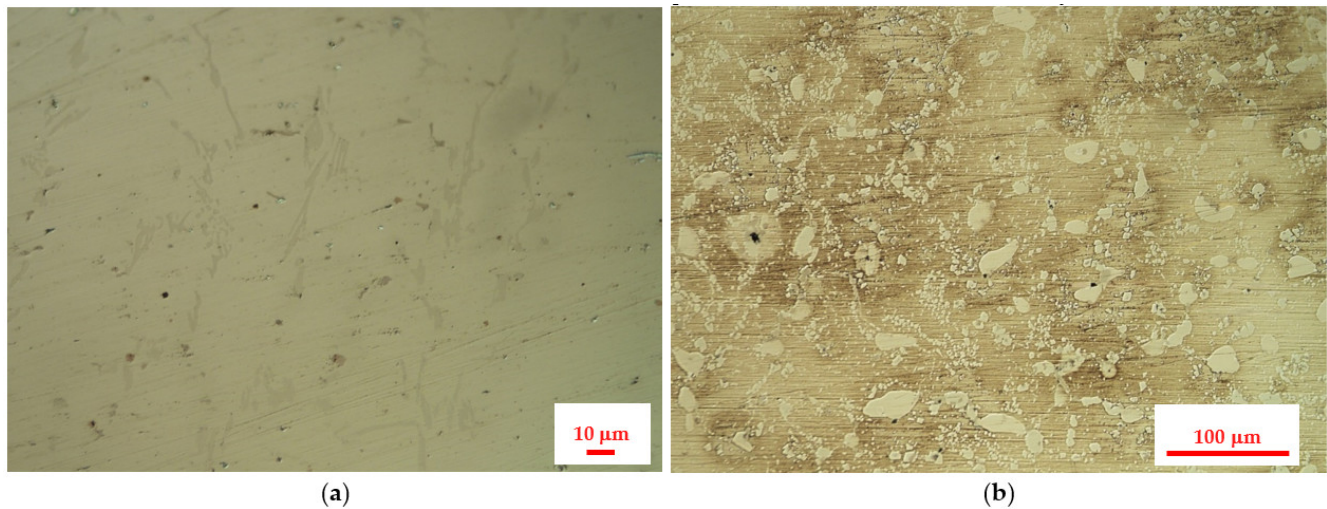
Figure 3. Surface images of the 0.4C-35Cr-45Ni-Nb alloy obtained during metallographic investigations: (a) as-received reference sample; (b) material after 5 years of service in the furnace.

The results of the investigation of the non-exposed reference sample are in accordance with the literature data [6–8]. The metallographic tests revealed carbides present in the form of branched lines (Figure 3a) [9,10]. The SEM image (Figure 4) shows dark structures (spot 1) containing significant amount of chromium and bright structures (spot 3) with higher niobium content with respect to the matrix. Very similar structure and elemental composition of particular phases of the alloy can be found in the paper [8].

In case of the alloy after 5 years of service exposure, one can notice a significant change in the microstructure. There are much more distinct precipitates of the carbides, which occupy a substantial area of the sample (Figure 3b). The change of microstructure results from long-term exposure to the temperature above 805–866 °C and from the influence of the stream inside the coil tubes, which favored carburization [2]. SEM and EDX also reveal chromium-rich phases (spot 1—Figure 5); however, the composition of particular phases differs with respect to the alloys subjected only to an ageing process [2,8]. This fact indicates that the change of microstructure is related to the impact of both aggressive environment and high temperature [11]. No creep process was identified, which suggests a high resistance of the alloy to this phenomenon.

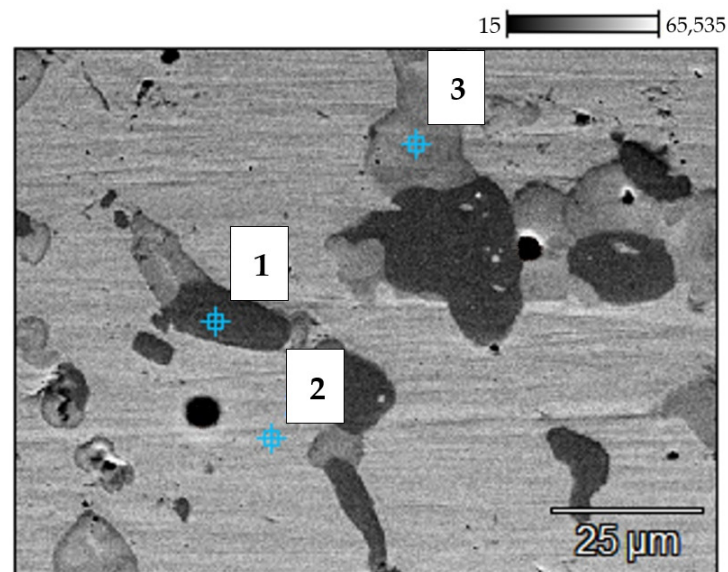
Figure 5. BSE SEM image of the 0.4C-35Cr-45Ni-Nb alloy—service exposed sample’s surface. Numbers indicate the spots of the EDX analysis.

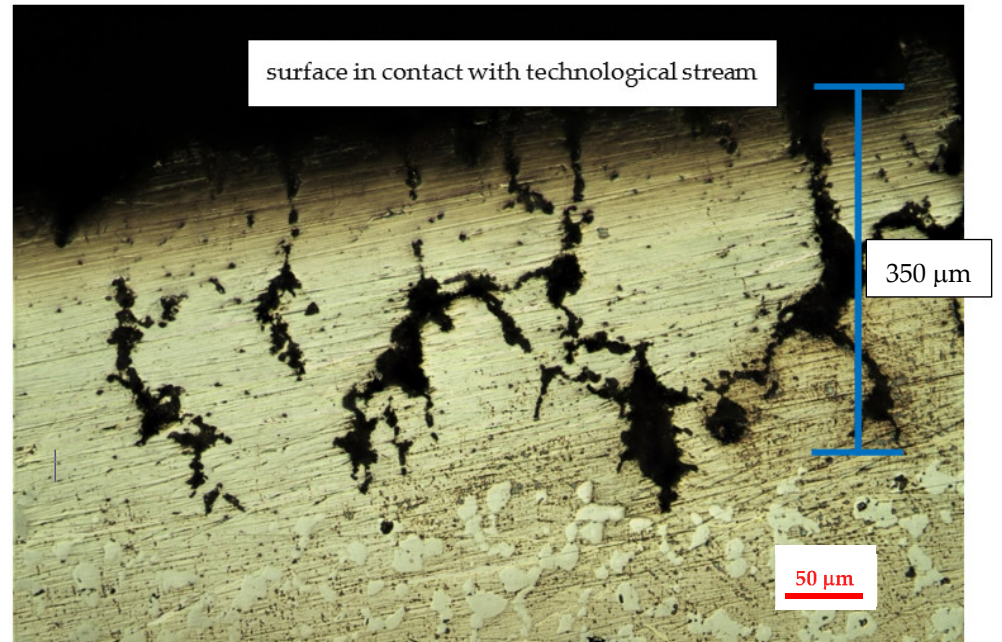
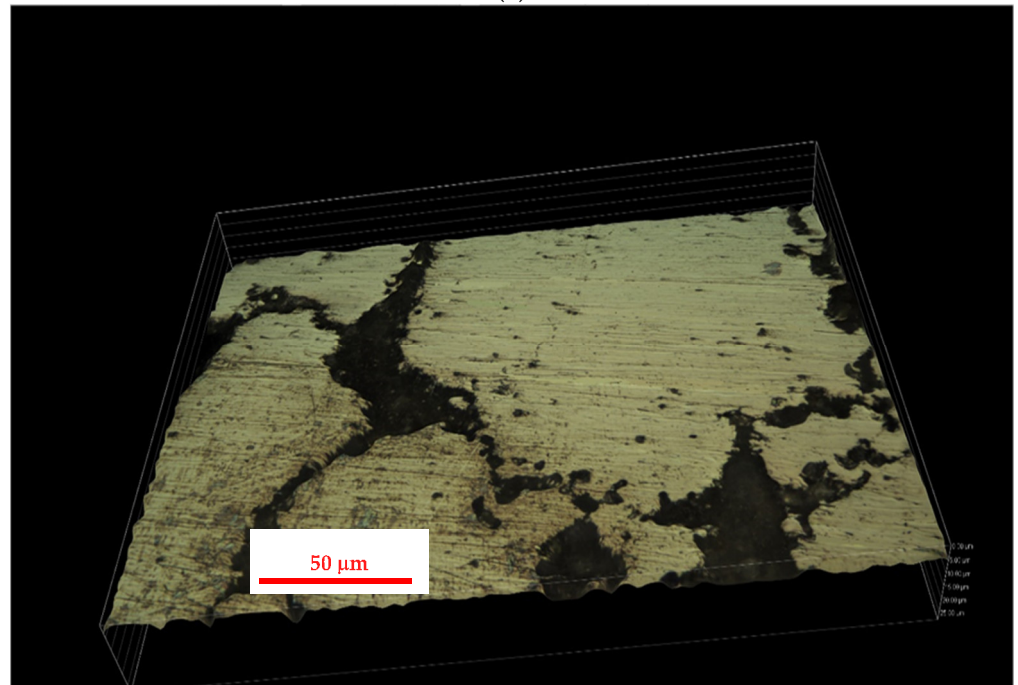
Figure 8. Surface images of the 0.4C-35Cr-45Ni-Nb alloy obtained during metallographic investigations of internal part of service exposed coil tube: (a) internal wall neighboring region; (b) magnification of a fragment of the region presented in (a).

The metallographic investigations show high degradation of the alloy structure in the part of the coil tube. This degradation extends ca. 300 μm from the internal wall to the bulk of the specimen. Visible dark structures are characterized by high amount of silicon and lower content of chromium (spot 1—Figure 9) as compared to the matrix. The presence of a narrow region suffering from dechromization process is also reported in some literature sources [2,12]. Moreover, the degraded zone of the alloy is much more carburized due to the presence of coke, which is formed during thermal degradation of cracked hydrocarbon feeds. Upon service conditions, the internal part of coil tubes can be subjected to metal dusting, although no significant corrosion losses were detected [13,14].

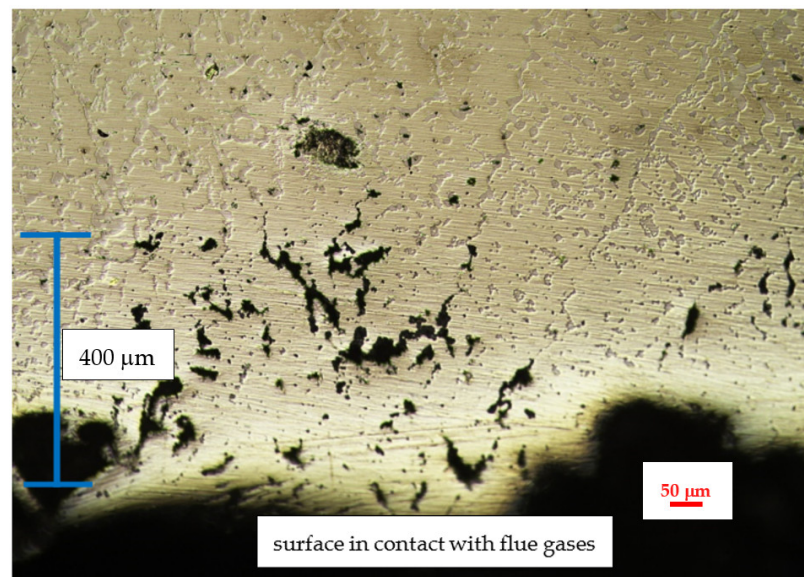
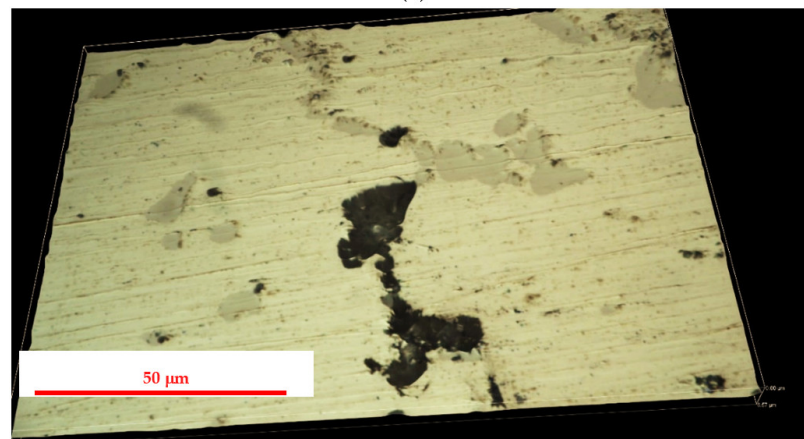
The external part of the coil tube was in contact with the flue gases used for heating of the furnace. In the analyzed case, the fuel consisted of gas hydrocarbons, mainly methane. Oxygen content in the flue gases stream was low, which indicated no risk of the oxidation mechanism [3]. The gas fuel utilized was of high purity, thus eliminating the mechanisms of fuel ash corrosion and flue gas dew point corrosion [3]. High temperature and low content of carbon compounds in the flue gases resulted in decarburization, which is evident on the metallographic images (Figure 10). It occupies a zone of ca. 200 μm , which corresponds to the region with a limited number of carbides [11]. The entire zone of significant structural degradation covers 400 μm .

Figure 10. Surface images of the 0.4C-35Cr-45Ni-Nb alloy obtained during metallographic investigations of external part of service exposed coil tube: (a) external wall neighboring region; (b) magnification of a fragment of the region presented in (a).

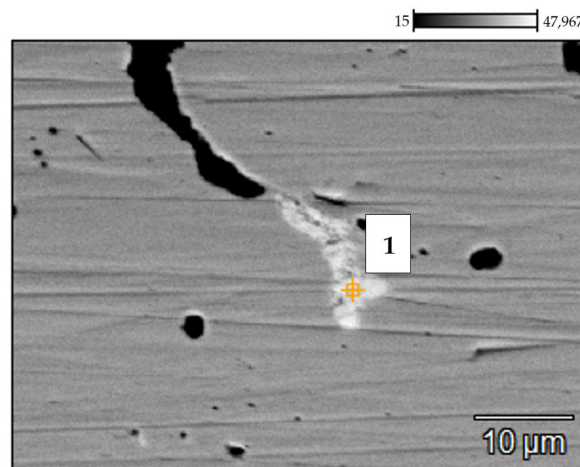
Figure 11. BSE SEM image of the 0.4C-35Cr-45Ni-Nb alloy surface—external part of the service exposed sample. The number indicates the spot of the EDX analysis.
