Investigation of the 0.4C-35Cr-45Ni-Nb Alloy after Service in High-Temperature Steam and Hydrocarbons Environment

Abstract: The paper presents the results of investigation of the 0.4C-35Cr-45Ni-Nb alloy, which operated in the cracked hydrocarbon feeds and dilution steam at 1125 °C. The material originated from the pyrolytic furnace coil tubes, of which internal walls were in contact with the aforementioned medium, whereas the external walls were in contact with the flue gases. The examination included metallographic and mechanical tests on the material after service exposure, the results of which were compared with the ones obtained for the as-received non-exposed specimens. The metallographic tests revealed changes in the alloy's structure manifested by formation of significant amount of the carbides due to carburization of the alloy from the steam and cracked hydrocarbon feeds side. The central and external parts of the alloy samples (having no contact with the process medium) underwent substantial degradation but within a relatively narrow zone of the material. The investigations of hydrogen and methane content in the alloy showed a high amount of these gases, resulting from hi

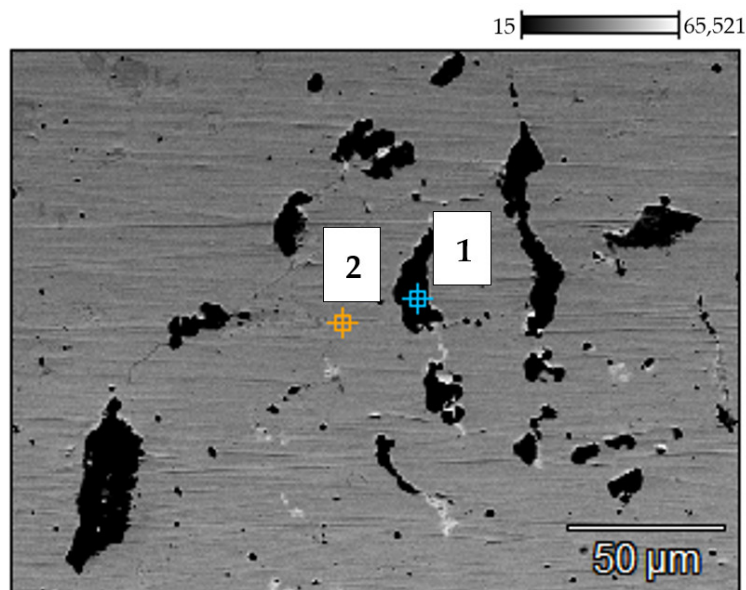
The metallographic investigations show high degradation of the alloy structure in the part of the coil tube. This degradation extends ca. 300 μm from the internal wall to the bulk of the specimen. Visible dark structures are characterized by high amount of silicon and lower content of chromium (spot 1—Figure 9) as compared to the matrix. The presence of a narrow region suffering from dechromization process is also reported in some literature sources [2,12]. Moreover, the degraded zone of the alloy is much more carburized due to the presence of coke, which is formed during thermal degradation of cracked hydrocarbon feeds. Upon service conditions, the internal part of coil tubes can be subjected to metal dusting, although no significant corrosion losses were detected [13,14].

Figure 9. BSE SEM image of the 0.4C-35Cr-45Ni-Nb alloy surface—internal part of the service exposed sample. Numbers indicate the spots of EDX analysis.

No.	C (%)	Si (%)	V (%)	Cr (%)	Mn (%)	Fe (%)	Ni (%)	Nb (%)
1	2.73	28.62	34.80	12.92	0.09	5.36	15.44	0.00
2	2.42	0.00	0.66	32.53	0.00	15.86	48.22	0.32

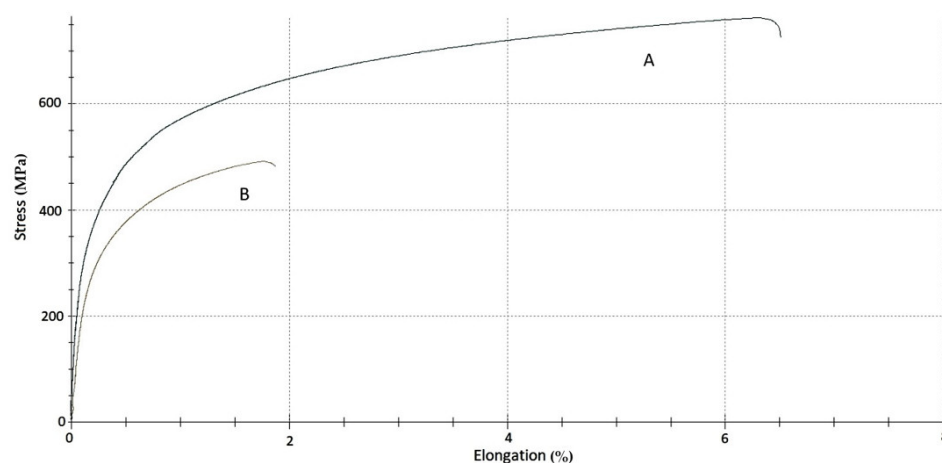
**Figure 12.** Results of mechanical tests of: (A) non-exposed reference sample; (B) service exposed sample.

The mechanical investigations revealed significant changes of the mechanical properties of the service exposed sample as compared to the reference material. Deterioration of plastic properties of the alloy is evident. The ultimate elongation of the exposed material decreased by more than three times compared to the non-exposed reference specimen. The maximum tensile stress also decreased by ca. 10%. Substantial deterioration of the mechanical properties is probably associated with the process of hydrogen and methane bubbles formation inside the alloy structure due to corrosion processes. Indisputably, it is a dangerous phenomenon (with potential negative influence on impact strength), which calls for more detailed investigation.
