Building modernization located in the conservation protection zone in the aspect of technical conditions

Abstract

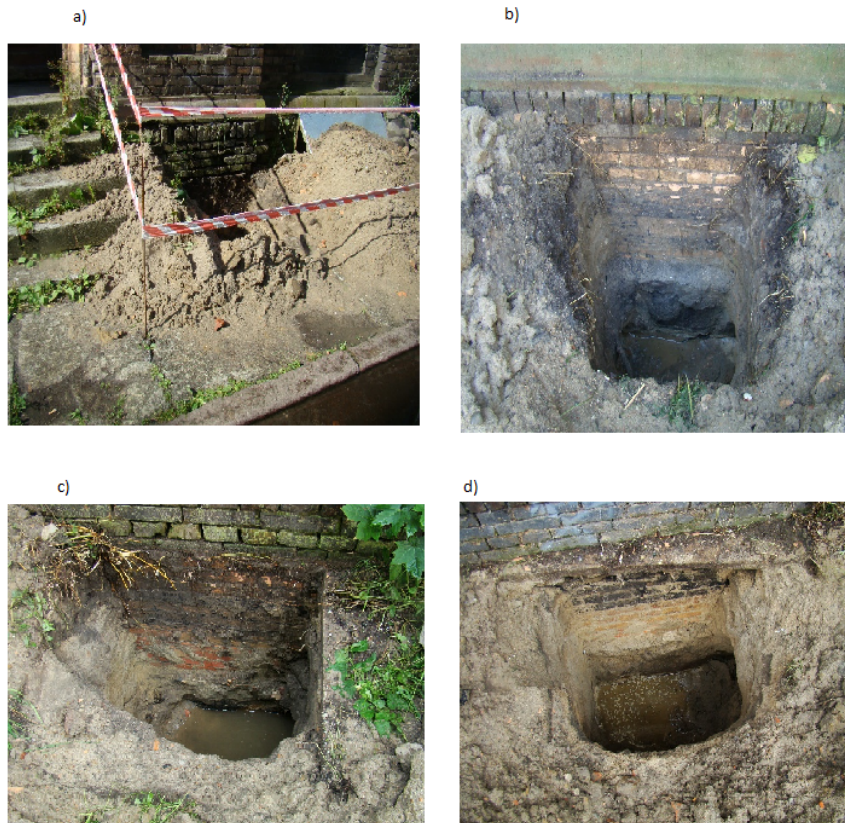
Figure 5. Building planned for modernization - outcrops from the side of the elevation: a) north-east, b) north-west, c) south-west, d) south-east

The groundwater level was not visible in the F1 outcrop along the north-eastern (front) elevation (Fig. 5a). The top level of the concrete footings made of rubble concrete was 60 cm below the ground level. In the F2 outcrop along the north-west elevation, groundwater was visible at the level of 65 cm below the level of the top of the continuous

footings (Fig. 5b). The top of the footings was 85 cm below the area around the building.

In the F3 outcrop, also made along the north-west elevation, groundwater was visible at the level of 60 cm below the level of the top of the footings (Fig. 5c). The top of the footings was 90 cm below the area around the building.

In the F4 opencast along the south-eastern elevation, groundwater was visible, similarly to the F2 and F3 opencasts, at the level of 60 cm below the level of the top of the continuous footings (Fig. 5d). The top of the footings was 95 cm below the area around the building.

The walls of the building to be modernized, made of homogeneous solid ceramic bricks, were set on benches made of rubble concrete, sunk into the ground. The top of the footings was at a depth of 60 to 95 cm below the ground level around the building, and the height of the footings (pedestals) ranged from 60 to 90 cm. Due to the level of foundation, the benches were placed below the ground freezing zone.

At the level of the top of the footings, there was no anti-moisture insulation to prevent capillary rising of moisture by the ceramic wall, and the footing itself (foundation plinth), as well as the part of the ceramic wall recessed into the ground, were not protected against the negative effects of moisture (water). On the basis of the excavations, it was found that the groundwater level was approximately at the foundation level, which resulted in the building structure being exposed to deformation due to the changing (fluctuating) stiffness of the ground caused by its periodic irrigation or drying. Thus, the probability of subsequent damage to structural elements, including external walls, was significantly increased. It should be noted that in the event of a targeted change in the use of the building, the unit ground pressure on the ground would increase and thus the probability of faster and increased subsidence of the building structure as a whole would increase. At the stage of assessing the technical condition of the building in terms of its potential modernization, it was not possible to clearly determine what will be the increase in loads and pressures on the ground after the target change in the way of use. According to the recommendations commonly used in engineering practice, if this increase is more than 20%, which is highly probable, the existing footings will be eligible for reinforcement.

- during design works, particular attention should be paid to the following issues:
 - foundations - possible reinforcement,
 - external walls - revitalization of external walls (homogeneous, ceramic), application of design solutions ensuring standard thermal and acoustic insulation of vertical partitions,

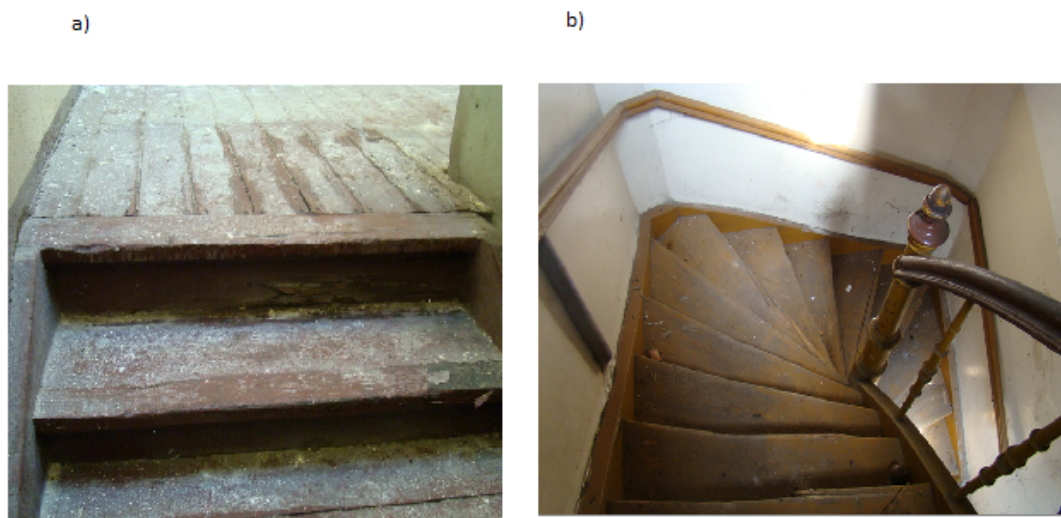
Figure 11. Building planned for modernization - damage to the runs of staircases: a) main and b) side

The main staircase had landings and running boards made of wooden elements. The steps were worn, the footrests and legrests were mechanically damaged (Fig. 11a), with extensive traces of larvae and insect feeding. The side

staircase was in a very similar technical condition, the communication of which was provided by the return operation stairs (Fig. 11b).

- staircases - reconstruction of staircases with particular emphasis on the need to adjust the width of escape routes and fire protection of structural elements.

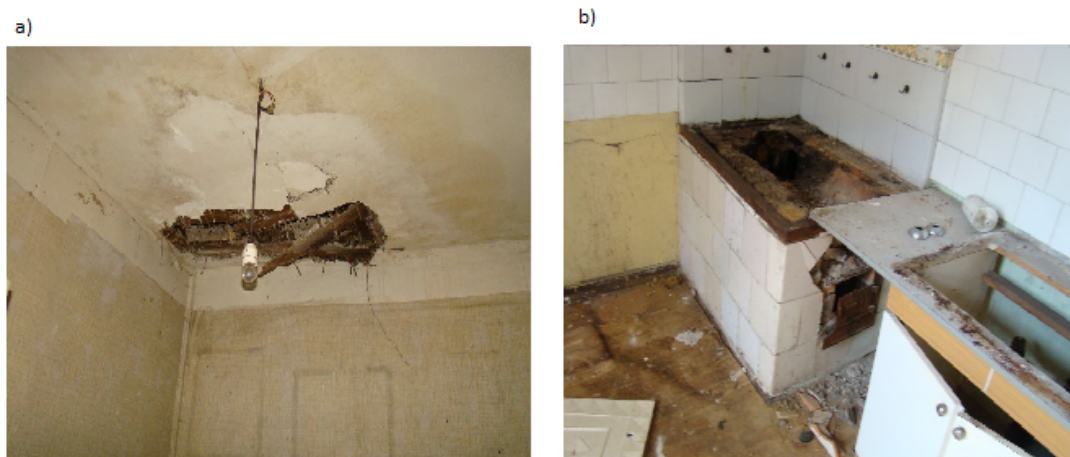
Figure 12. Building planned for modernization – lokale mieszkalne: a) broken ceiling above the ground floor, b) depreciation of equipment

The residential premises in the area of the building were out of service, there were visible traces of extensive water stains and mechanical damage to the finishing layers (Fig. 12). The walls and ceilings of the plastering were chafed and locally damp. There were pipe installations in the rooms, and the cable systems in most of the rooms of the residential premises were also dismantled.
