# Building modernization located in the conservation protection zone in the aspect of technical conditions

Maciej NIEDOSTATKIEWICZ\*<sup>1</sup>

## Abstract

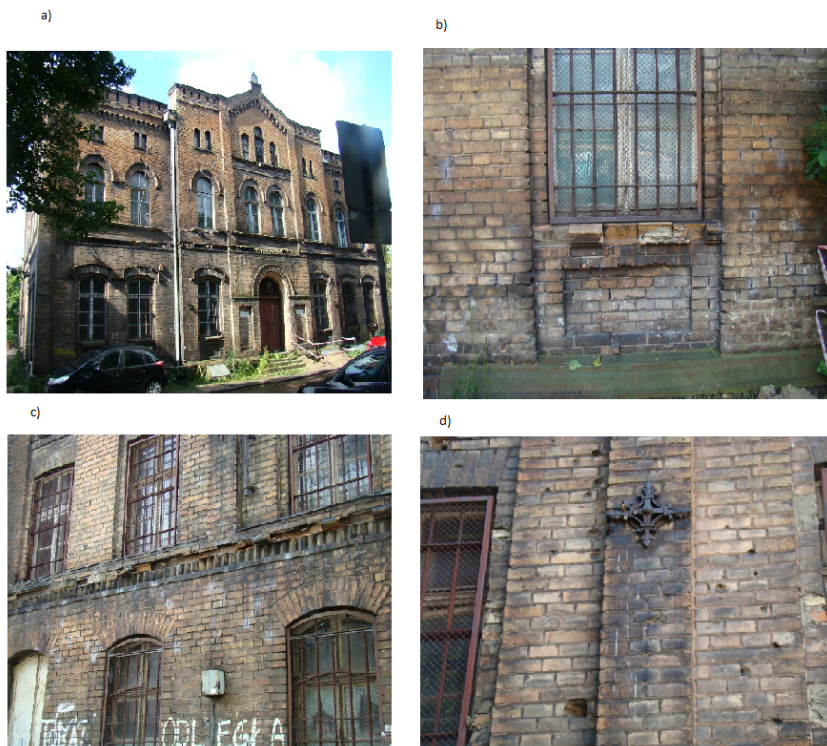
The general view of the building from the north-eastern façade is shown in Figure 3a. On the north-west façade, traces of mechanical damage to the wall were visible, moreover, extensive damage was visible in the form of scratches in the

sill zones (Fig. 3b). In addition, scratches on the window vaults were visible on the façade (Figure 3c). Decorative thrust washers of front bolts were visible on the elevation plane (Fig. 3d).

Figure 3. Building planned for modernization - elevations: north-east: a) view, north-west: damage to: b) the sill zone, c) brick basement window lintels (arches), d) front anchoring retaining plate

The scratches visible on the façade occurred in the sash strips and in the area of lintels - these are places where the stiffness of the wall was changed and the occurrence of scratches in these places, especially diagonal and close to diagonal, was explainable. The vertical and slightly sloping cracks visible on the elevations, locally turning into cracks, were damage whose morphology indicates that they are the result of thermal deformation of the external walls.

- during design works, particular attention should be paid to the following issues:
  - foundations - possible reinforcement,
  - external walls - revitalization of external walls (homogeneous, ceramic), application of design solutions ensuring standard thermal and acoustic insulation of vertical partitions,

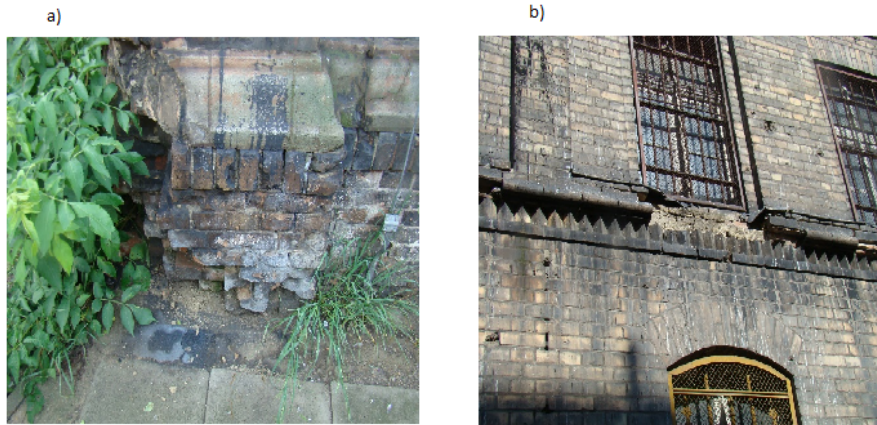
The corner of the building at the junction of the south-west and south-east façades was cracked, and the morphology of its scratches (scratches and diagonal cracks) indicated that it was gradually subsiding (Fig. 4a).

Very large losses of ceramic decorative elements were visible on the façade surface (Fig. 4b).

Figure 4. Building planned for modernization - south-eastern elevation: damage to the brick wall: a) in the level of the plinth, b) in the level of the above-ground part

The oblique scratches, in particular the oblique scratching in the corner area of the south-west and south-east façades, testified to the local occurrence of uneven subsidence, probably caused by local softening of the subsoil resulting from changes in the groundwater level.

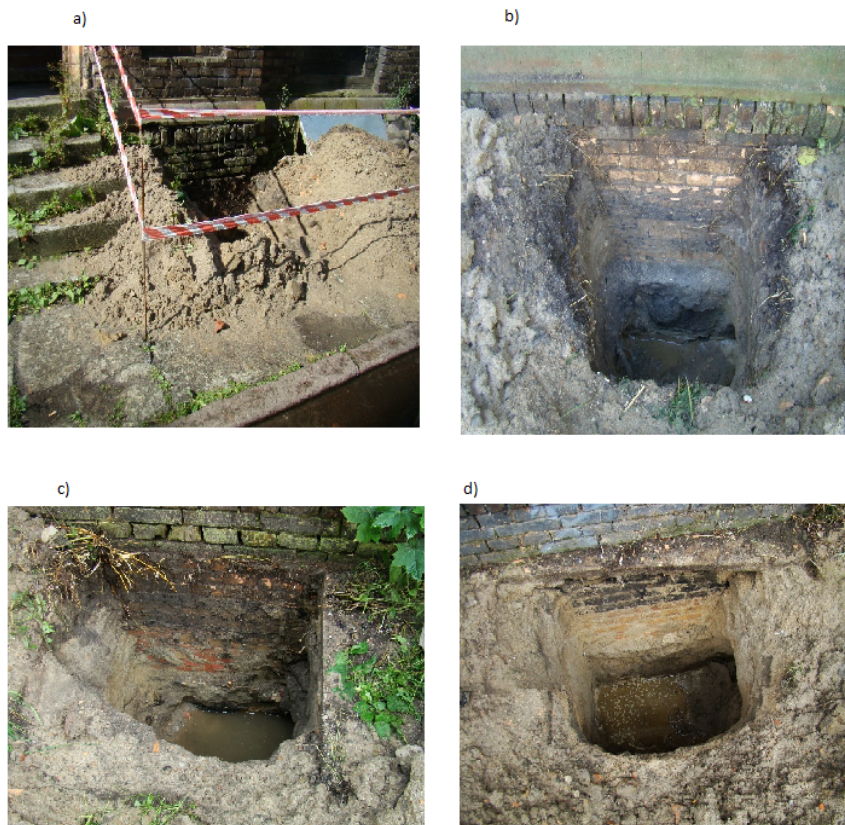
Figure 5. Building planned for modernization - outcrops from the side of the elevation: a) north-east, b) north-west, c) south-west, d) south-east

The groundwater level was not visible in the F1 outcrop along the north-eastern (front) elevation (Fig. 5a). The top level of the concrete footings made of rubble concrete was 60 cm below the ground level. In the F2 outcrop along the north-west elevation, groundwater was visible at the level of 65 cm below the level of the top of the continuous

footings (Fig. 5b). The top of the footings was 85 cm below the area around the building.

In the F3 outcrop, also made along the north-west elevation, groundwater was visible at the level of 60 cm below the level of the top of the footings (Fig. 5c). The top of the footings was 90 cm below the area around the building.

In the F4 opencast along the south-eastern elevation, groundwater was visible, similarly to the F2 and F3 opencasts, at the level of 60 cm below the level of the top of the continuous footings (Fig. 5d). The top of the footings was 95 cm below the area around the building.

The walls of the building to be modernized, made of homogeneous solid ceramic bricks, were set on benches made of rubble concrete, sunk into the ground. The top of the footings was at a depth of 60 to 95 cm below the ground level around the building, and the height of the footings (pedestals) ranged from 60 to 90 cm. Due to the level of foundation, the benches were placed below the ground freezing zone.

At the level of the top of the footings, there was no anti-moisture insulation to prevent capillary rising of moisture by the ceramic wall, and the footing itself (foundation plinth), as well as the part of the ceramic wall recessed into the ground, were not protected against the negative effects of moisture (water). On the basis of the excavations, it was found that the groundwater level was approximately at the foundation level, which resulted in the building structure being exposed to deformation due to the changing (fluctuating) stiffness of the ground caused by its periodic irrigation or drying. Thus, the probability of subsequent damage to structural elements, including external walls, was significantly increased. It should be noted that in the event of a targeted change in the use of the building, the unit ground pressure on the ground would increase and thus the probability of faster and increased subsidence of the building structure as a whole would increase. At the stage of assessing the technical condition of the building in terms of its potential modernization, it was not possible to clearly determine what will be the increase in loads and pressures on the ground after the target change in the way of use. According to the recommendations commonly used in engineering practice, if this increase is more than 20%, which is highly probable, the existing footings will be eligible for reinforcement.

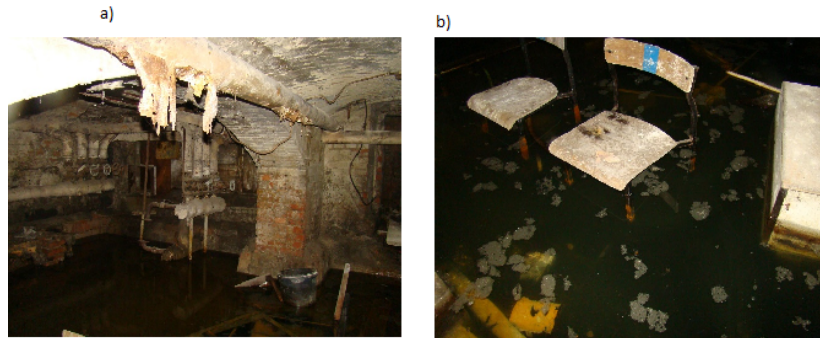
Figure 6. Building planned for modernization - flooded cellars: a) view, b) close-up

In the basement level, the consequences of the utilization of the building with inefficient waterproofing of parts of the walls sunk into the ground were visible. In practice, the entire cellars were flooded with water (Fig. 6a).

Section vaults constituting the vaulting of the basement storey were loosened, loose bricks falling out of keystones and scratches of joints on the entire palate of the vaults were visible. In most of the rooms in the basement level there was water, the basements were flooded to a height of 50 cm (Fig. 6b).

Section vaults in the level of the ceiling above the ground floor in most cases had cracks in the key, resulting in bricks falling out in the keystone. Some of the vaults were intensely scratched in the keystone area. In addition, scratches occurred in the places where vaults were founded on the walls, in the so-called nodes. The immediate cause of the damage was local overload of the ceiling during the earlier operation of the building, in some cases the damage could have arisen as a consequence of local uneven settlement of the building. The extent of damage to the ceiling above the basement was due to the fact that there was no reinforced concrete rim in the ceiling level, which would increase the spatial stiffness of the building as a whole.

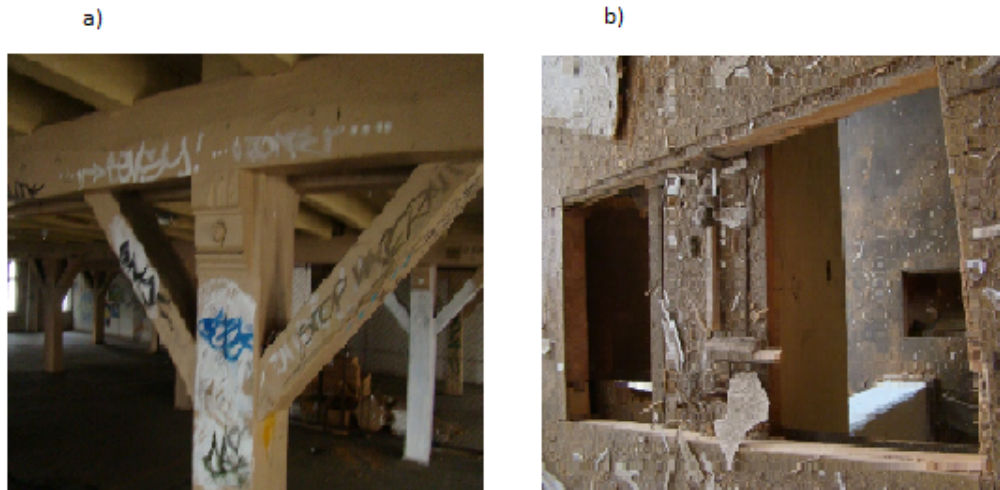
Figure 8. Building planned for modernization ceiling above the first floor: a) fragment of the wooden frame, b) structure of the ceiling

Wooden posts and wooden bolts on the first floor level, similarly to the ceiling above the ground floor, showed numerous scratches and cracks (Fig. 8a). The dimensions of the wooden poles in the cross-section were 32x32 cm, the

transoms were made as two-branch transoms from beams 2x15x31 cm. Stiffening of the structure of wooden frames was provided by swords measuring 25x35 cm. Wooden ceiling beams with dimensions of 15.5x28 cm were spaced from 80 cm to 90 cm. The ceiling above the ground floor was made of wooden naked, as in the case of the ceiling above the ground floor. It was found in the open-pit mines that the floor beams were made of 3.8 cm thick planks covered with 0.5 cm thick hard-type fibreboard (Fig. 8b).

- inter-story ceilings - reinforcement of wooden ceiling beams combined with front and side anchoring, ensuring non-flammability of wooden ceiling beams and proper acoustic insulation of horizontal partitions,

- wooden load-bearing structure (mullions and transoms) - local reinforcement and replacement of mechanically damaged wooden elements, affected by biological corrosion and damaged as a result of feeding larvae and insects,

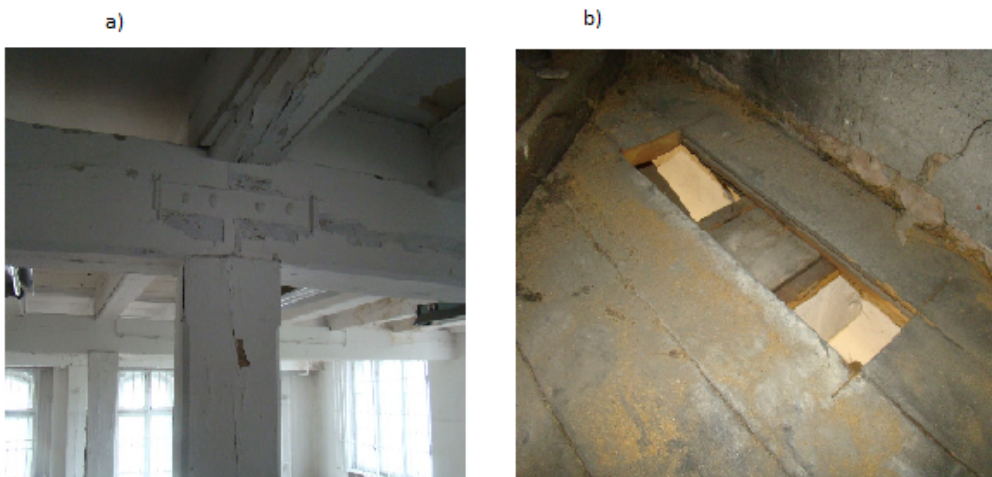
Figure 9. Building planned for modernization - ceiling above the second floor: a) a fragment of a wooden frame, b) a structure of the ceiling

Wooden posts and wooden bolts on the second floor, similarly to the ceiling above the ground floor, showed numerous scratches and cracks (Fig. 9a). In some of the rooms on the second floor, leaks were visible due to leakage of the roof covering. The dimensions of the wooden poles in the cross-section were 32x32 cm, the transoms were made as single-branch transoms from 25x30 cm beams. The structure of the ceiling above the second floor does not have a stiffening in the form of swords next to wooden poles. The direction of constructing the transverse frames horizontally

above the 2nd floor (perpendicular to the front façade) was perpendicular to the direction of their construction horizontally above the 1st floor and above the ground floor (parallel to the front façade). Wooden ceiling beams with dimensions of 15.5x28 cm were spaced from 85 cm to 90 cm. The ceiling above the ground floor was made as wooden naked, as in the case of the ceiling above the ground floor and above the first floor (Fig. 9b). In the outcrops, it was found that the floor beams were made of 3.8 cm thick planks with a 0.5 cm thick hard-type fibreboard covering.

Due to the leaks in the roofing, the beams in the floor level above the 2nd floor were very damp, local signs of biological corrosion development were visible. The development of biological corrosion was particularly intense in the adjacent zones.

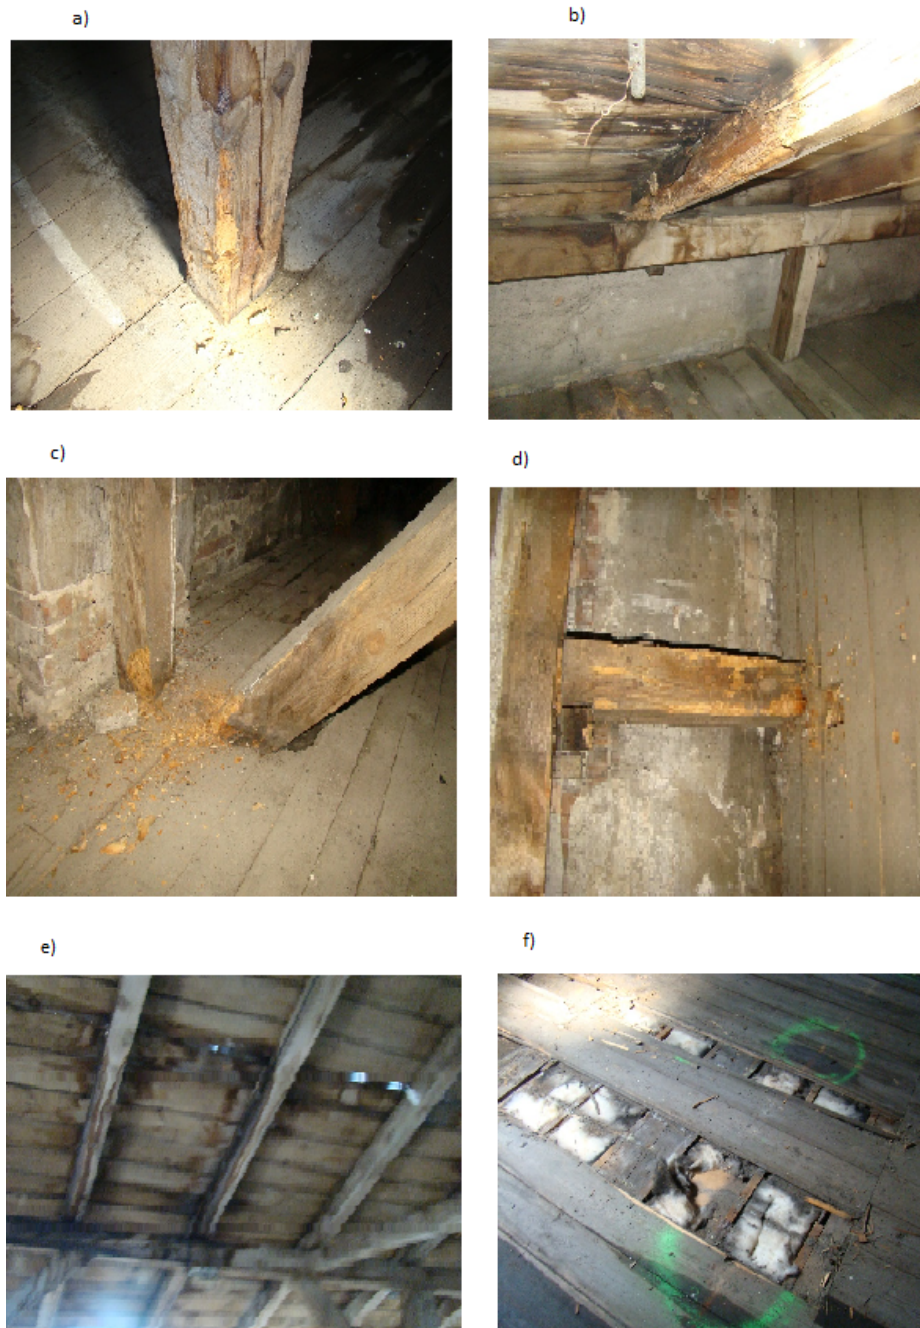
Figure 10. Building planned for modernization - attic: damage to the wooden roof truss in terms of: a) post foundation, b), c) rafter backrest, d) wall board support, e) roof formwork, and f) ceiling structure above the second floor

In the attic level, the elements of the wooden roof truss had extensive damage. Some of the wooden posts showed, along their entire height, traces of larvae and insect feeding (Fig. 10a). In most cases, the roof rafters were damp as a result of leaks in the roofing material. Long-term dampness led in some cases to significant corrosion losses, reaching up to 80% of the cross-sectional area (Fig. 10b). Corrosion damage also occurred at the anchoring point of the diagonal strut in the floor beams (Fig. 10c). The posts supporting the wall plate were in some cases so damaged by corrosion that they hung in the air (Fig. 10d). The formwork of the roof was damp as a result of leakage of the roof covering (Fig. 10e). Moistening of the floorboards was also identified (Fig. 10f).

Based on the estimated results of measurements with a hygrometer, it was determined that the degree of moisture in wooden rafters in the eaves zone, defined as the measured mass moisture  $U_m$  [%], ranged from 19,26% to 23,32%, which qualified the rafters as damp and from 34,26% to 36,32%, which qualified them as wet (Tab. 2 and Tab. 4). In the case of the formwork of the roof slope, the degree of moisture in the eaves zone, defined as the measured mass humidity  $U_m$  [%], ranged from 24,22% to 25,28%, which qualified the boards as damp and ranged from 31,06% to 44,25%, which qualified the boards as wet (Tab. 2 and Tab. 4).

The direct cause of the dampness of wooden elements were leaks from the roof slope occurring in the past period, with a high probability assessing the extent of damage that has been maintained for many years.

The leaks contributed to the dampness of the floor boards at the level of the ceiling above the 2nd floor and to the dampness of the wooden elements of the wooden steep roof structure, in particular the intermediate purlins.

In the case of a fragment of the attic from the south-west elevation, the development of biological corrosion led to almost complete degradation of the rafters.

Apart from damage, biological corrosion of the elements of the wooden roof truss showed traces of extensive feeding of larvae and insects. The scope of the damage to the wooden elements indicated that the destruction of the built-in structural timber took place in the past period and in most cases related to the so-called wood destruction phase 1:

- wooden roof truss - disassembly of the existing roof truss and its reconstruction (boarding and load-bearing structure).
  - roofing - disassembly of the existing and reconstruction of the roofing,

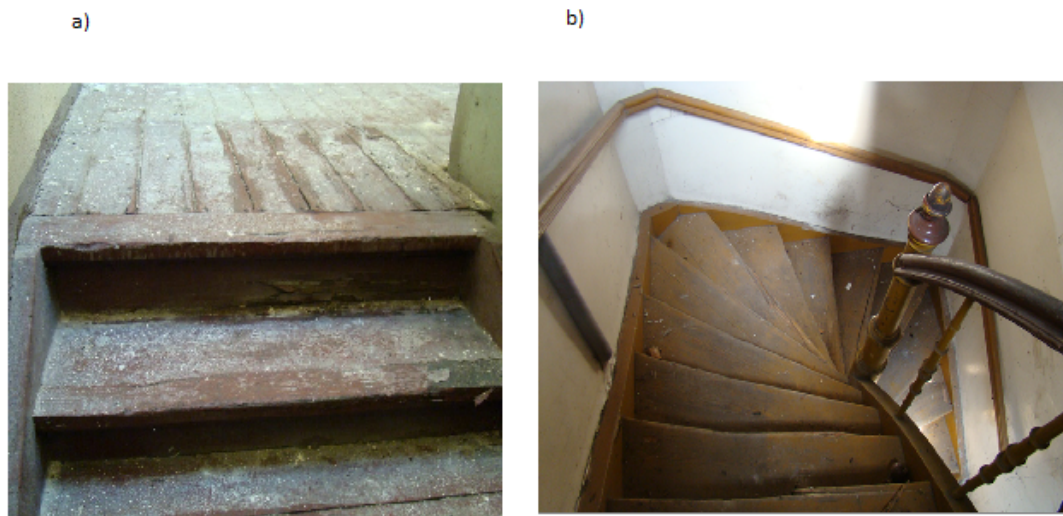
Figure 11. Building planned for modernization - damage to the runs of staircases: a) main and b) side

The main staircase had landings and running boards made of wooden elements. The steps were worn, the footrests and legrests were mechanically damaged (Fig. 11a), with extensive traces of larvae and insect feeding. The side

staircase was in a very similar technical condition, the communication of which was provided by the return operation stairs (Fig. 11b).

- staircases - reconstruction of staircases with particular emphasis on the need to adjust the width of escape routes and fire protection of structural elements.

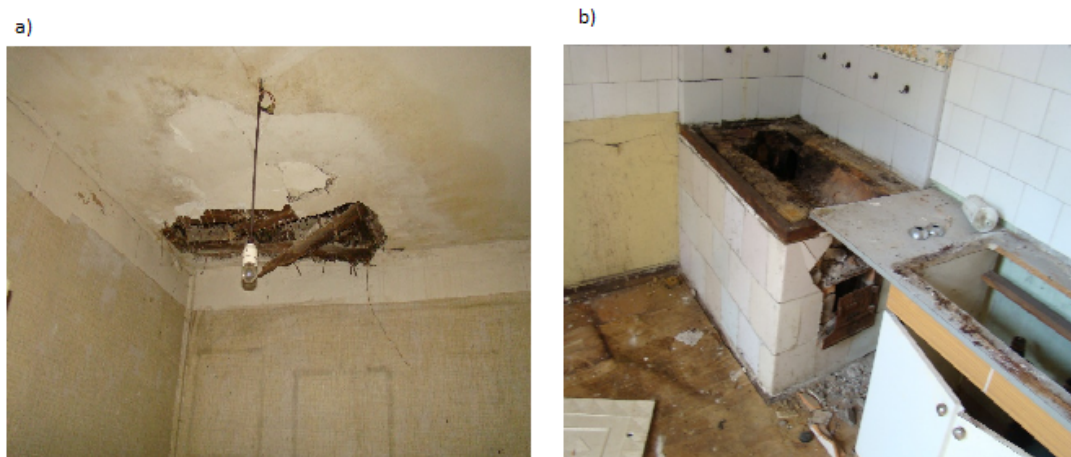
Figure 12. Building planned for modernization – lokale mieszkalne: a) broken ceiling above the ground floor, b) depreciation of equipment

The residential premises in the area of the building were out of service, there were visible traces of extensive water stains and mechanical damage to the finishing layers (Fig. 12). The walls and ceilings of the plastering were chafed and locally damp. There were pipe installations in the rooms, and the cable systems in most of the rooms of the residential premises were also dismantled.
