Building modernization located in the conservation protection zone in the aspect of technical conditions

Abstract

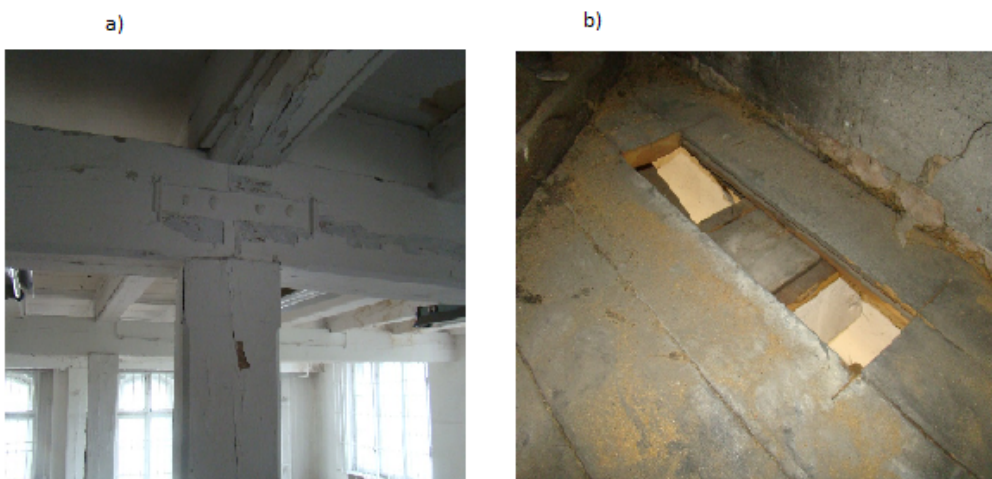
Figure 9. Building planned for modernization - ceiling above the second floor: a) a fragment of a wooden frame, b) a structure of the ceiling

Wooden posts and wooden bolts on the second floor, similarly to the ceiling above the ground floor, showed numerous scratches and cracks (Fig. 9a). In some of the rooms on the second floor, leaks were visible due to leakage of the roof covering. The dimensions of the wooden poles in the cross-section were 32x32 cm, the transoms were made as single-branch transoms from 25x30 cm beams. The structure of the ceiling above the second floor does not have a stiffening in the form of swords next to wooden poles. The direction of constructing the transverse frames horizontally

above the 2nd floor (perpendicular to the front façade) was perpendicular to the direction of their construction horizontally above the 1st floor and above the ground floor (parallel to the front façade). Wooden ceiling beams with dimensions of 15.5x28 cm were spaced from 85 cm to 90 cm. The ceiling above the ground floor was made as wooden naked, as in the case of the ceiling above the ground floor and above the first floor (Fig. 9b). In the outcrops, it was found that the floor beams were made of 3.8 cm thick planks with a 0.5 cm thick hard-type fibreboard covering.

Due to the leaks in the roofing, the beams in the floor level above the 2nd floor were very damp, local signs of biological corrosion development were visible. The development of biological corrosion was particularly intense in the adjacent zones.
