Demolition of the cereal elevator building located in the conservation protection zone in the aspect of technical, functional-utility and economic conditions

Maciej NIEDOSTATKIEWICZ^{*1}, Tomasz MAJEWSKI²

Abstract

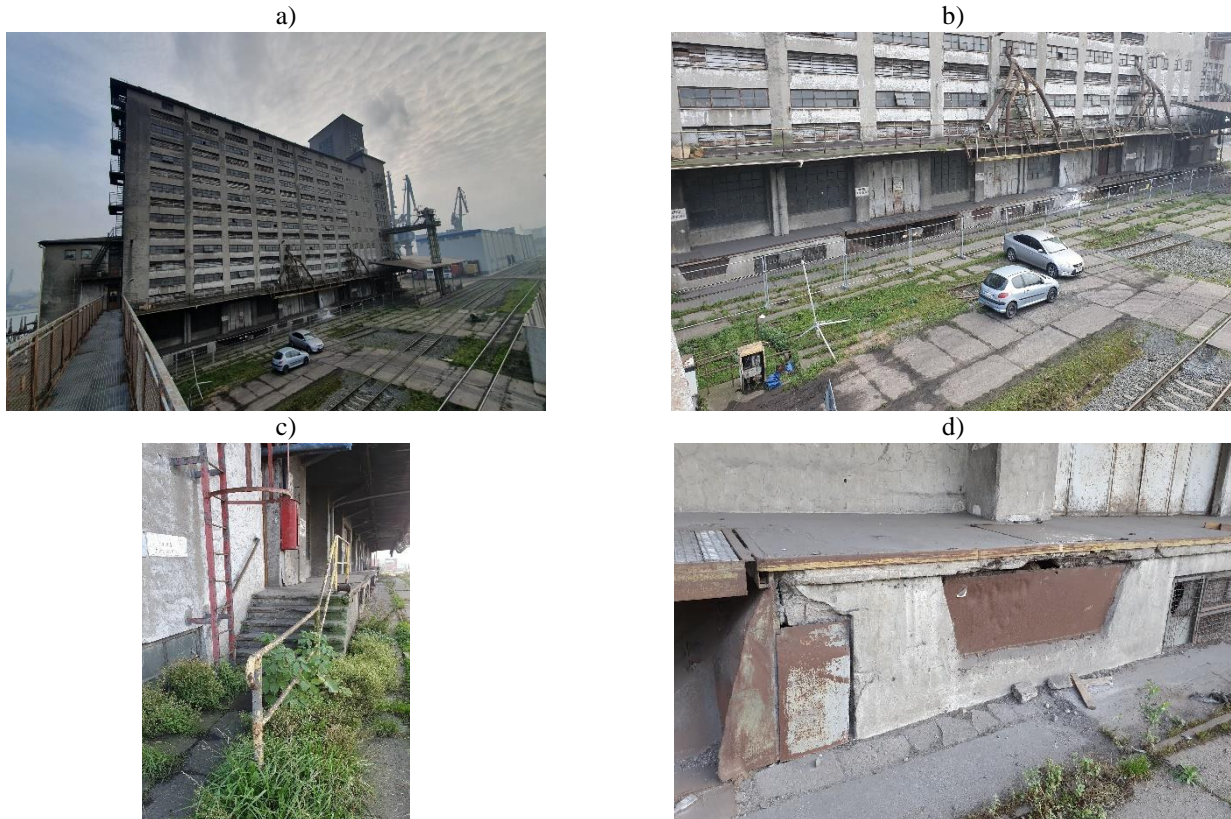
On the facade of the building, there were visible remains of the installation used in the past period for the transport of loose materials (Photo 1). The transport ramp along the outer longitudinal wall had extensive damage in the form of concrete defects - chipping and falling off of the concrete cover.

Photo 1: Grain Elevator building - elevation from the land side: a) general view, b) close-up, unloading ramp at the ground floor level: c) general view, d) damage in close-up
