# Demolition of the cereal elevator building located in the conservation protection zone in the aspect of technical, functional-utility and economic conditions

Maciej NIEDOSTATKIEWICZ<sup>\*1</sup>, Tomasz MAJEWSKI<sup>2</sup>

<sup>1</sup> Department of Engineering Structures, Faculty of Civil and Environmental Engineering, Gdańsk University of Technology, Gdańsk, Poland

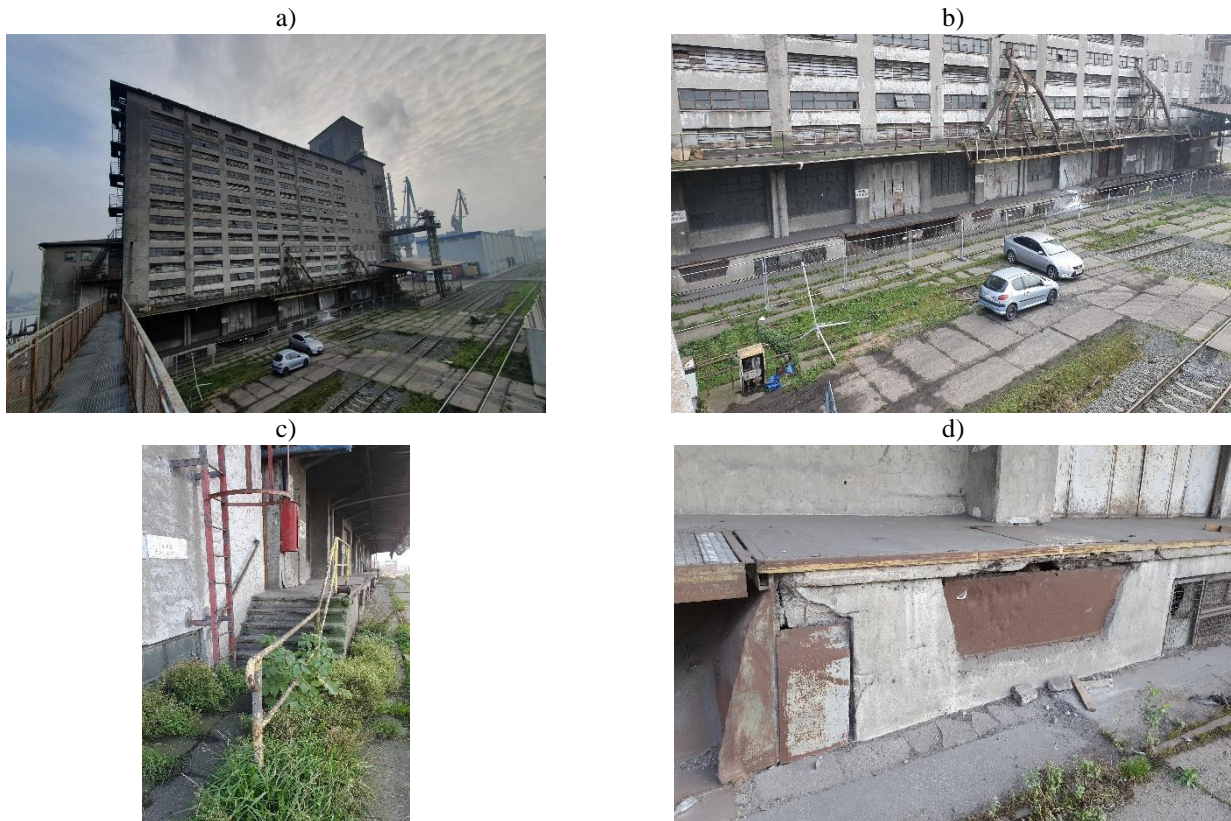
On the facade of the building, there were visible remains of the installation used in the past period for the transport of loose materials (Photo 1). The transport ramp along the outer longitudinal wall had extensive damage in the form of concrete defects - chipping and falling off of the concrete cover.

Photo 1: Grain Elevator building - elevation from the land side: a) general view, b) close-up, unloading ramp at the ground floor level: c) general view, d) damage in close-up

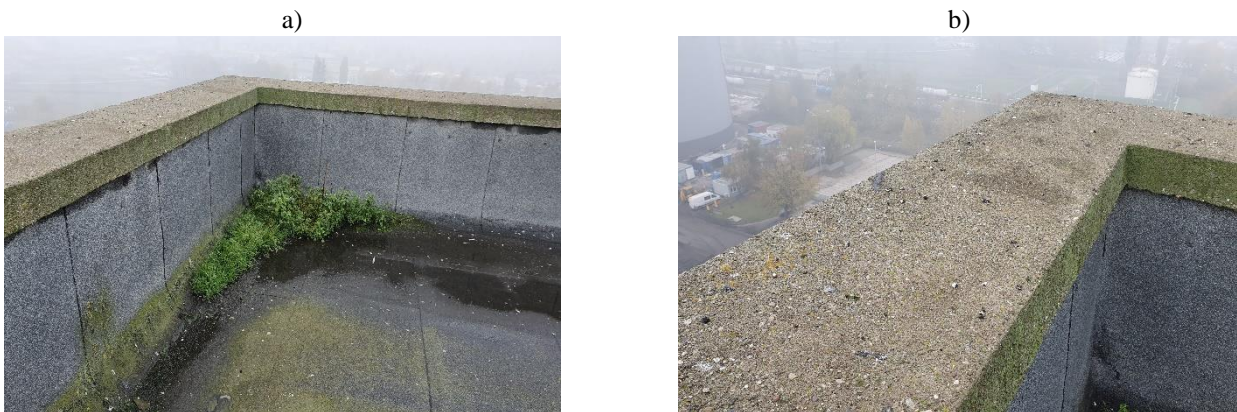
On the roof of storey +10, damage to the roofing felt was visible, and the concrete elements in the horizontal roof had extensive erosive damage (Photo 2).

The structural elements of the flat roofs above the level of +8, +9 and +10 did not show any significant structural damage - there was no visible excessive deflection. There were signs of freezing in the bottom view. The roofs had a tight, but intimate and decapitalized covering made of heat-welded roofing felt. The gutters on the roofs were not periodically inspected: they were not cleaned regularly, which resulted in their lack of patency and contributed to flooding (damp) the external walls with water.

Photo. 2: Grain Elevator building - roof level: decapitalization of: a) roofing felt (blistering and unevenness), b) cornice elements (carbonation)

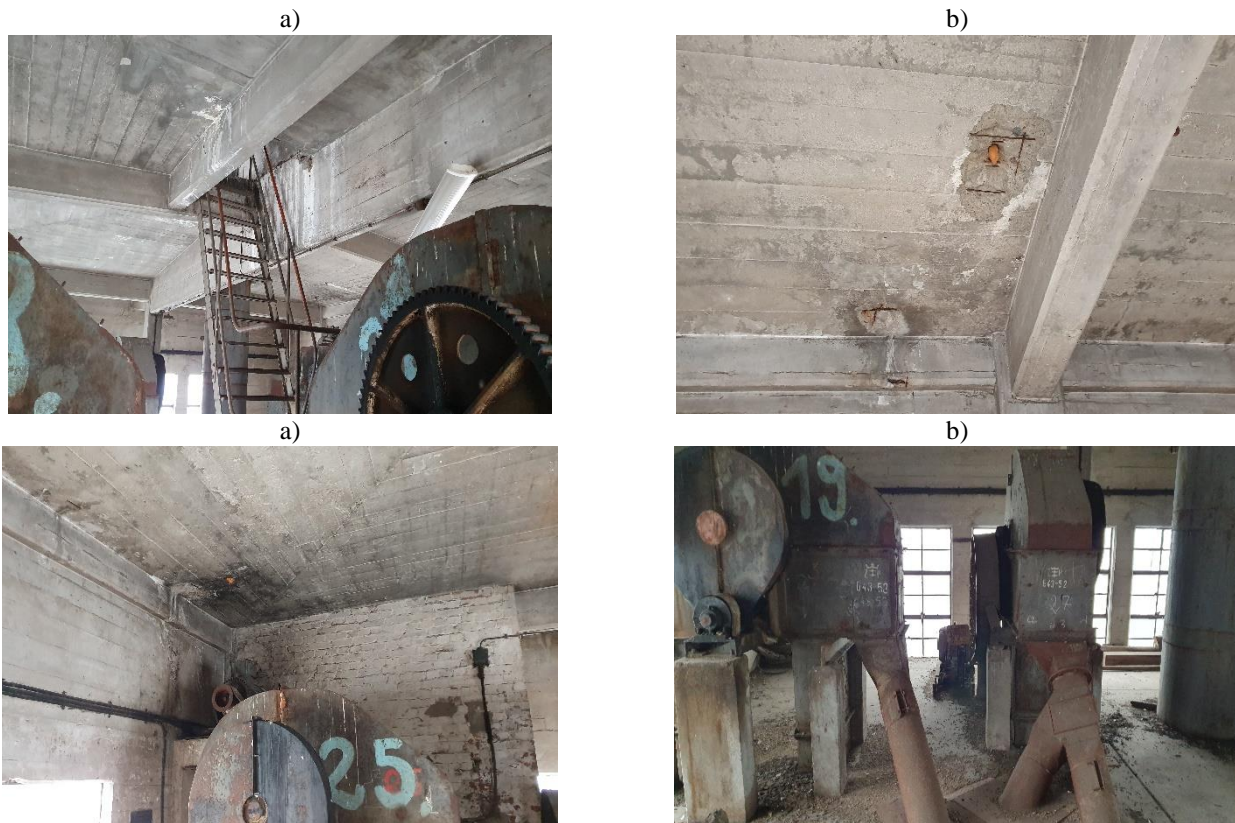
In the rooms on the +10 level, mechanical damage to the ceiling above this level was visible. Elements of devices used for transporting loose materials were also visible (Photo 3).

Photo 3: Grain Elevator building - level +10: a) mechanical damage to structural elements, b) defective and incomplete equipment for transporting loose materials

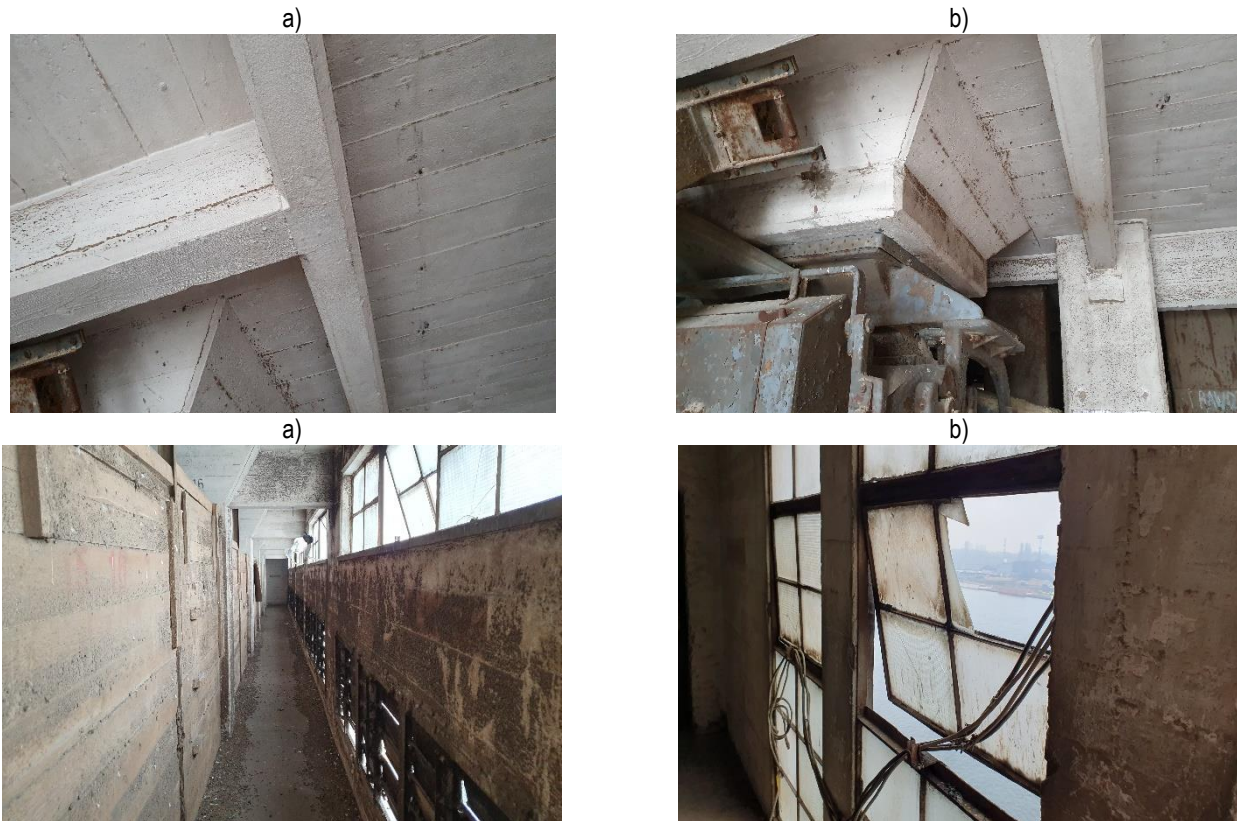
Reinforced concrete elements, in practice at the level of all above-ground storeys, especially at the level of +5, had local mechanical damage visible on the ceiling, walls and columns. As in the case of other storeys, in the rooms there were visible inoperative devices for transporting loose materials. Loss of concrete cover was visible on some of the pillars between the windows (reinforced concrete columns) (Photo 5).

The steel window joinery (in the warehouse part of the building) had numerous mechanical damages and was intensely corroded: surface corrosion was very extensive, locally it turned into pitting corrosion.

Photo 5: Grain Elevator building - level +5: a) mechanical damage to structural elements, b) equipment for transporting loose materials left inoperative and incomplete, decapitalization of: c) ventilation shutters, d) window joinery

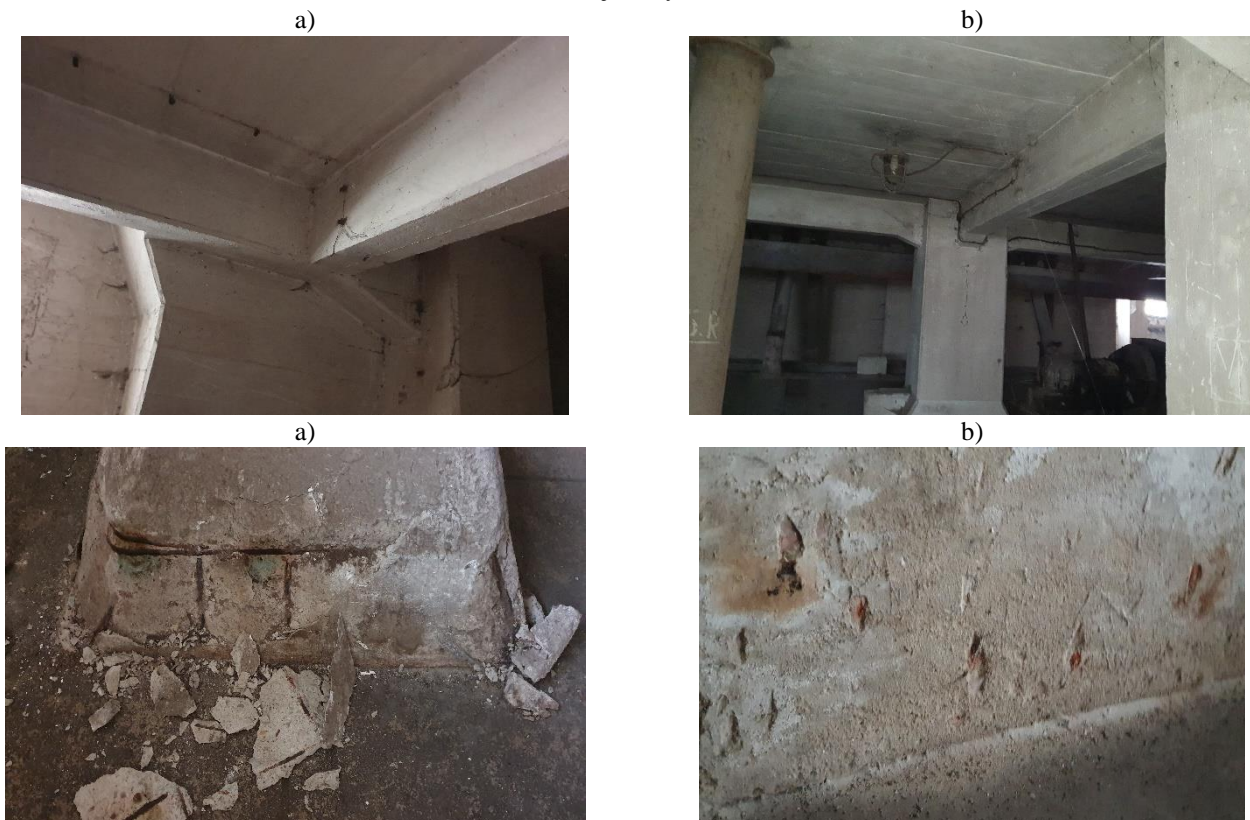
The reinforced concrete elements in level -1 had mechanical damage visible on the ceiling, walls and internal columns. Most of the internal columns showed very intense damage to the concrete cover of the bars, its falling off and dampness. Traces of freezing and dampness on the outer walls were visible in the floor zone. The floor in the underground level had extensive cracks and chipping (Photo 6).

The results of the moisture test showed that the greatest dampness occurred in the outer walls of the lowest floors (basement (level -1) and ground floor (level 0)) - it was caused by capillary rising of water from the ground, splashing rainwater in the near zone and inoperative damp insulation of the walls in the part buried in the ground. The degree of moisture content made it possible to classify these elements as dry, with local places of increased humidity.

Photo 6: Grain Elevator building - level -1: a) mechanical damage to structural elements, floor zone: c) concrete cover falls off the column heads at the level of the foundation slab, d) moisture in the outer wall
