# Bunker demolition located in a conservation protection zone in the light of technical, national defense, functional-utility and economic conditions

## Abstract

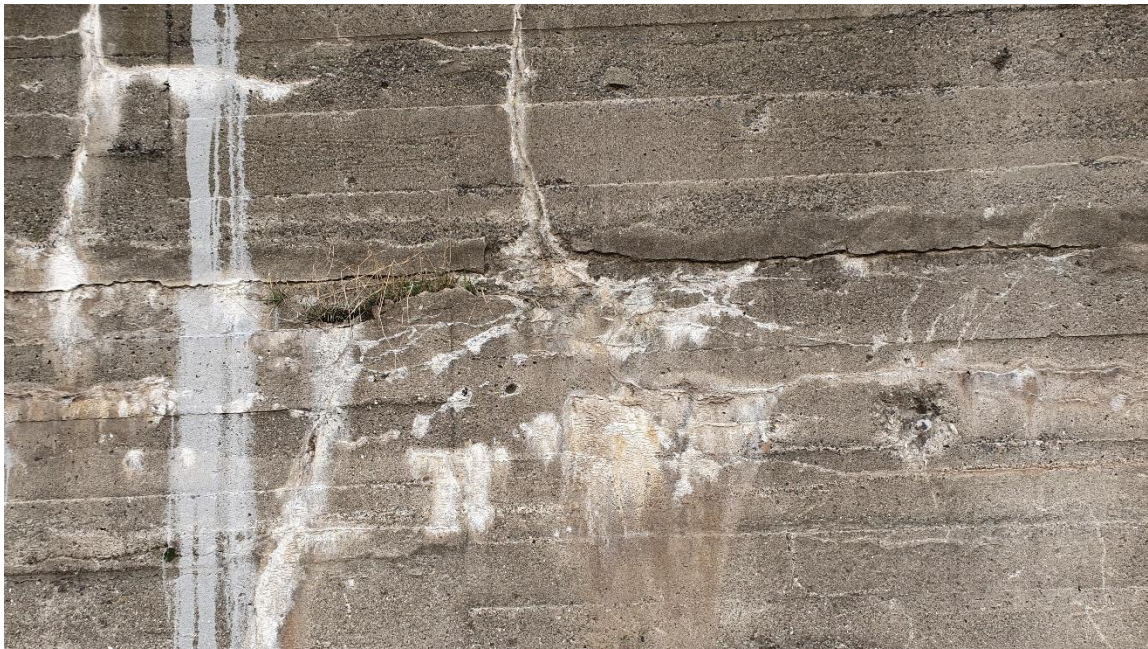
A single-storey annex adjoined the external gable wall on the left (Photo 1b). The condition of the left gable wall was similar to the condition of the front wall in terms of the extent of damage - there were numerous places (cracks and cracks) from which calcium carbonates were leached, especially intensive in the upper part of the wall (Photo 2).

Photo 2: Examples of calcium carbonate leaks on the south-west elevation (external gable (transverse) wall from the land side (left)) of the Bunker building

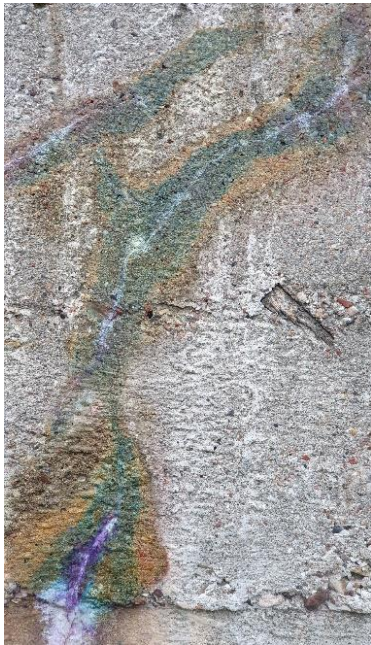
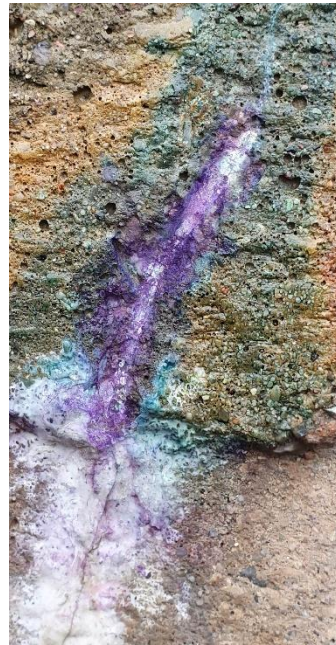
On the walls of Bunker, based on chemical tests, high carbonation of concrete, i.e. low pH value ( $\sim 10$  pH) was found (Photo 4). This means that the concrete cover has lost its natural ability to protect the reinforcement against corrosion, which results in the acceleration of the destruction of the concrete structure on the one hand, and on the other hand, it means that the process of corrosion of the reinforcement bars is active and progressing, which was confirmed by brown-rust tarnish on the concrete surface. Photo 5 shows the study of the degree of concrete carbonation on the external wall in the place of a wet crack.

Photo 5: Discoloration of concrete after the Rainbow Test on the concrete surface, in the place of a crack on the wall of the right annex - test site after the test: a) view, b), c) close-up: green-violet coloration indicates advanced carbonation of concrete and its reduced ability to protect the reinforcement, the orange color indicates advanced carbonation of the exposed concrete surfaces, washing out of calcium carbonates is visible in the area of cracked concrete fragments
