# Bunker demolition located in a conservation protection zone in the light of technical, national defense, functional-utility and economic conditions

Maciej NIEDOSTATKIEWICZ<sup>\*1</sup>, Tomasz MAJEWSKI<sup>2</sup>

## Abstract

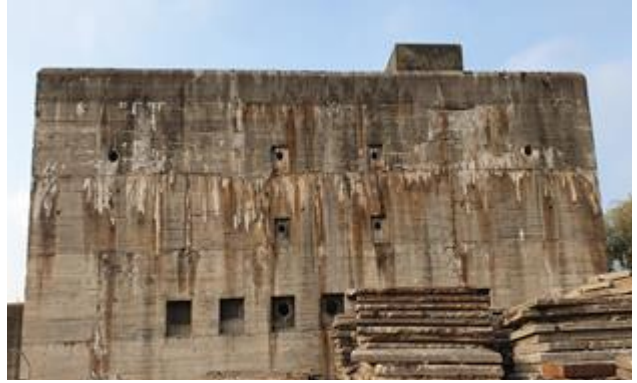
On the front elevation, numerous concrete damages were visible in the form of scratches, cracks and concrete losses, as well as multi-colored efflorescence in places of concrete discontinuity (cracks and cracks), caused by leaching of calcium compounds from the concrete and corrosion of the reinforcement (Photo 1a). Pores and capillaries were visible on the surface of the concrete, and the concrete had an open structure.

Photo 1: Bunker building elevations: a) south-east: external longitudinal (front) wall from the land/water side, b) south-west: external gable (transverse) wall from the land side (left), c) north-east: external gable wall (lateral) landward (right)

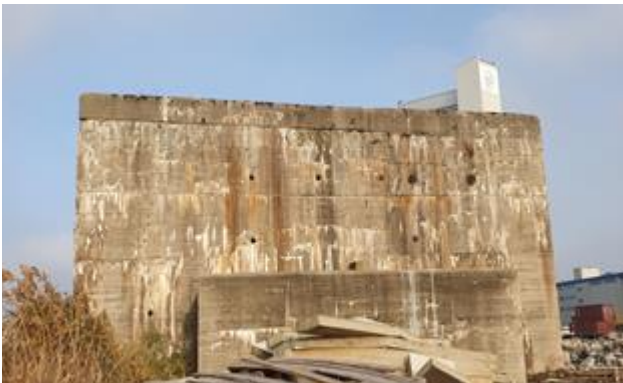
b)

A single-storey annex adjoined the external gable wall on the left (Photo 1b). The condition of the left gable wall was similar to the condition of the front wall in terms of the extent of damage - there were numerous places (cracks and cracks) from which calcium carbonates were leached, especially intensive in the upper part of the wall (Photo 2).

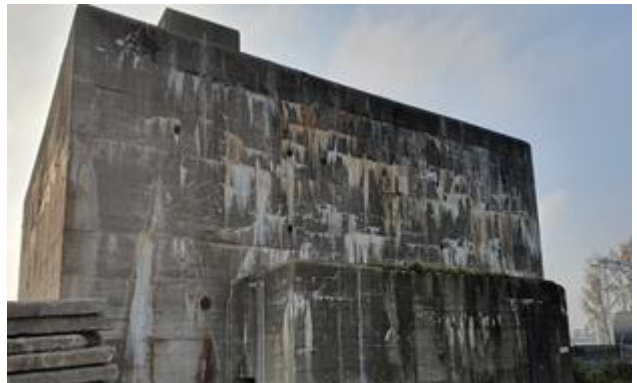
c)

A single-storey annex was also adjacent to the outer right gable wall (Photo 1c). The condition of the right gable wall was similar to the condition of the front wall and the left gable wall in terms of the extent of damage.

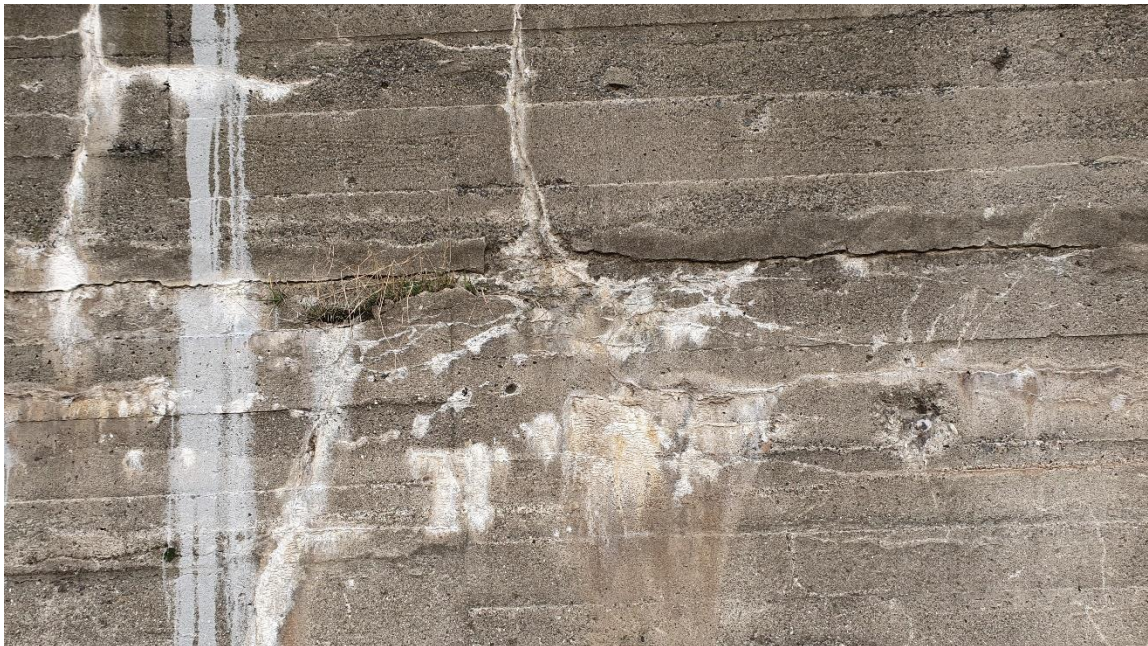
Photo 2: Examples of calcium carbonate leaks on the south-west elevation (external gable (transverse) wall from the land side (left)) of the Bunker building

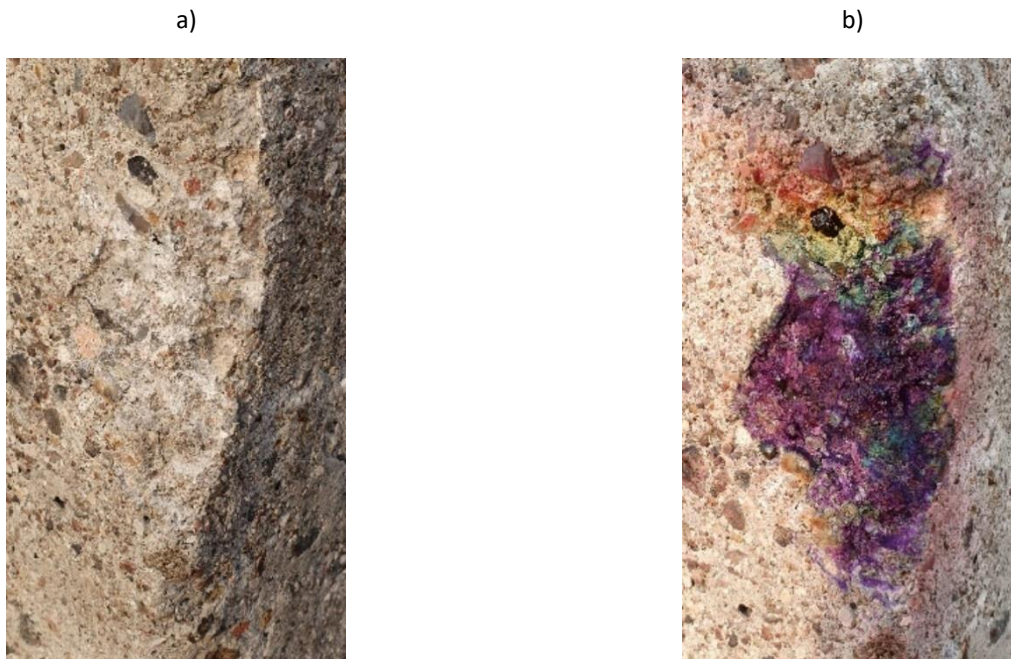
On the walls of Bunker, based on chemical tests, high carbonation of concrete, i.e. low pH value ( $\sim 10$  pH) was found (Photo 4). This means that the concrete cover has lost its natural ability to protect the reinforcement against corrosion, which results in the acceleration of the destruction of the concrete structure on the one hand, and on the other hand, it means that the process of corrosion of the reinforcement bars is active and progressing, which was confirmed by brown-rust tarnish on the concrete surface. Photo 5 shows the study of the degree of concrete carbonation on the external wall in the place of a wet crack.

Photo 4: Discoloration of concrete after the Rainbow Test in the place of forging the concrete cover to a depth of 2 cm in the corner of the left annex - view of the test site: a) before, b) after the test: purple-green coloration indicates advanced carbonation of the concrete cover and its reduced capacity to protect the armament

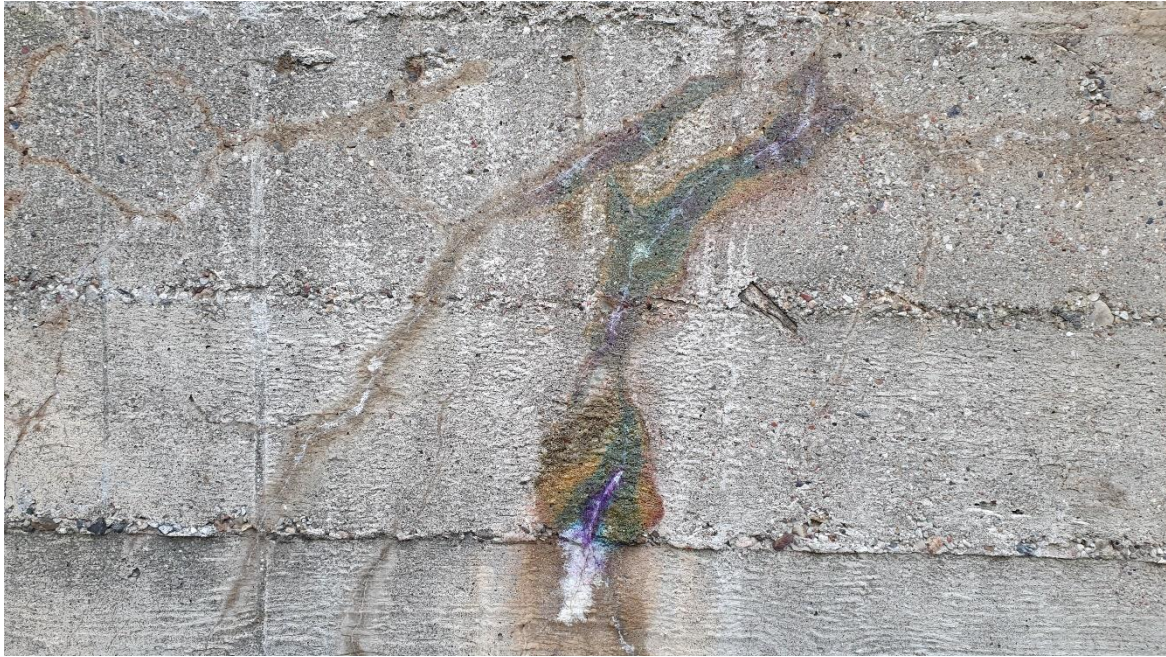
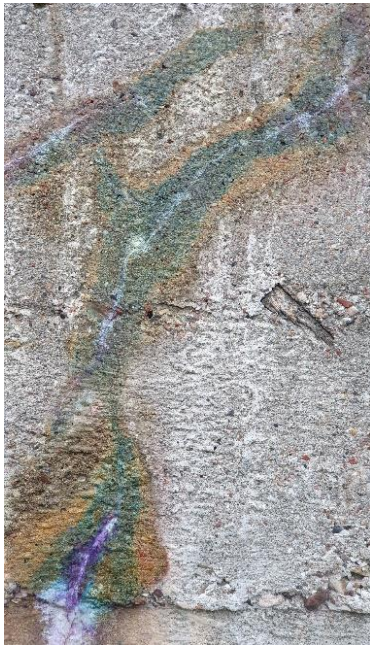
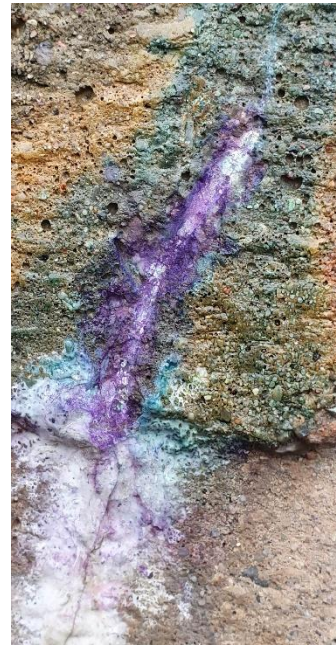
Photo 5: Discoloration of concrete after the Rainbow Test on the concrete surface, in the place of a crack on the wall of the right annex - test site after the test: a) view, b), c) close-up: green-violet coloration indicates advanced carbonation of concrete and its reduced ability to protect the reinforcement, the orange color indicates advanced carbonation of the exposed concrete surfaces, washing out of calcium carbonates is visible in the area of cracked concrete fragments
