Renovation works in buildings in the area of former defensive fortifications

Abstract

The paper presents the Complex of Buildings which was created in Gdańsk as a result of the reconstruction and development of the remains of the defensive fortifications of Redita Napoleńska. Some of the buildings of the Building Complex, after many years of operation, were in an emergency condition and required urgent renovation and repair work. The paper contains a detailed analysis of the technical condition of individual buildings of the Building Complex and analyzes the impact of the current use and the lack of regular periodic repairs on the technical efficiency of these facilities. Conceptual solutions in the field of renovation and repair works were also presented, the purpose of which was to bring the objects in question to the proper technical condition.

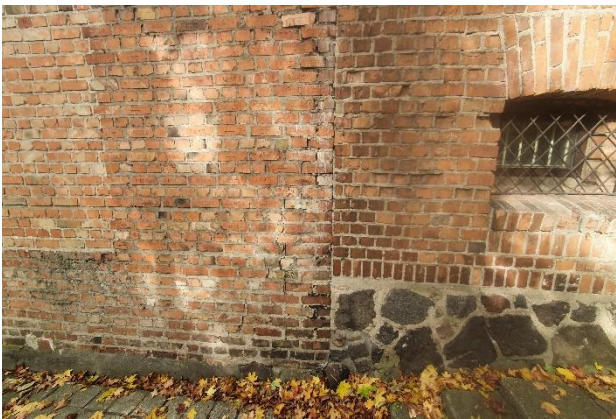
Photo. 2: No masonry bond at the junction of the former office spaces (A) with the former staff apartment (B), part of which are the rooms of the Southern Guardhouse

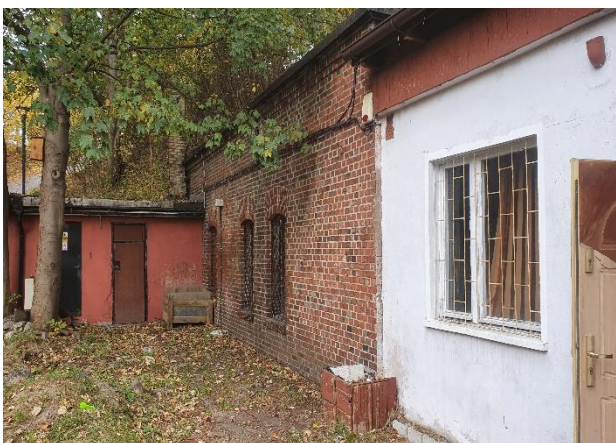
Photo. 3: Utility rooms (C) adjacent to the former service apartment (B)

Taking into account the technical and economic conditions, it was recommended to demolish the utility rooms (C) - the construction works planned for implementation had to be carried out in the following scope:

- based on the developed demolition project, demolish the existing facility, similarly to the former office premises (A),
- taking into account the current regulations, the demolition of the facility is possible on the basis of an administrative decision, the so-called a demolition permit issued by the competent local administrative authority, in consultation with the Provincial Conservator of Monuments,
- until the decision on demolition was made, regular inspections of the technical condition of the facility in question had to be carried out at monthly intervals.

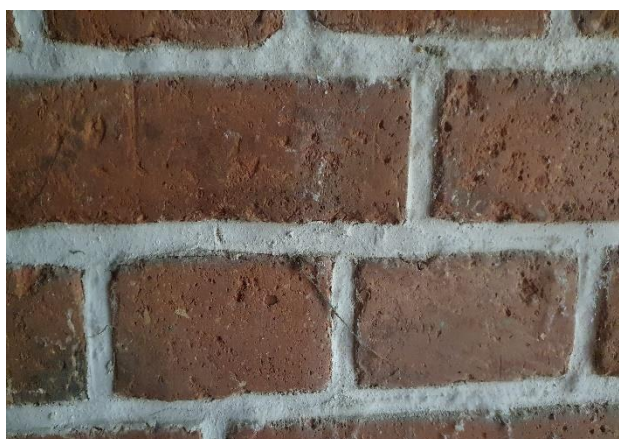
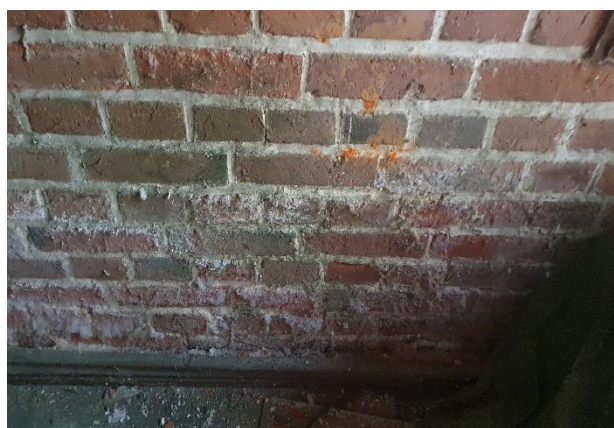
In the rooms of the former service apartment (B), local traces of dampness were visible, both in the floor area and at the height of the wall. In the historical part of the South Guardhouse, cracks and scratches in the plaster on the fillings under the brick arches were visible. Salination was visible on the surface of the walls inside the rooms of the Southern Guardhouse (Photo 6a and 6b), particularly intense on the surface of bricks, on fragments of walls that were subjected to renovation works in the past period. The porous lime-sand mortar was replaced with a sealed cement or cement-lime mortar (Photo 6c and Photo 6d).

In the rooms of the Southern Guardhouse, on the walls, especially in the floor zone, salt efflorescence and brick discoloration were visible on the surface of the brick wall - this situation was caused by the capillary rise of moisture resulting from the lack or technically inefficient anti-moisture insulation of the vertical and horizontal parts of the walls sunk in the ground. Similar faults and damages also occurred locally on keystones and runoffs of brick vaults and were a consequence of moisture seepage from the roof side as a result of local leaks in the roofing as well as due to the lack of proper thermal insulation of the roof over part (B) of the Building Complex. .

Extensive discoloration occurred on the old fragments of the wall made of old bricks (historical fragments of the wall), the joints of which had previously been cleaned and filled with modern mortar (as part of renovation works carried out in recent years) and on the wall made of new brick laid on modern mortar. It should be noted here that the number of redevelopments with modern bricks along with filling with modern mortar was negligible.

Increased humidity and the presence of salt in the air were manifested by bright efflorescence, discoloration and salt crystallization on the surface of the wall. According to the authors, such a mechanism of brick wall destruction also occurs in the rooms of the Southern Guardhouse.

Photo. 6: Salting the walls inside the rooms of the former service apartment (B)

- ❖ reconstruction of the anti-moisture insulation of the vertical and horizontal parts of the walls sunk into the ground,
 - ❖ revitalization of the flat roof by insulating it and adapting it to the current requirements in the field of thermal protection,
