Renovation works in buildings in the area of former defensive fortifications

Abstract

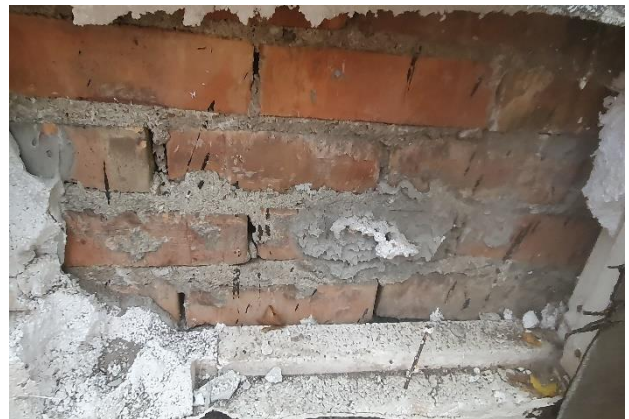
- inner outcrop (inside the building) O1: contemporary brick wall + cement-lime plaster from the inside (Photo 9a),
- inner outcrop (inside the building) O2: contemporary brick wall + cement-lime plaster from the inside (Photo 9b),

- inner outcrop (inside the building) O3: local redevelopment of a modern brick wall with a fragment of a modern wall built later (with high probability in the place of a bricked-up window opening) + cement-lime plaster from the inside (Photo 9c),

- inner outcrop (inside the building) O4: contemporary fragment - brick wall with redevelopment made of cellular concrete (aerated concrete) + 4 cm polystyrene insulation with a protective layer (elevation mesh) and gypsum plaster from the inside (Photo 9d),

- inner outcrop (inside the building) O5: probably an old (historical) brick wall + 4 cm polystyrene insulation with a protective layer (elevation mesh) and glazed tiles on the inside (Photo 9e),

- inner outcrop (inside the building) O6: probably an old (historical) brick wall + 4 cm polystyrene insulation with a protective layer (elevation mesh) and gypsum finish from the inside (Photo 9f),

- outdoor outcrop (outside the building) O7:

contemporary brick wall + 10 cm polystyrene insulation with a protective layer (elevation mesh) (Photo 9g),

- external outcrop (outside the building) O8:
contemporary brick wall with a protective layer of plaster + 10 cm polystyrene insulation with a protective layer (elevation mesh) (Photo 9h),
- outdoor outcrop (outside the building) O9:
contemporary brick wall + 10 cm polystyrene insulation with a protective layer (elevation mesh) (Photo 9i),
- outdoor outcrop (outside the building) O10:
contemporary brick wall + 10 cm polystyrene insulation with a protective layer (elevation mesh) (Photo 9j),
- outdoor outcrop (outside the building) O11:
contemporary brick wall + 10 cm polystyrene insulation with a protective layer (elevation mesh) (Photo 9k).

Photo. 9: View of the outer wall (from the escarpment side) of the former office rooms (A): a) O1, b) O2, c) O3, d) O4, e) O5, f) O6, g) O7, h) O8, i) O9, j) O10, k) O11
