Research paper

Settlement of a historic building due to seepage-induced soil deformation

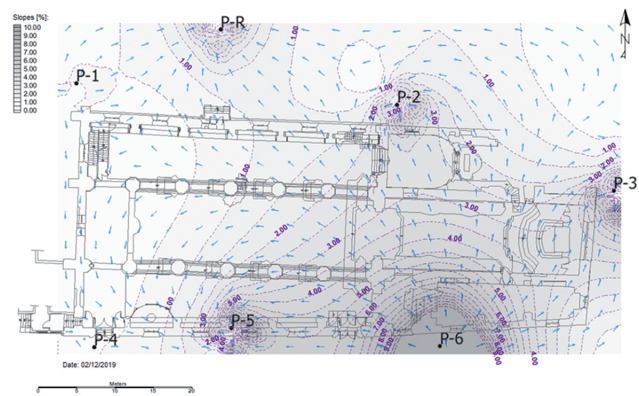
Fig. 12. Map of local groundwater table declines with seepage directions for 2/12/2019, against the background of the Basilica basement level plan

The presented results show how local declines in the Basilica area subsoil change. It can be clearly seen that the phenomenon varies over time, but qualitatively similar situations occur, such as on 2/12/2019 and 3/2/2020. The cyclical changes in the Basilica subsoil hydraulic gradients can initiate the formation of seepage-induced deformations. These changes can have various location, and the detachment of the subsoil from the Basilica floor was also found in several places.
