Research paper

Settlement of a historic building due to seepage-induced soil deformation

3. Soil seepage-induced deformations within the area of the St. Nicholas basilica in Gdańsk – case study

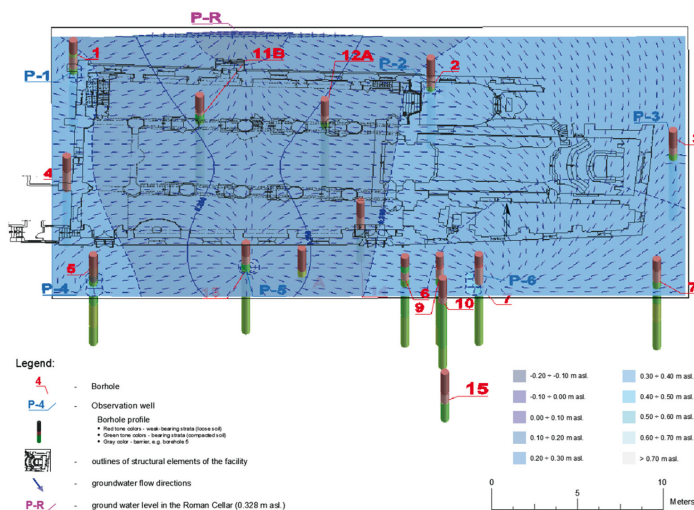
Fig. 5. Groundwater table level map with marked soil profiles at the borehole and piezometer location, with seepage directions for 31/7/2019, against the background of the Basilica basement level plan

31/7/2019, against the background of the Basilica basement level plan, with marked soil profiles in test boreholes and piezometers. Fig. 5 also shows water seepage directions resulting from piezometer groundwater levels. The analysis covered changing water levels on individual piezometers, as well as varying water seepage directions and seepage gradient values. Gradient values were analysed both along the entire length between the piezometers and locally, e.g., in the area of the pillars that experienced the greatest settlement.

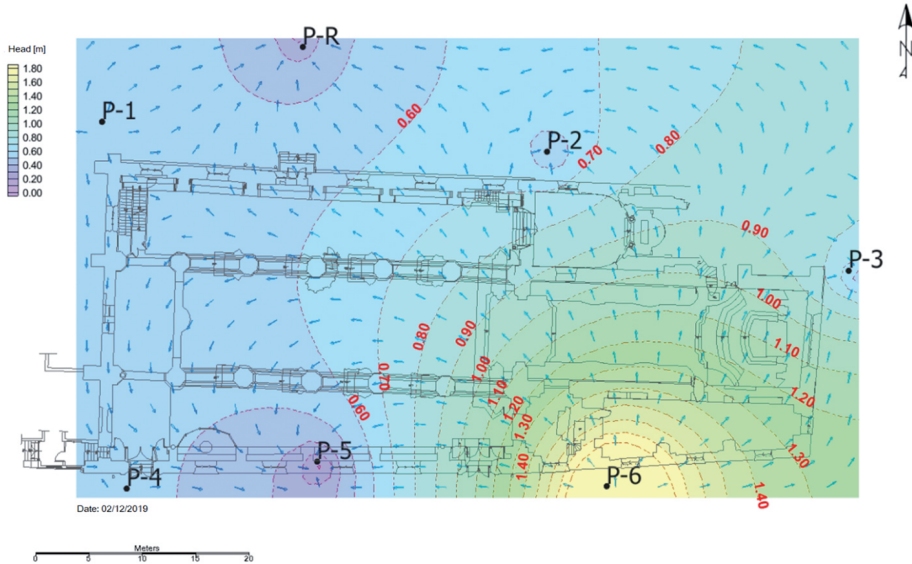
Fig. 6. Groundwater table level map with seepage directions for 2/12/2019, against the background of the Basilica basement level plan

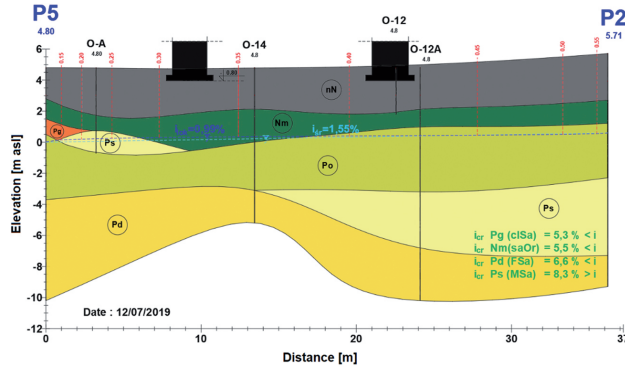
Fig. 8. Averaged groundwater table position and local table change within the Basilica foundation area for 12/7/2019 – P5-P2 longitudinal profile
