# Emergency condition of the ceramic facade of a residential building

Maciej NIEDOSTATKIEWICZ\*<sup>1</sup>

<sup>1</sup>Faculty of Civil and Environmental Engineering, Gdańsk University of Technology, Gdańsk, Poland

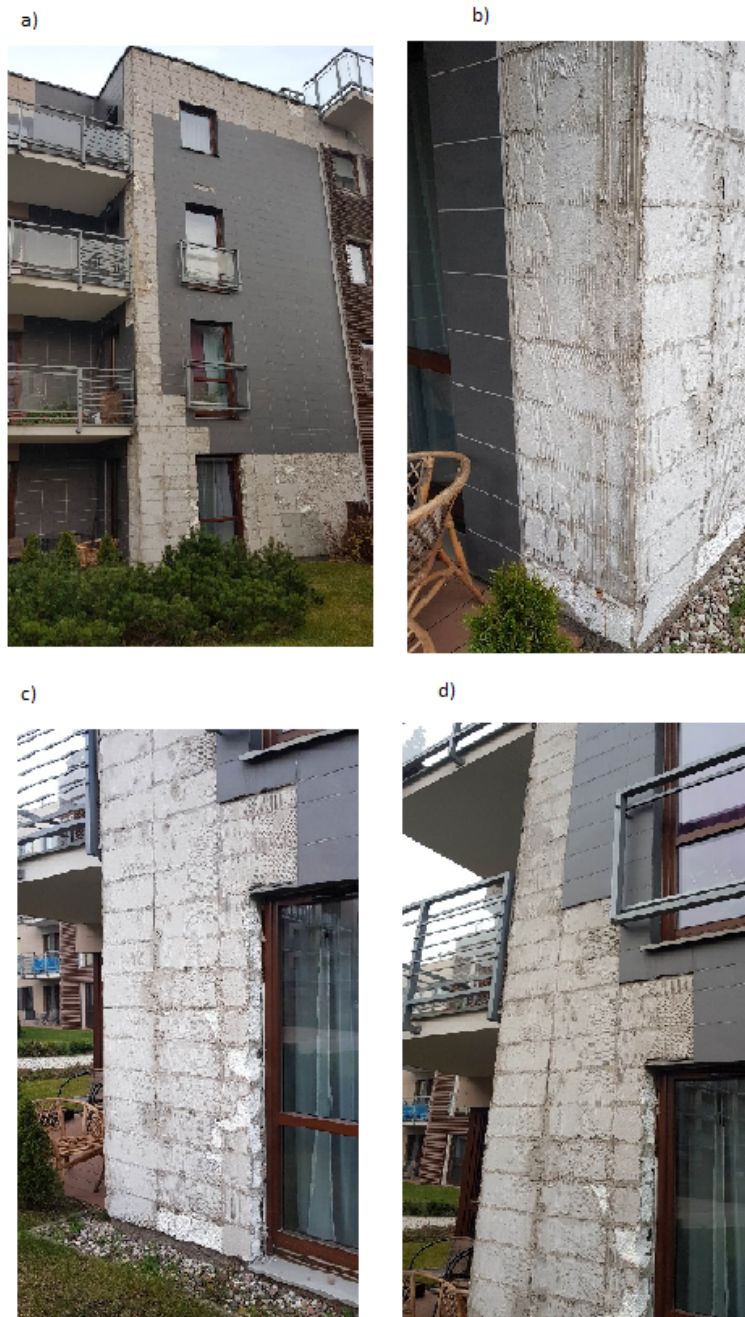
On the facade fragments made of ceramic tiles, extensive blooms were visible, occurring at the joints between individual ceramic tiles. 50% of the facade surface made with the use of ceramic cladding had damage in the form of its detachment from the substrate, i.e. from the adhesive layer, made on a heat-insulating material such as polystyrene. These damages occur over the entire height of the building, at the height of 4 above-ground storeys (Fig. 1).

Figure 1. Damaged ceramic cladding a), b), c) and d) of the building facade

In the case of damage to the ceramic cladding of the building façade, it was most likely a consequence of using too little water added to the adhesive, which resulted in its drying too quickly instead of the spread of bonding over time. Carrying out cladding works in the period when the wind was probably periodically blowing, which resulted in exceeding the so-called open time and resulted in the glue drying out, and consequently accelerated setting start contributed to the tiles being scorched by the glue layer. Likewise, the probable performance of works in the period of periodic increased insolation had a negative effect on the adhesion of the adhesive to the substrate and to the tiles. In addition, the implementation of the cladding fragments on the thickened adhesive layer led to excessive shrinkage and loss of adhesion. Leaks in the attic's plinth also contributed to the degradation of the cladding.

Local efflorescence on the ceramic cladding of the building façade resulted from the occurrence of local leaks in the attic roofing, which could result in the penetration of rainwater into the façade finishing layers, which by gravitation resulted in leaching of calcium compounds. In addition, the locally increased diffusion of water vapor transported to the outside leaches calcium compounds from cement mortars, and the limited transport surface, which is a grout, also made as cement-based mortar, contributes to the formation of efflorescence [20].

- disassembly of the damaged ceramic cladding on the entire surface of all facades of the building,
- re-profiling the substrate: gluing an additional layer of facade mesh in places of damage, additional pinning of the thermal insulation material (polystyrene), making a new layer of glue on the entire surface,
- reconstruction of all facades of the building using the facade plaster,
- checking the tightness of flashings and flashing, especially in the area of parapets, taking into account the possibility of their complete replacement.

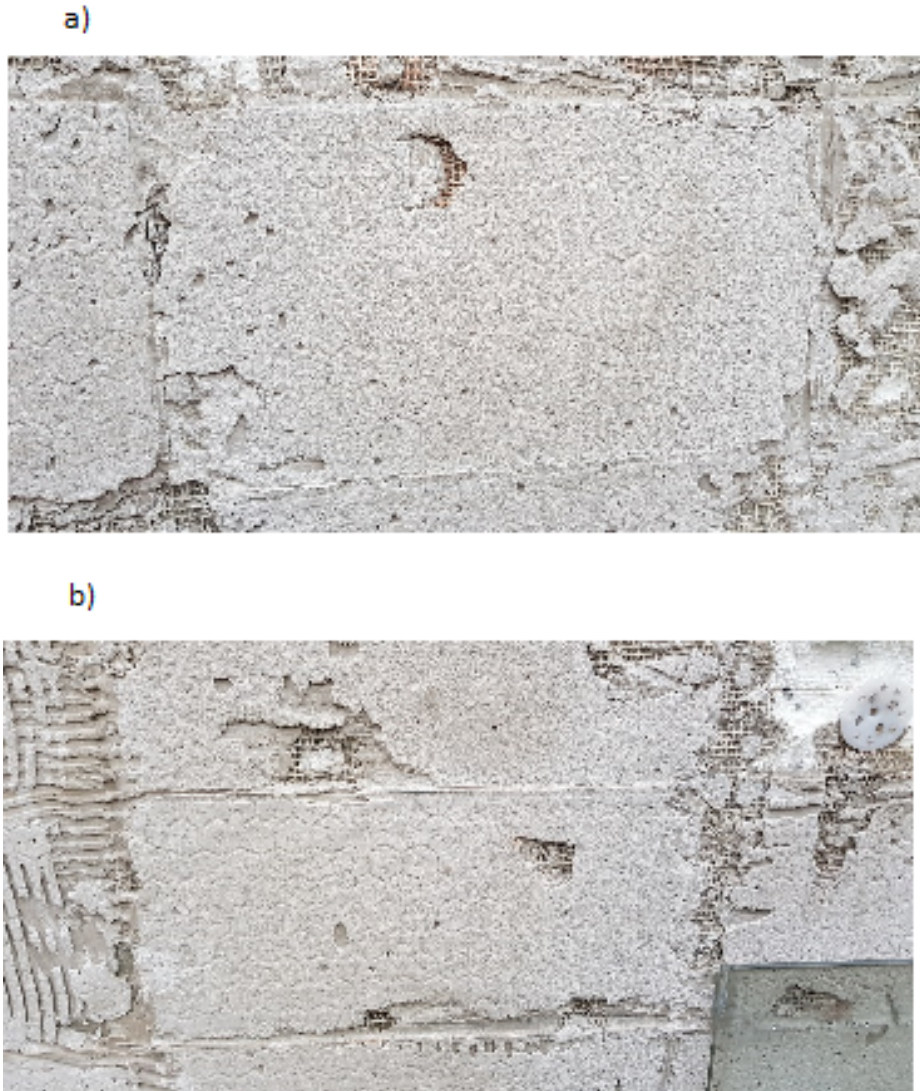
Figure 3. Mechanism a), b) (method of detaching) the ceramic cladding of the building facade
