Monitoring of a historic sacral building on an example Basilica St. Nicholas in Gdańsk

Abstract

The paper describes the case of monitoring the technical condition of a historic sacral building after a failure and during renovation works. In order to monitor the condition of the building, safely conduct diagnostic work, identify the causes of failures and safely carry out renovation works, a detailed Facility Monitoring Program has been developed, which has been implemented, is operational and is a source of valuable data used to assess the current condition of the facility.

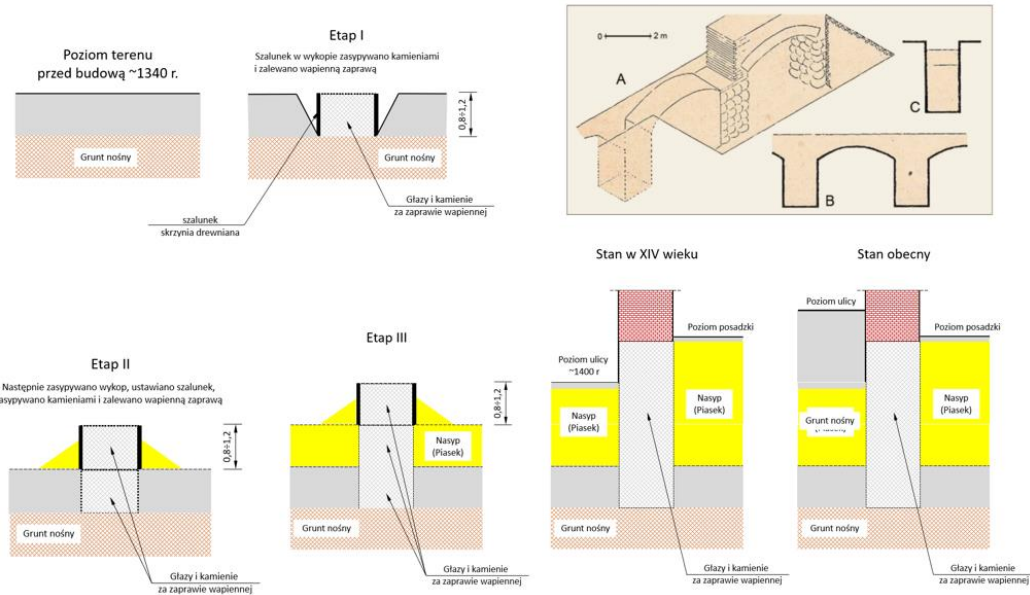
In order to recognize the type and condition of the foundations of the Basilica, classic narrow-spatial excavations were made. The excavations revealed that the foundations of the building were made in the form of stone pillars, on which brick arches are based, above which ceramic walls and pillars of the building were built [31]–[32]. The condition of the foundations of the building was different in individual excavations. Based on the inspection, it was found that the stone foundations were placed directly on the layers of load-bearing soils (sands and gravels), under which no wooden piles and fascines were found. The layered structure of the pillars at their height was determined. The foundations were made in three stages, approximately 1.0 m high for each layer of stones (Fig. 3). Boulders and stones are laid on lime mortar, and the external surfaces are clad with clay.

Fig. 3. Foundations of the building of the Basilica of St. St. Nicholas in Gdańsk Basilica [31]–[32]

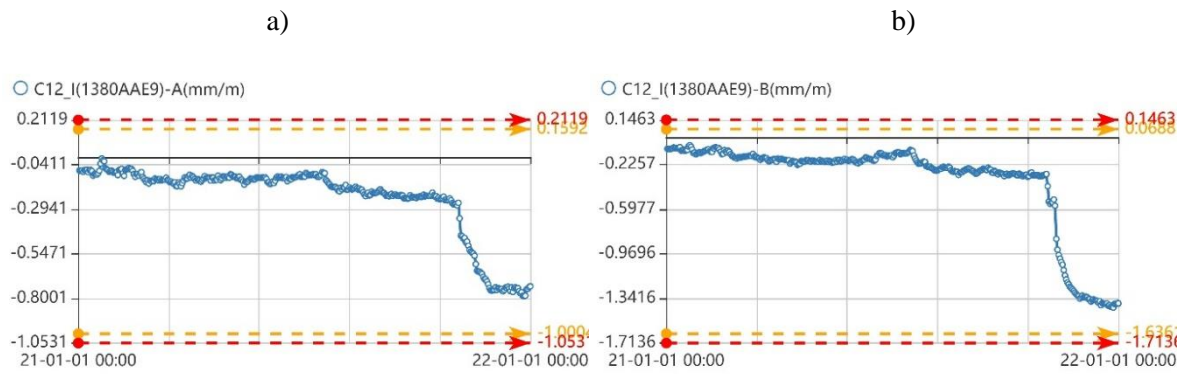
A cracked inter-column arch is based on the F2 and F3 pillars, Fig. 9, Fig. 10 and Fig. 11 show the results of inclination measurements of three selected pillars, F1, F2 and F3, respectively. Fig. 12 shows changes in vertical displacements (settlements) of piers F1 (a) and F2 (b) recorded in 2021. by distance sensors D17_I and D18_I. The charts show changes in the trend of recorded values caused by an increase in the load from the weight of the concrete ribs and the shell reinforcing the arches.

Fig. 9. Inclination of the pillar F1 of the southern aisle in the direction of axis A (a) and axis B (b): readings of the C12_I sensor in the period 01.01÷31.12.2021

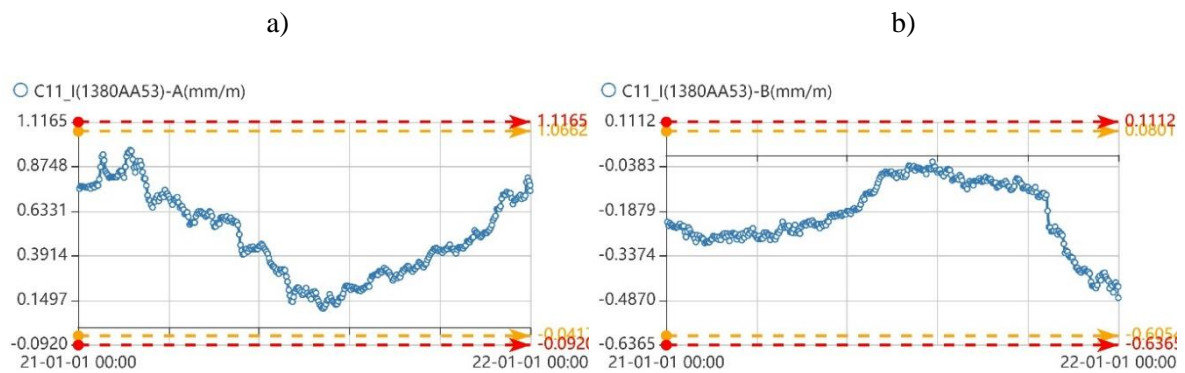
Fig. 10. Inclination of the pillar F2 of the southern aisle in the direction of axis A (a) and axis B (b): readings of the C11_I sensor in the period 01.01÷31.12.2021

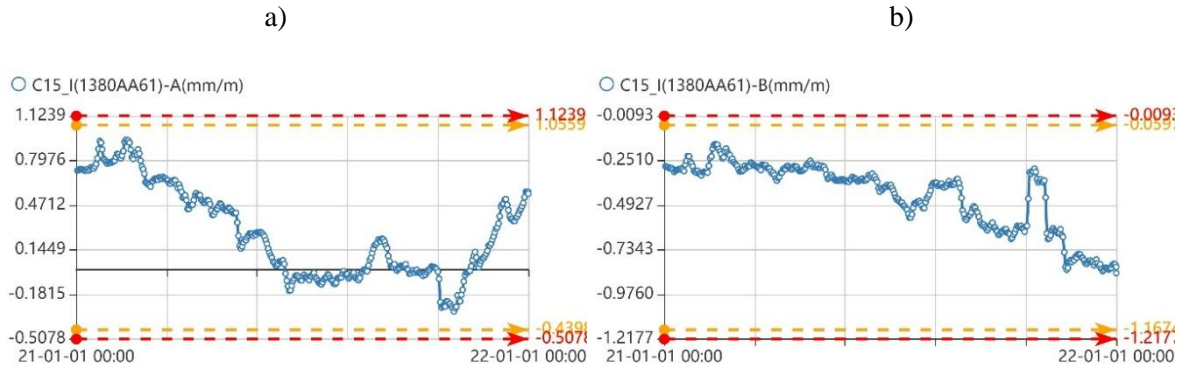
Fig. 11. Inclination of the pillar F3 of the southern aisle in the direction of axis A (a) and axis B (b): readings of the C15_I sensor in the period 01.01÷31.12.2021

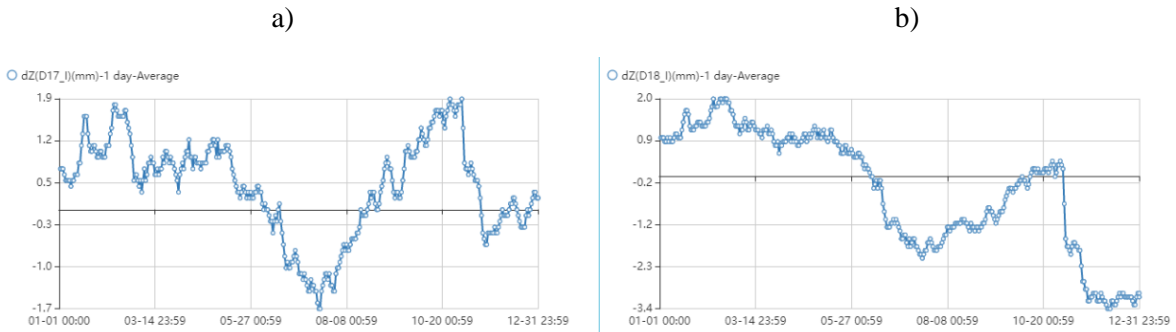
Fig. 12. Vertical displacement of the pillars of the southern aisle based on readings from distance sensors: a) C17_I (F1) and b) C18_I (F2) in the period 01.01÷31.12.2021
