Monitoring of a historic sacral building on an example Basilica St. Nicholas in Gdańsk

Tomasz MAJEWSKI^{*1}, Maciej NIEDOSTATKIEWICZ²

Abstract

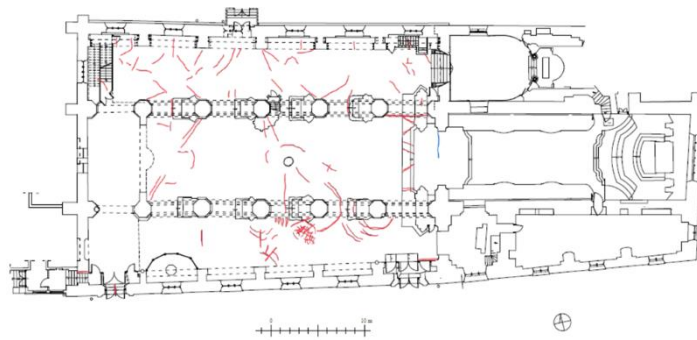
In the initial stage of the recognition, a visual inspection of the condition of the Basilica's structural elements was made (Photo 1 and Fig. 1), photographic and drawing documentation of the faults and damages was prepared [24]. Photo 2 and Photo 3 show the photos of the cracked arch between the pillars of the southern aisle and representative damage to the vault rib for the southern aisle. Based on the information collected, it was decided to immediately temporarily support the damaged vaults of the south aisle with temporary supporting scaffolding. The scaffolding was to be placed on the historic floor of the church, which was deformed and locally collapsed. For this reason, local covers were made to check the condition of the subfloor under the floor, in which voids and cavities were found. Preliminary tests of the entire floor in the Basilica were carried out using the GPR ground-penetrating radar [25]. Based on the results obtained, a decision was made to temporarily dismantle the floor within the southern aisle for the duration of the scaffolding operation. Before dismantling the floor, a detailed conservation inventory was made. After dismantling the floor, scaffolding was erected to protect the vaults of the southern aisle (Photo 4).

Fig. 1. Basilica of St. St. Mikołaja in Gdańsk: morphology of the features - as of January 19, 2019. [24]

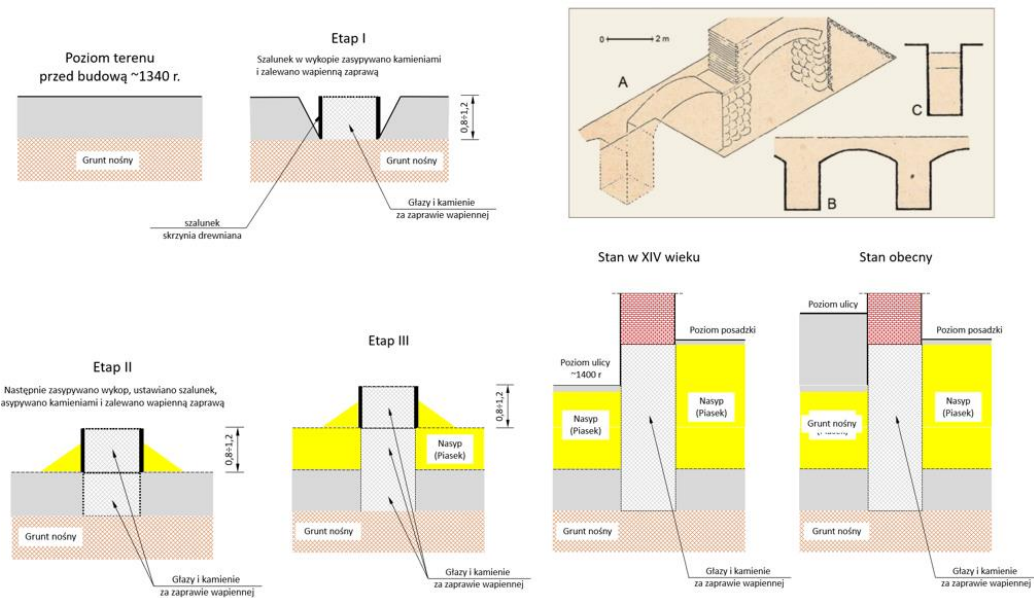
In order to recognize the type and condition of the foundations of the Basilica, classic narrow-spatial excavations were made. The excavations revealed that the foundations of the building were made in the form of stone pillars, on which brick arches are based, above which ceramic walls and pillars of the building were built [31]–[32]. The condition of the foundations of the building was different in individual excavations. Based on the inspection, it was found that the stone foundations were placed directly on the layers of load-bearing soils (sands and gravels), under which no wooden piles and fascines were found. The layered structure of the pillars at their height was determined. The foundations were made in three stages, approximately 1.0 m high for each layer of stones (Fig. 3). Boulders and stones are laid on lime mortar, and the external surfaces are clad with clay.

Fig. 3. Foundations of the building of the Basilica of St. St. Nicholas in Gdańsk Basilica [31]–[32]

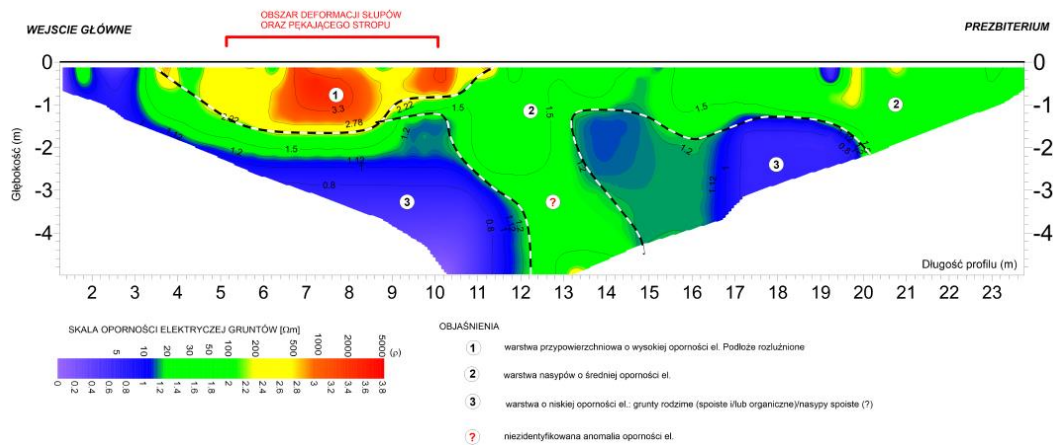
Basic and extended geotechnical surveys of the ground under the building and in its immediate vicinity were also performed. Basic research included geotechnical drilling and probing [33]–[36] and installation of piezometers, advanced geophysical methods were used for extended research: electroresistance tomography (ERT) [37]–[39], georadar (GRP) [40]–[43] and multi-channel surface wave analysis (MASW) [44]–[45]. Selected results of the above-mentioned studies are presented in Fig. 4, Fig. 5 and Fig. 6, as well as described in [24]–[25], [31], [46]–[49].

Fig. 4. Electrofusion profile made along the southern aisle of the Basilica of St. St. Mikołaja in Gdańsk based on measurements using electroresistance tomography (ERT) [31]
