Revitalizing the Sacral Complex of the Parish of the Sacred Heart of Jesus in Gdynia: A Comprehensive Restoration Project in Alignment with Monument Conservator's Guidelines and Technical Prerequisites

Maciej NIEDOSTATKIEWICZ^{*1}, Jacek BRAMORSKI^{2,3}

¹ Department of Engineering Structures, Faculty of Civil and Environmental Engineering,
Gdańsk University of Technology, Gdańsk, Poland

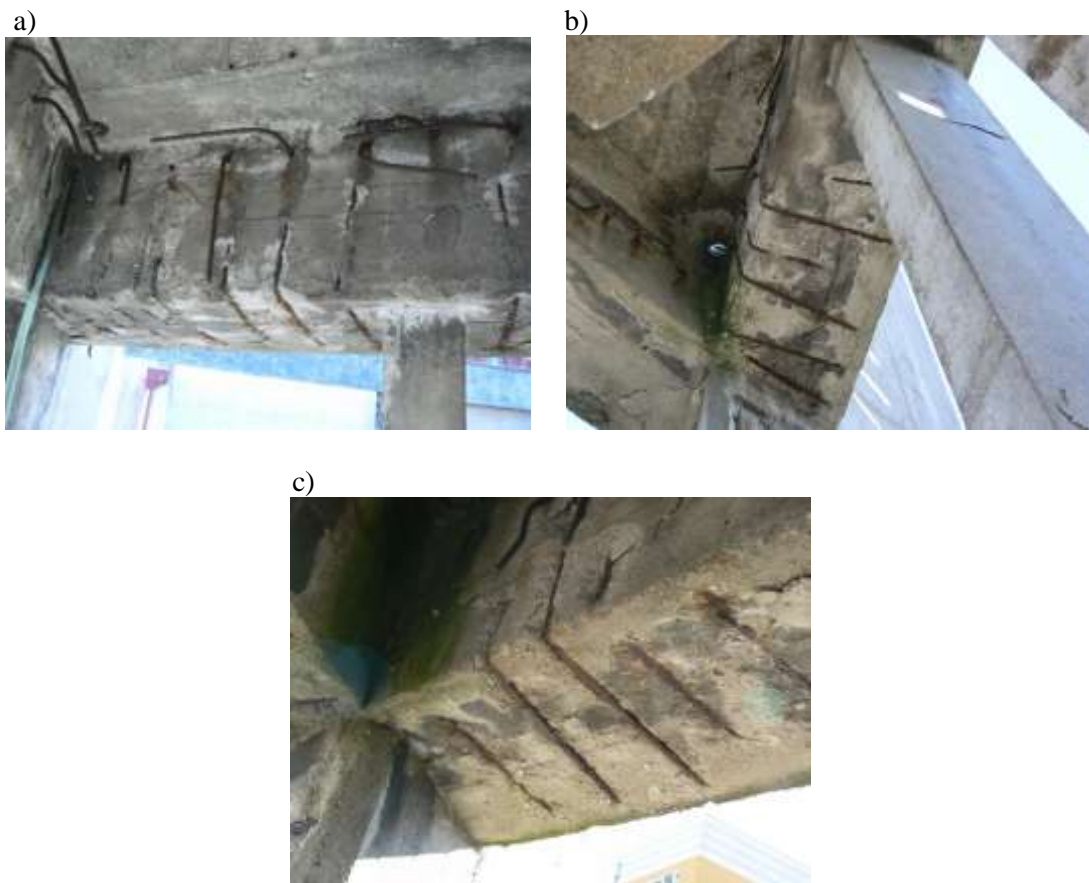
transoms were found. On the other hand, there was massive loosening of the cover of the main reinforcement and stirrups as a result of corrosion of the bars and stirrups (Photo 2, Photo 3 and Photo 4).

Photo 3. Examples of damage to the monolithic reinforced concrete bolts of the belfry tower: a), b), c) losses of the concrete cover and corrosion of the reinforcement bars (photo by Maciej Niedostatkiewicz)

- structural elements (main columns in the axes A, B, C, prefabricated auxiliary posts, as well as transoms and beams at the level of technical platforms from 1 to 6) were reprofiled with the use of PCC and PCC II repair compounds,
- scratches on the column of the spiral stairs between levels 2-3 were secured by the use of adhesive injection. It was assumed that if the cracking of the column reappeared, it would be necessary to strengthen it and protect it by gluing carbon mats, creating the form of closed rings around the column between the prefabricated steps of the stairs,
- after the reprofiling, the surfaces of the reinforced concrete elements were covered with hydrophobing agents that minimize the migration of moisture and compounds contained in the air into the concrete, at the same time minimizing the progress of concrete carbonation.

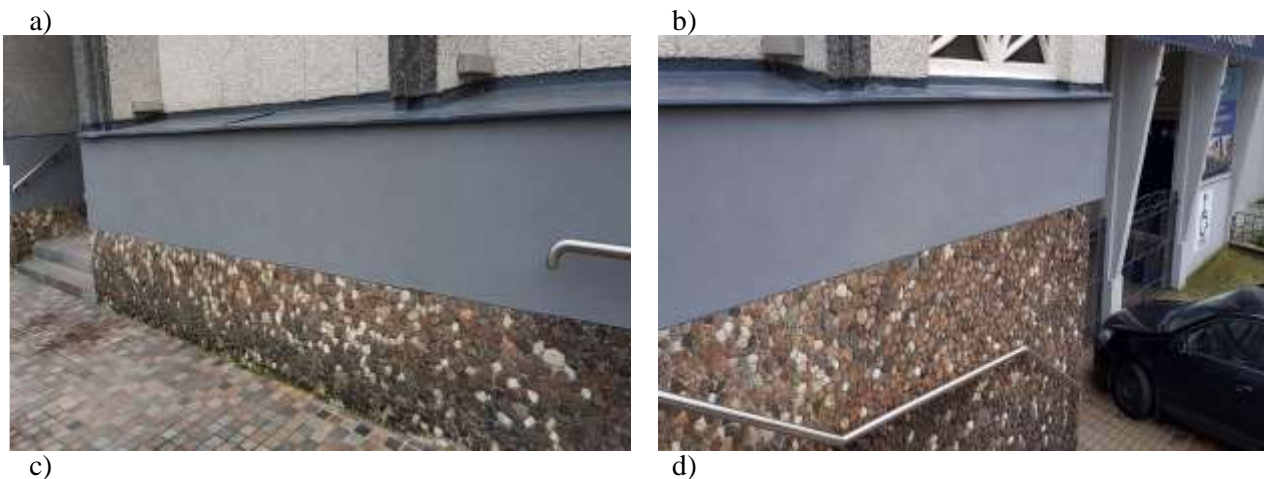
Photo 15. Base cornice after completion of renovation works: a), b) along the western elevation (from the side of 3 Maja Street), c) from the southern elevation (along Armii Krajowej Street), d) along the eastern elevation (from the side of Monsignore Hilarego Jastaka Street), e), f) from the northern elevation (along Stefana Batorego Street) (street names as of 2023) (photo by Maciej Niedostatkiewicz)

The lower part had damage similar to damage to the stone cladding of the wall at the main entrance. The stones were dirty, covered with a coating. Single stones were loosened, some of the joints were chipped. As part of the renovation works, the entire surface of the lower part of the plinth was first wetted with water at a temperature of $\sim 30^{\circ}\text{C}$, and then a thin layer of ammonium fluoride-based cleaning paste was applied to the surface of the plinth using a bench brush and the plinth was again washed with warm water. After cleaning, loose stones were glued in, and then the jointed stone cladding was supplemented with the materials used to repair the stone cladding of the wall at the main entrance.

The upper part of the plinth had damages in the form of plaster burns from the concrete base, the entire surface of the plaster was discolored and faded. As part of the renovation work, the scalded plaster was chipped off and restored. The new plaster was made as a layered plaster, with a primer layer and a top layer, after prior priming of the substrate and making a bond bridge. The top layer of the plaster was made as colored in the mass, with the use of fine quartz aggregate, with the use of a trass mortar dyed in the mass. The newly made external plaster on the plinth was made as rubbed plaster, with a structure matched to the structure of the plaster fragments left. After the local plaster repairs were completed, its entire surface was secured with an additional protective paint coating, in accordance with the conservation guidelines - a silicone facade paint was used, characterized by high water vapor diffusivity. As part of

the repair work, the flashings on the upper surface of the plinth were also replaced. The original flashings were made of zinc sheet, joined with the use of reflected and smooth coils, they were replaced with flashings made of steel-titanium sheet joined with standing seams.
