Revitalizing the Sacral Complex of the Parish of the Sacred Heart of Jesus in Gdynia: A Comprehensive Restoration Project in Alignment with Monument Conservator's Guidelines and Technical Prerequisites

Maciej NIEDOSTATKIEWICZ^{*1}, Jacek BRAMORSKI^{2,3}

¹ Department of Engineering Structures, Faculty of Civil and Environmental Engineering,
Gdańsk University of Technology, Gdańsk, Poland

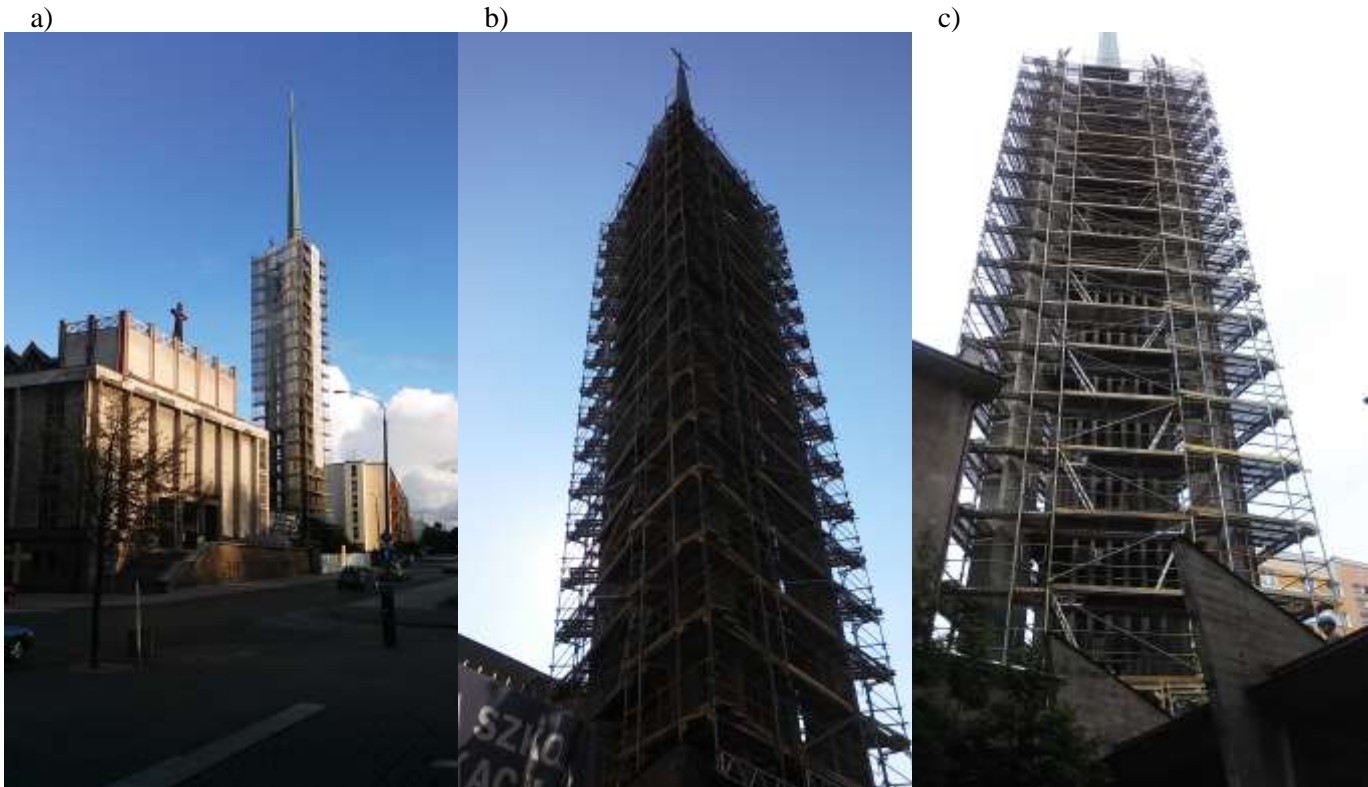
Photo 7. Reinforced concrete belfry tower during renovation works: a) general view, b), c) close-up details of the scaffolding (photo by Jacek Bramorski)

- structural elements (main columns in the axes A, B, C, prefabricated auxiliary posts, as well as transoms and beams at the level of technical platforms from 1 to 6) were reprofiled with the use of PCC and PCC II repair compounds,
- scratches on the column of the spiral stairs between levels 2-3 were secured by the use of adhesive injection. It was assumed that if the cracking of the column reappeared, it would be necessary to strengthen it and protect it by gluing carbon mats, creating the form of closed rings around the column between the prefabricated steps of the stairs,
- after the reprofiling, the surfaces of the reinforced concrete elements were covered with hydrophobing agents that minimize the migration of moisture and compounds contained in the air into the concrete, at the same time minimizing the progress of concrete carbonation.

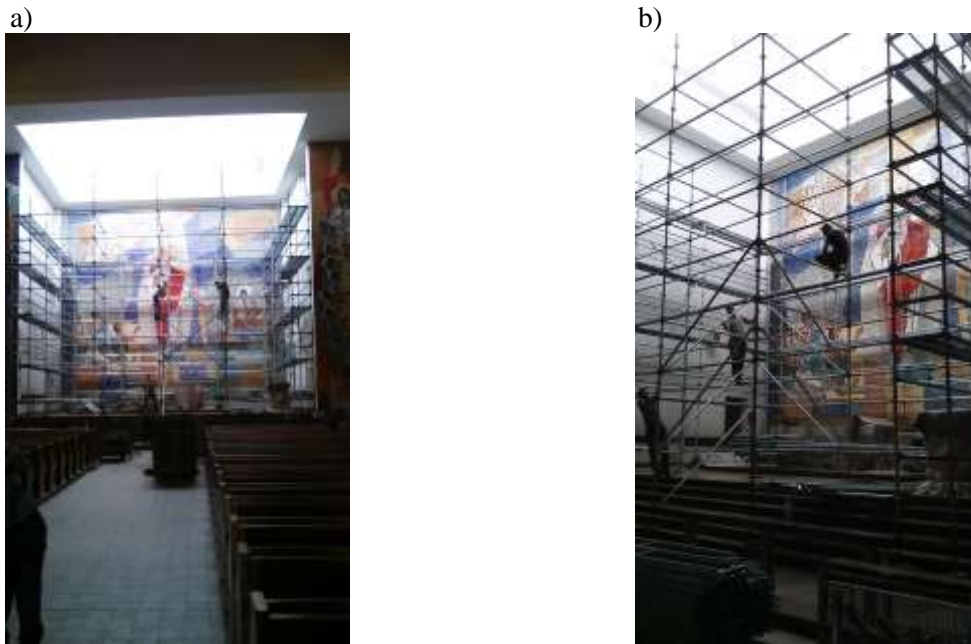
Photo 8. Preparatory works for the renovation of the presbytery cover: a), b) scaffolding assembly (photo by Jacek Bramorski)

The scope of renovation works included the disassembly of the existing glazing (single glazing), reprofiling of the so-called concrete joinery constituting a grid for glazing and re-assembly of small-sized elements of glass panes. As part of the repair work, painting work was also carried out in the inner part of the tower.

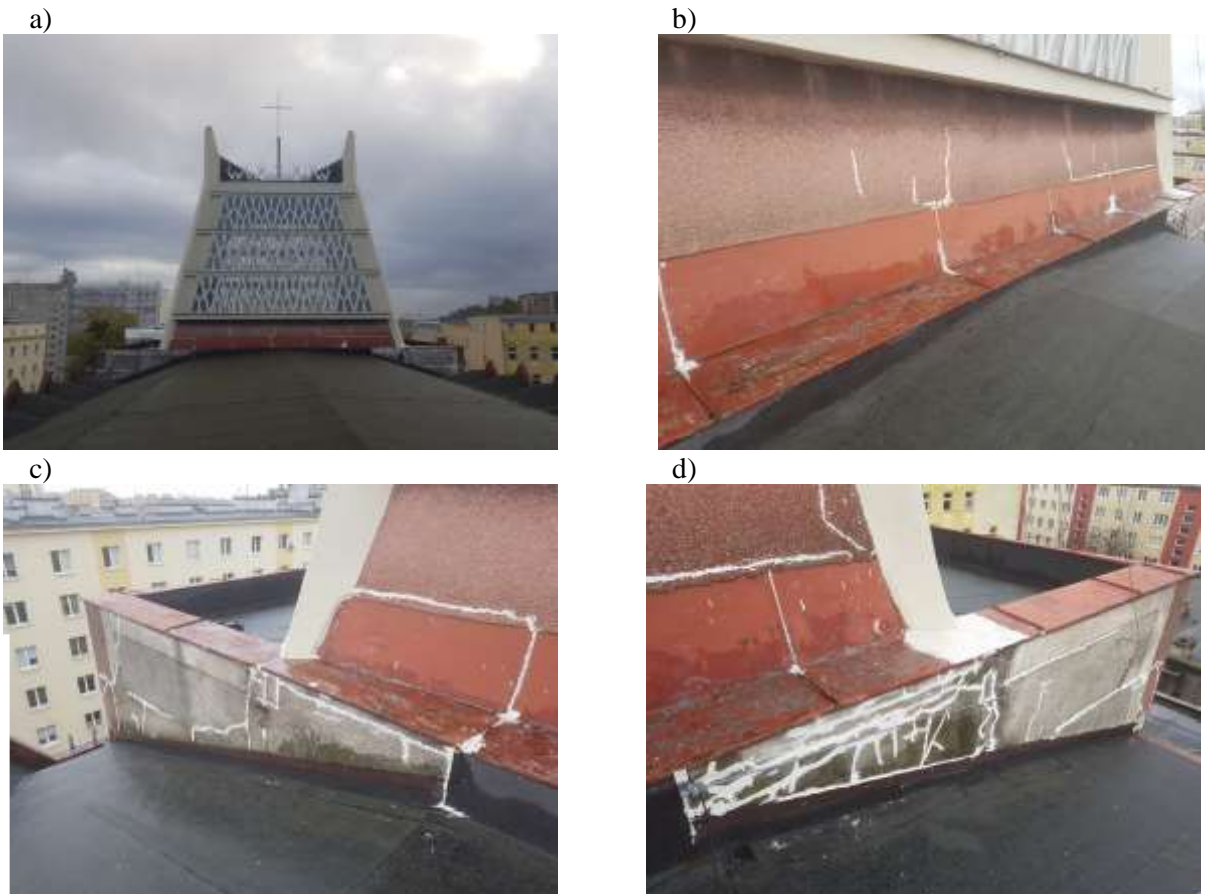
Photo 9. Roof of the Church of the SHoJ in Gdynia: a) general view towards the so-called lantern over the presbytery, b) cracks in the plaster of the lantern plinth, c), d) cracks in the plaster of the attic along the lantern, flashings of the attic along the lantern: e) before and f) after the replacement (photo by Maciej Niedostatkiewicz and Jacek Bramorski)

The renovation works also included the replacement of the existing, intensively depreciated flashings. The main scope of renovation works on the roof over the central nave included reprofiling the reinforced concrete gable beams of the roof slopes - the beams had numerous corrosion damages, the concrete cover of the reinforcement bars was falling off and extensive moisture damage was visible (Photo 10). The repair works included the reprofiling of reinforced concrete elements with the use of PCCI and PCC II repair compounds, taking into account the use of passivating materials for corroded reinforcing bars. The scope of renovation works also included the replacement of flashings and flashings of the roof slopes and the replacement of existing downpipes.

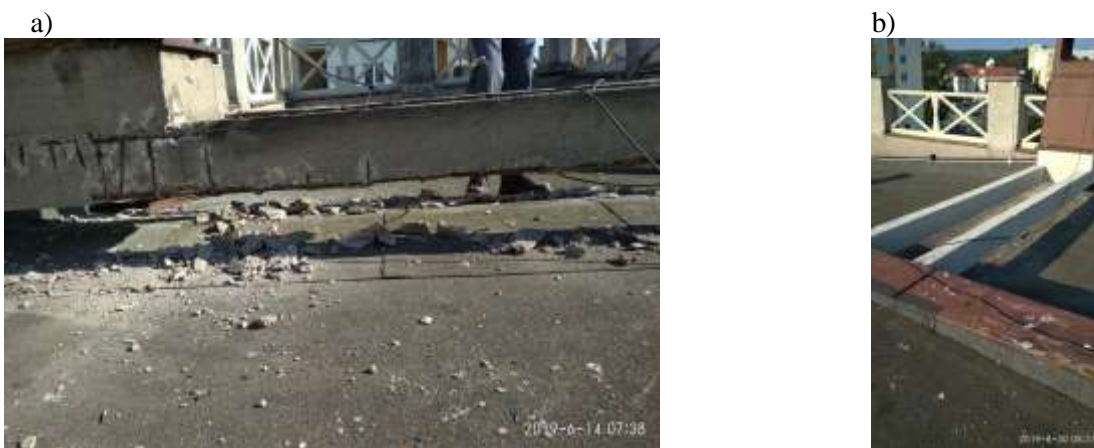
Photo 11. Reinforced concrete, monolithic beams of the grate supporting the cross from the west elevation (along 3 Maja Street) - condition: a) before, b) after renovation (street names as of 2023) (photo by Maciej Niedostatkiwicz)

As part of the repair work on the reinforced concrete elements of the roof slope above the central nave, the reinforced concrete beams supporting the cross placed on the roof, visible from the side of the front façade, were also reprofiled (Photo 11).

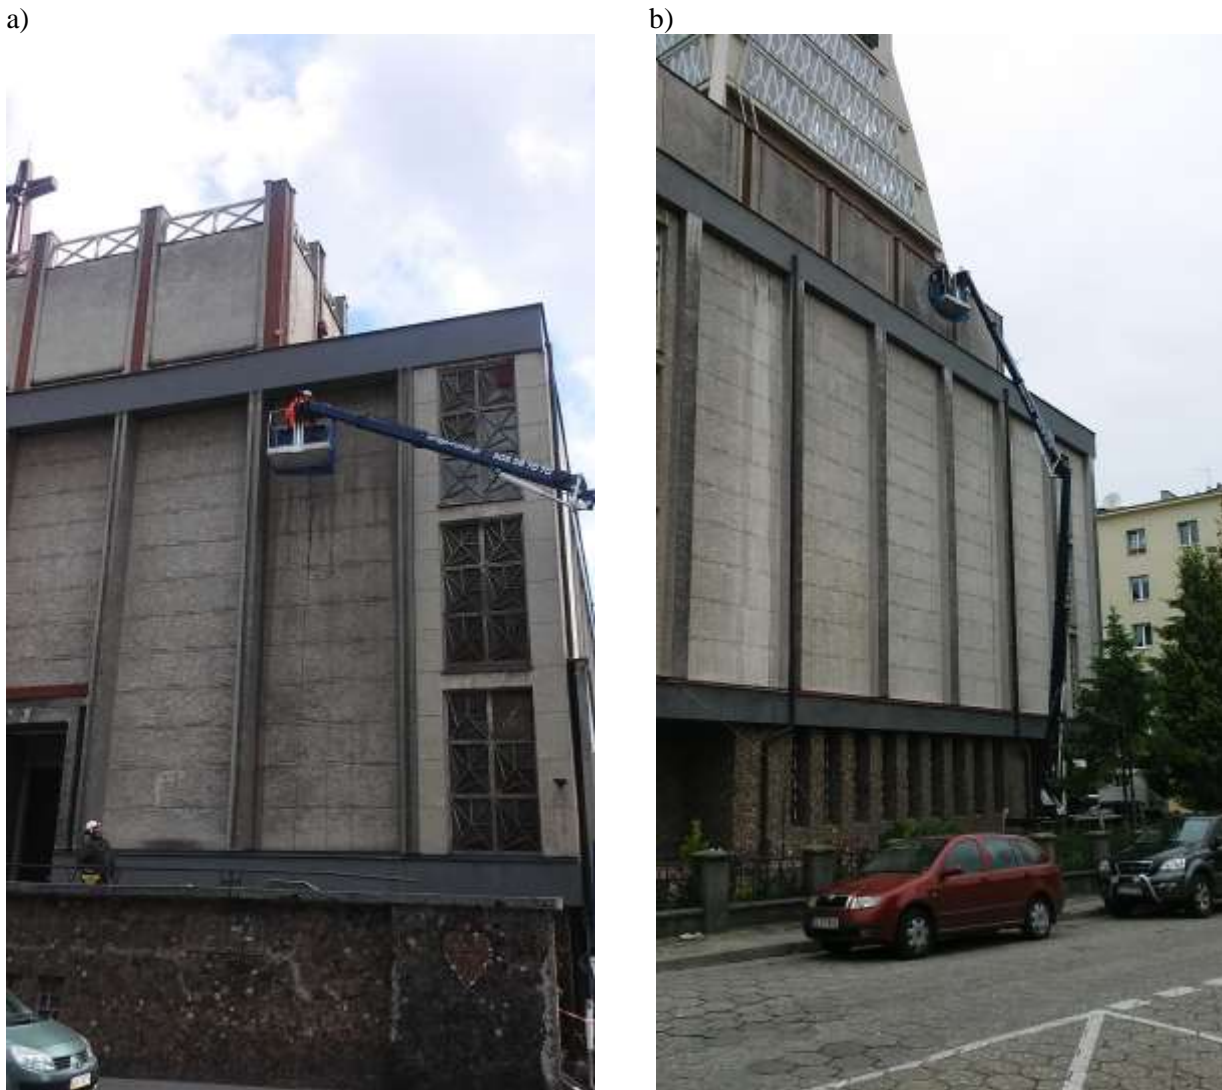
Photo 16. Church facades during their cleaning: a) western (from the side of 3 Maja Street) and b) eastern (from the side of Monsignore Hilarego Jastaka Street) (street names as of 2023) (photo by Jacek Bramorski)

The next stage of the renovation works of the Church building was the cleaning of the elevation (Photo 16). All facades of the building were subjected to restoration works, which were cleaned using the hydromonitoring method (Photo 17), using hot water at a temperature of 30°C. As an addition to the purification, an agent with a neutral pH was used, containing surfactants, i.e. surfactants that lower the surface tension of water. Thanks to the emulsifying properties of the agent used, the washed dirt and impurities were bound, especially the layer of grease and dust accumulated over the years of operation on the surface of the plaster made as the so-called. scraper. After cleaning, the facades were not additionally secured with a protective paint coating with the addition of anti-algae and anti-fungal agents, it was assumed that the protection would be provided by preservatives used in the production of the detergent in order to obtain its durability.

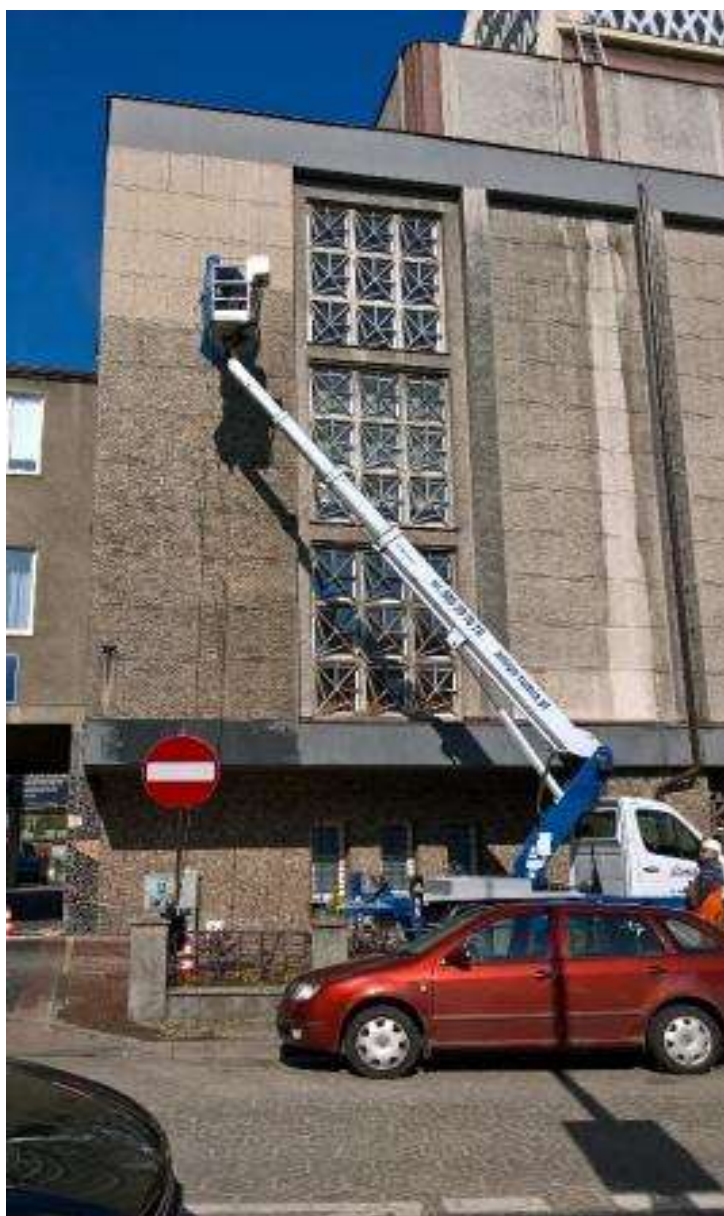
Photo 17. Comparison of the structure and color of the facade a) before and b) after its cleaning - on the example of the eastern facade (from the side of Monsignore Hilarego Jastaka Street) (street names as of 2023) (photo by Jacek Bramorski)

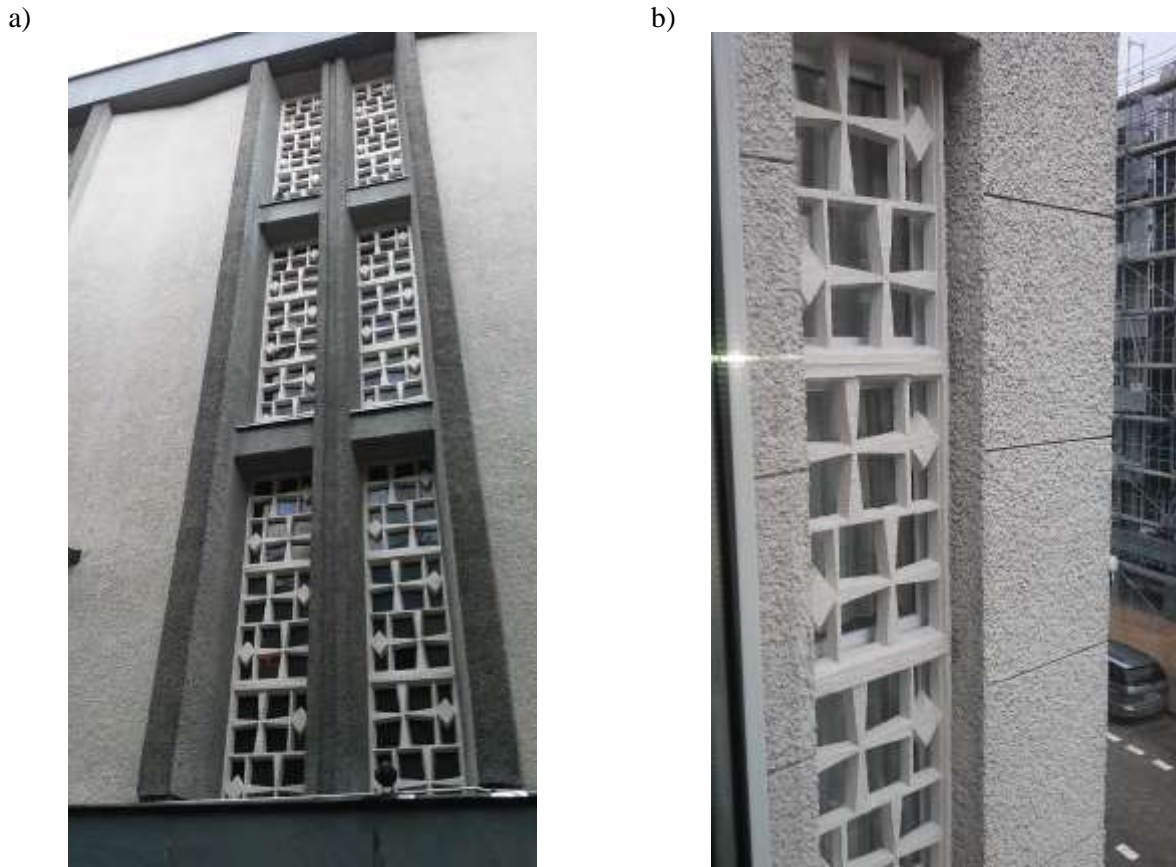
Photo 18: The condition of the facade from the south (along Armii Krajowej Street) after cleaning: a) view of the facade plaster, b) concrete window frames after revitalization (name of the street as of 2023) (photo by Jacek Bramorski)
