Revitalizing the Sacral Complex of the Parish of the Sacred Heart of Jesus in Gdynia: A Comprehensive Restoration Project in Alignment with Monument Conservator's Guidelines and Technical Prerequisites

Maciej NIEDOSTATKIEWICZ^{*1}, Jacek BRAMORSKI^{2,3}

¹ Department of Engineering Structures, Faculty of Civil and Environmental Engineering,
Gdańsk University of Technology, Gdańsk, Poland

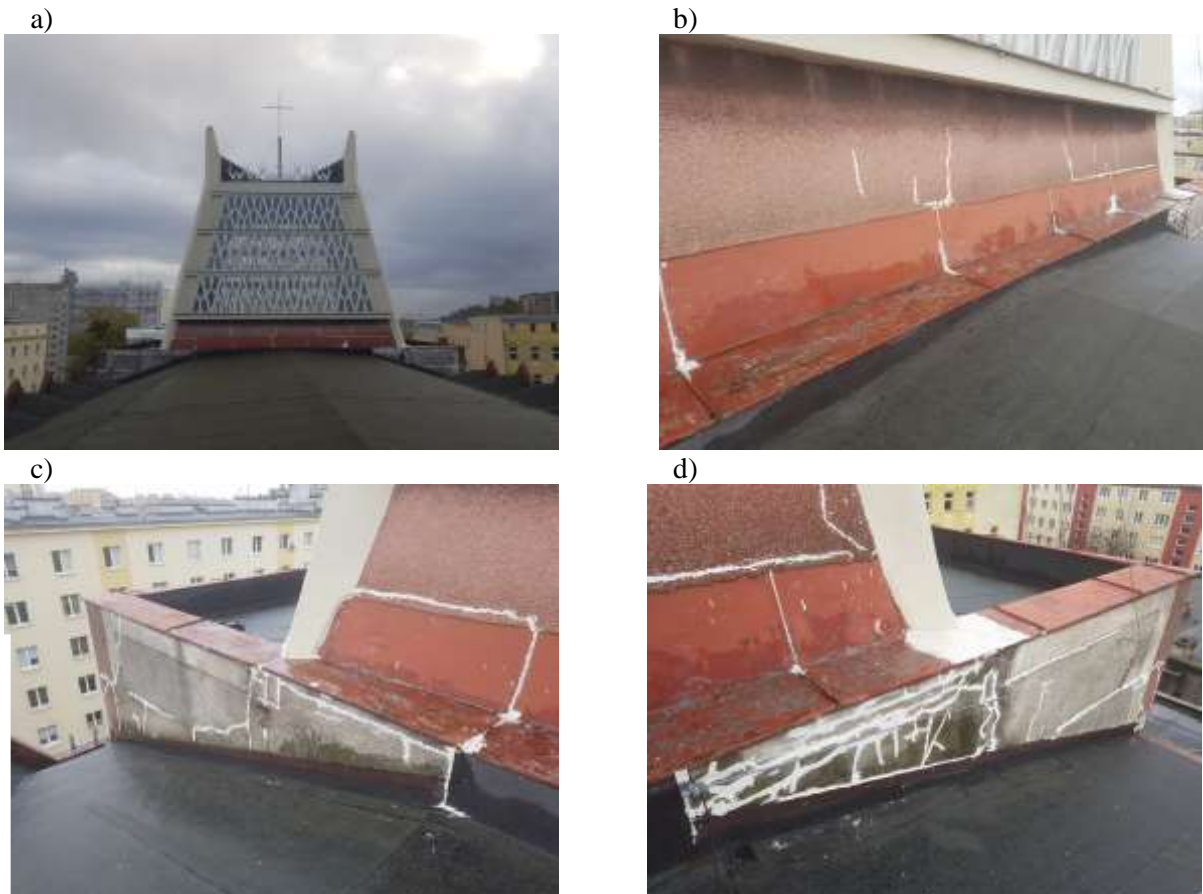
Photo 9. Roof of the Church of the SHoJ in Gdynia: a) general view towards the so-called lantern over the presbytery, b) cracks in the plaster of the lantern plinth, c), d) cracks in the plaster of the attic along the lantern, flashings of the attic along the lantern: e) before and f) after the replacement (photo by Maciej Niedostatkiwicz and Jacek Bramorski)

The renovation works also included the replacement of the existing, intensively depreciated flashings. The main scope of renovation works on the roof over the central nave included reprofiling the reinforced concrete gable beams of the roof slopes - the beams had numerous corrosion damages, the concrete cover of the reinforcement bars was falling off and extensive moisture damage was visible (Photo 10). The repair works included the reprofiling of reinforced concrete elements with the use of PCCI and PCC II repair compounds, taking into account the use of passivating materials for corroded reinforcing bars. The scope of renovation works also included the replacement of flashings and flashings of the roof slopes and the replacement of existing downpipes.

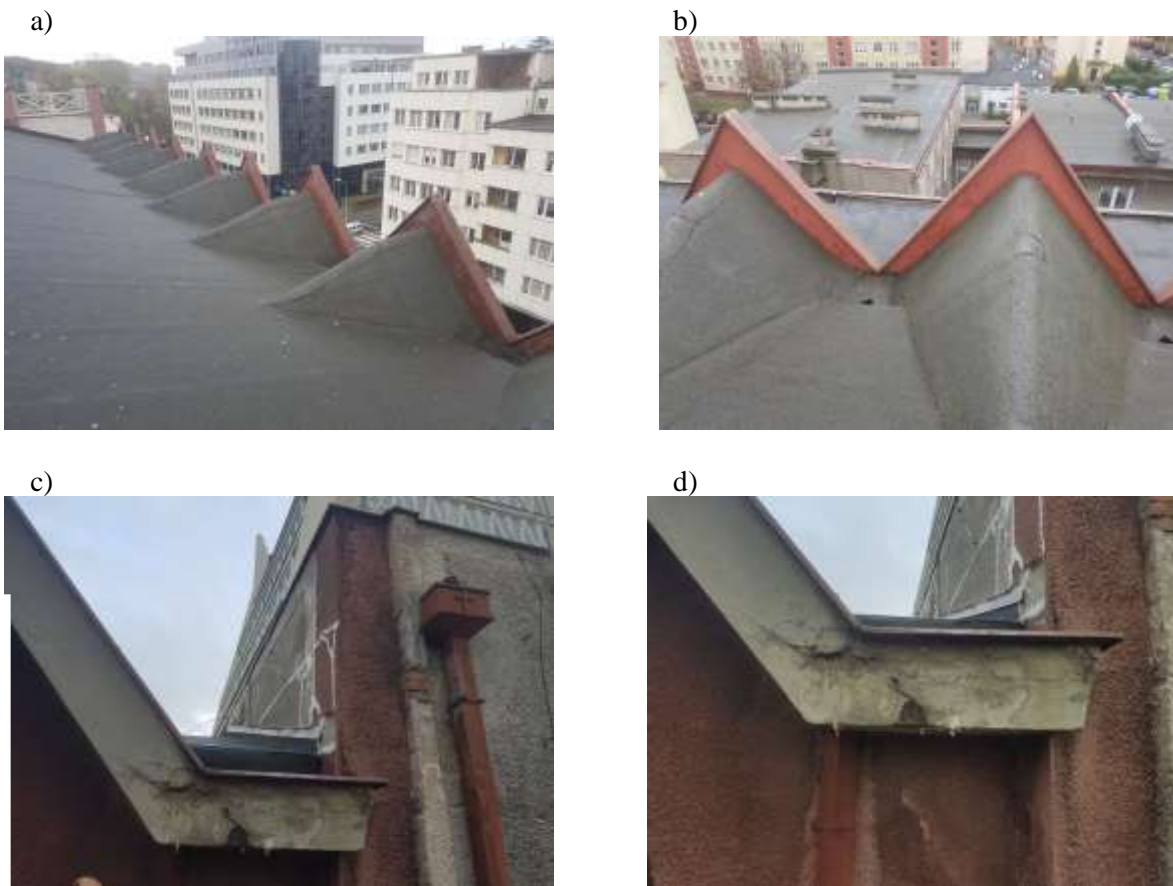
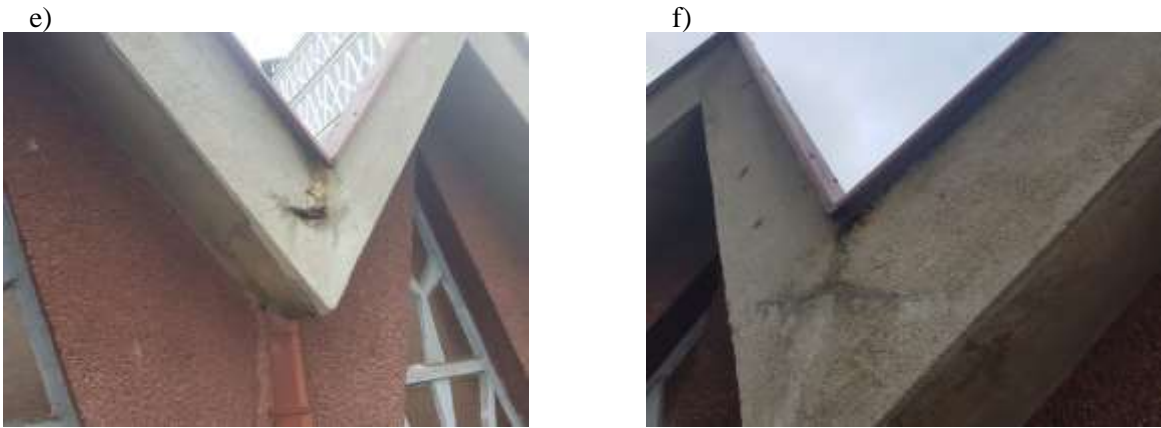
Photo 10. Shed roof over the nave of the Church of the SHoJ in Gdynia: view: a) general, b) close-up, c), d), e), f) examples of damage to the roof cornice (photo by Maciej Niedostatkiwicz)

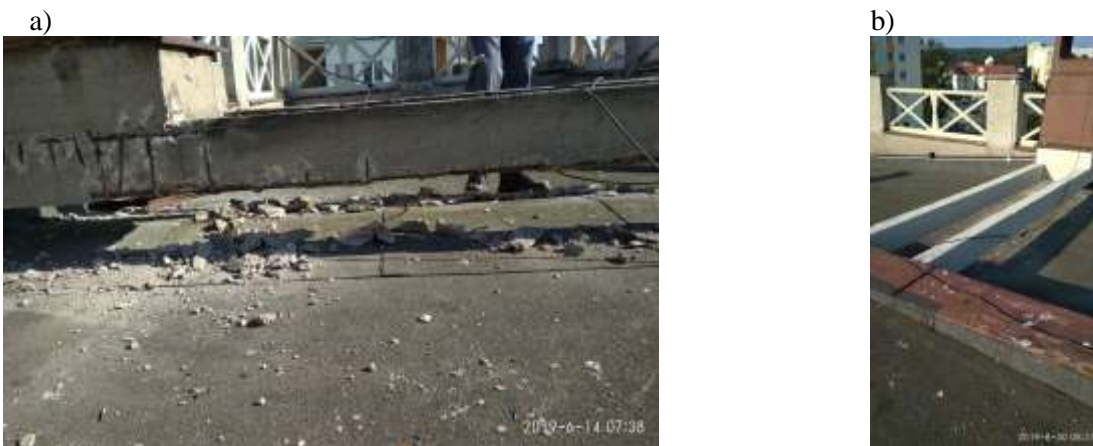
Photo 11. Reinforced concrete, monolithic beams of the grate supporting the cross from the west elevation (along 3 Maja Street) - condition: a) before, b) after renovation (street names as of 2023) (photo by Maciej Niedostatkiwicz)

As part of the repair work on the reinforced concrete elements of the roof slope above the central nave, the reinforced concrete beams supporting the cross placed on the roof, visible from the side of the front façade, were also reprofiled (Photo 11).

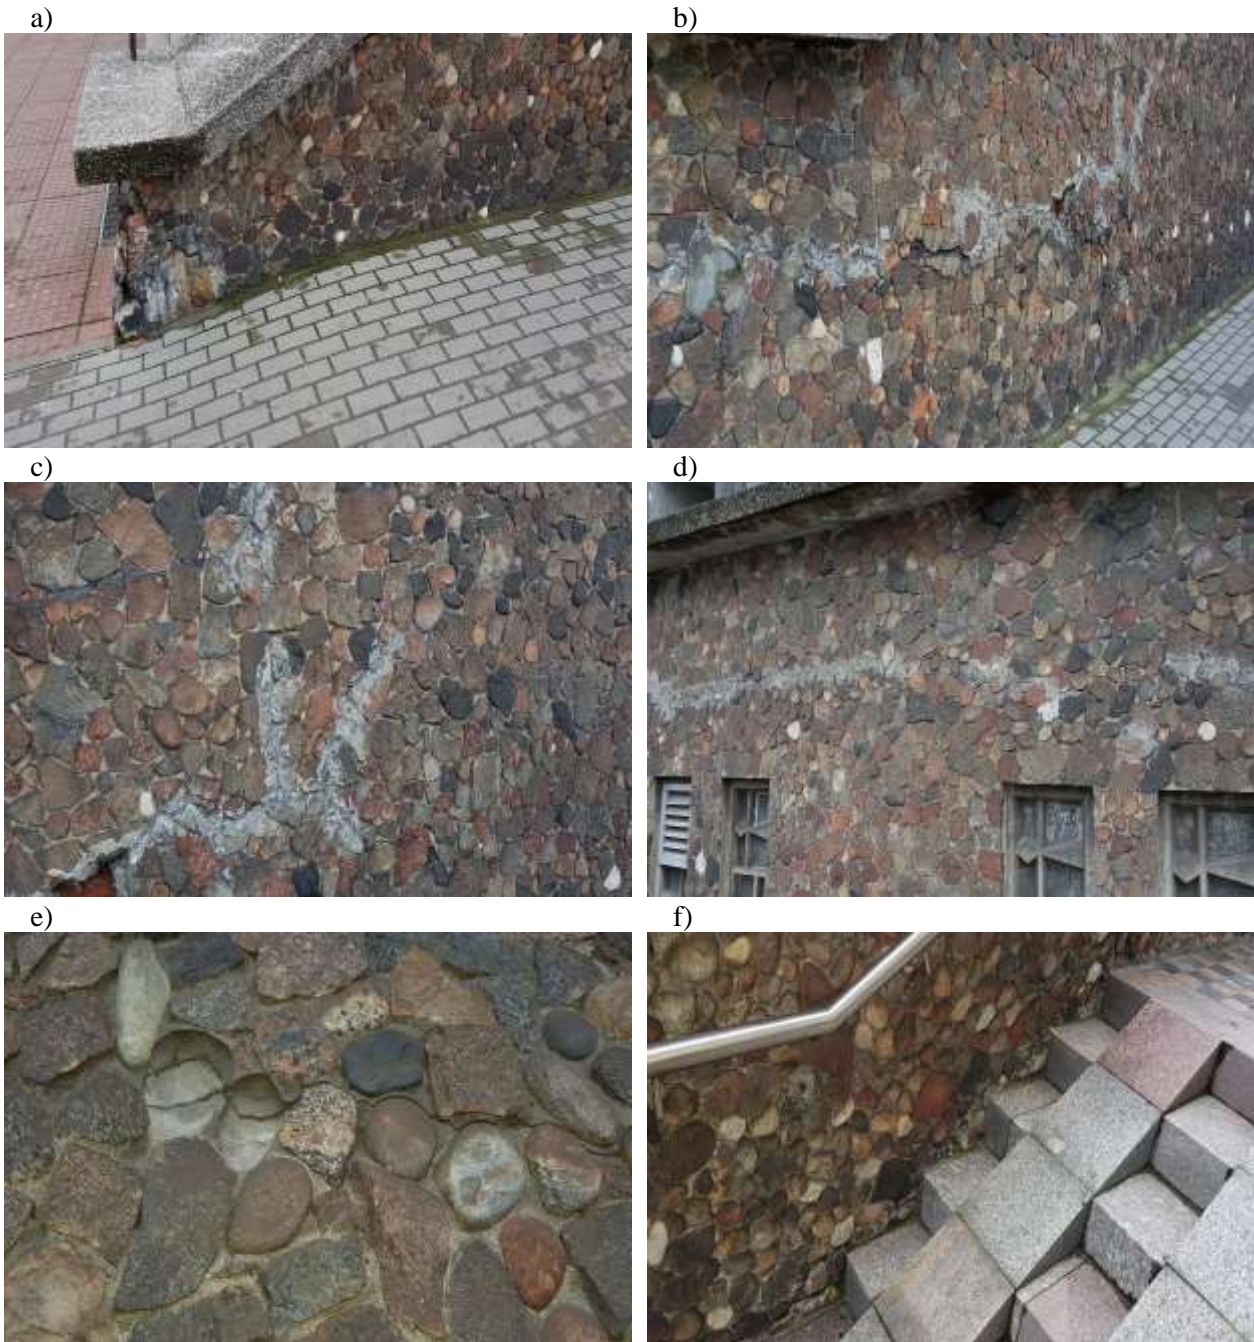
Over the years of operation, the stone cladding underwent natural decapitalization - the joints underwent carbonation, pores opened in them and capillaries through which water began to penetrate into the space between the cladding and the wall. In the middle of the height of the wall, the cladding was scratched, its lower part was buckling. The stability of the cladding was preserved thanks to its inclination in the direction "from the street", which was ~ 100 .

Photo 12. Damage to the stone cladding of the wall at the entrance from the west elevation (along 3 Maja Street): a), b), c), d) wall cracks, e) stone falling out from the outside, f) cracks from the inside (street names as of 2023) (photo by Maciej Niedostatkiewicz)

As part of the renovation works, the cladding was dismantled, locally down to the foundation level (Photo 14a), its stable fragments were left along part of the length of the wall. The cladding was rebuilt with recovered stones, after their prior mechanical cleaning and bathing in a paste solution with the addition of ammonium fluoride. A vapor-permeable, low-shrinkage packaged mortar with a reduced amount of lime was used to build the stone cladding. The laying of the cladding was preceded by the implementation of anti-moisture insulation on the footing and on the outer wall in the ground zone (Photo 14b). The insulation was made of a mineral mortar based on polymer-modified microsilica. As part of the work related to the execution of insulation, a facet was profiled at the junction of the continuous footing and the structural wall.

As part of the renovation works, the terrazzo cap of the wall was also renovated: existing cracks were furrowed, repaired with a filling injection, and after mechanical grinding of the terrazzo cap, a protective hydrophobic coating was applied on its upper and side surfaces.

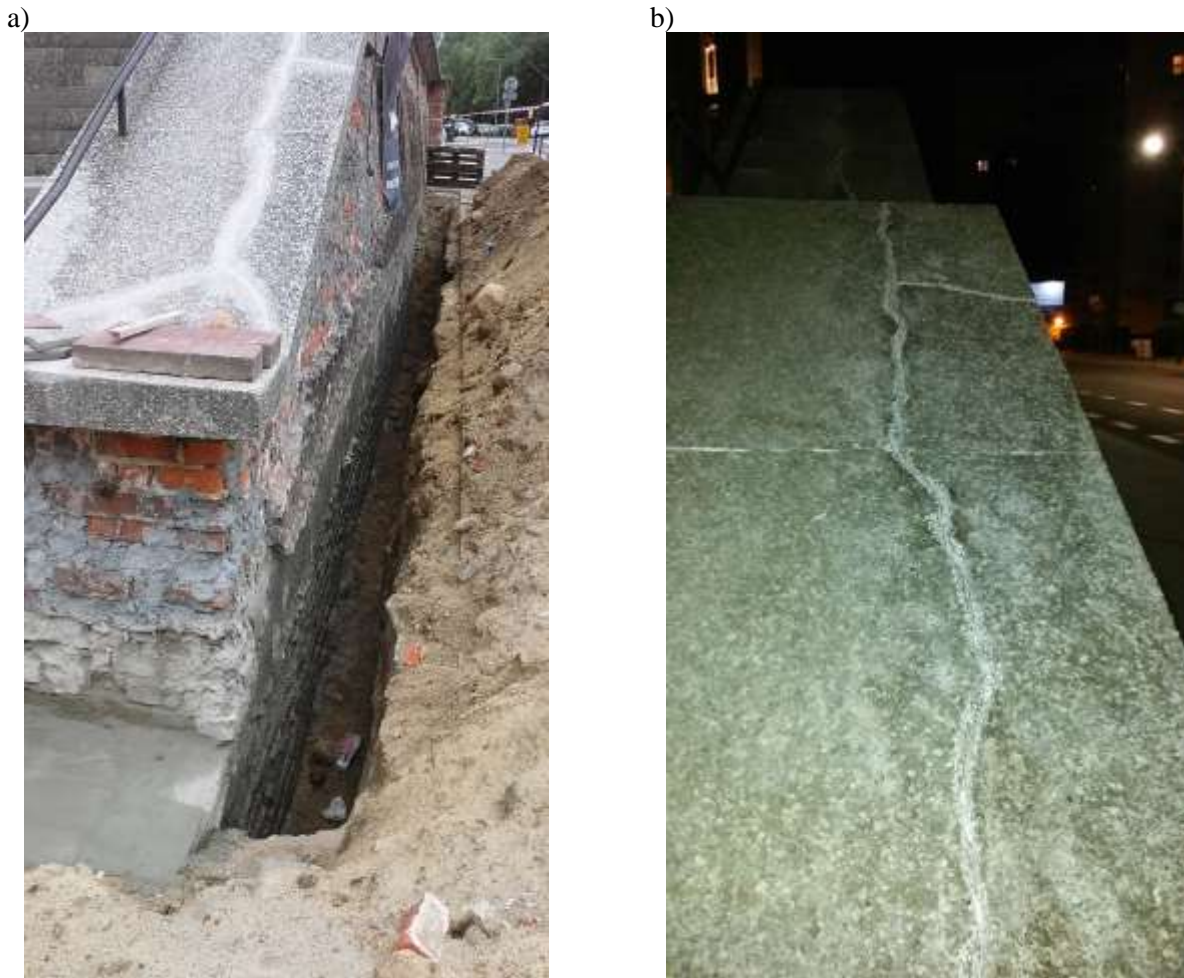
Photo 14. The wall at the entrance from the west elevation (along 3 Maja Street) during renovation works: a) dismantled cracked stone cladding and implementation of vertical damp-proof insulation, b) repaired cracks in the terrazzo cladding of the wall cap (names of the street as of 2023) (photo by Jacek Bramorski)

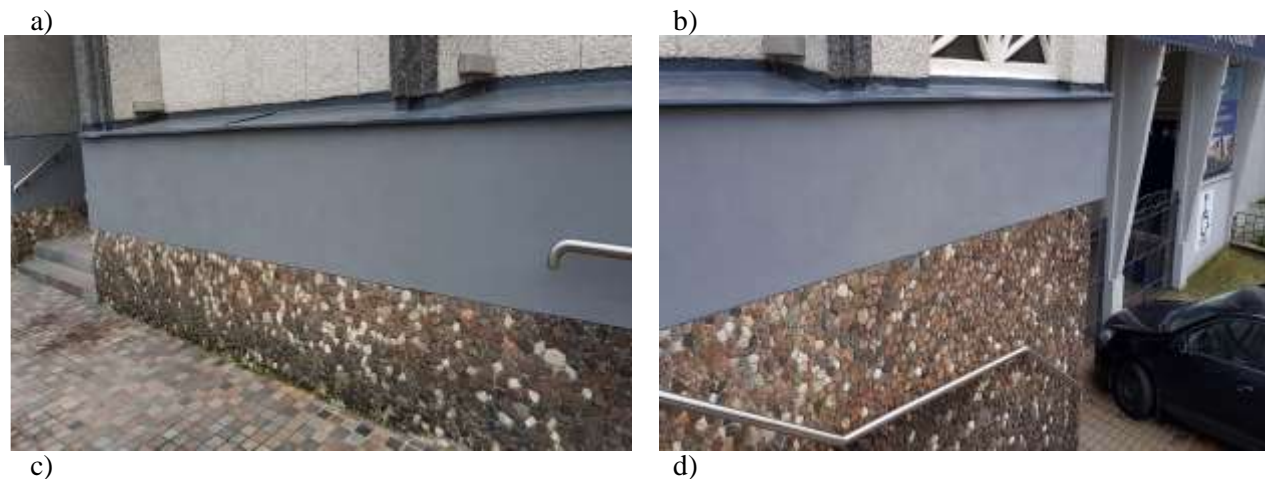
Photo 15. Base cornice after completion of renovation works: a), b) along the western elevation (from the side of 3 Maja Street), c) from the southern elevation (along Armii Krajowej Street), d) along the eastern elevation (from the side of Monsignore Hilarego Jastaka Street), e), f) from the northern elevation (along Stefana Batorego Street) (street names as of 2023) (photo by Maciej Niedostatkiwicz)

The lower part had damage similar to damage to the stone cladding of the wall at the main entrance. The stones were dirty, covered with a coating. Single stones were loosened, some of the joints were chipped. As part of the renovation works, the entire surface of the lower part of the plinth was first wetted with water at a temperature of $\sim 30^{\circ}\text{C}$, and then a thin layer of ammonium fluoride-based cleaning paste was applied to the surface of the plinth using a bench brush and the plinth was again washed with warm water. After cleaning, loose stones were glued in, and then the jointed stone cladding was supplemented with the materials used to repair the stone cladding of the wall at the main entrance.

The upper part of the plinth had damages in the form of plaster burns from the concrete base, the entire surface of the plaster was discolored and faded. As part of the renovation work, the scalded plaster was chipped off and restored. The new plaster was made as a layered plaster, with a primer layer and a top layer, after prior priming of the substrate and making a bond bridge. The top layer of the plaster was made as colored in the mass, with the use of fine quartz aggregate, with the use of a trass mortar dyed in the mass. The newly made external plaster on the plinth was made as rubbed plaster, with a structure matched to the structure of the plaster fragments left. After the local plaster repairs were completed, its entire surface was secured with an additional protective paint coating, in accordance with the conservation guidelines - a silicone facade paint was used, characterized by high water vapor diffusivity. As part of

the repair work, the flashings on the upper surface of the plinth were also replaced. The original flashings were made of zinc sheet, joined with the use of reflected and smooth coils, they were replaced with flashings made of steel-titanium sheet joined with standing seams.

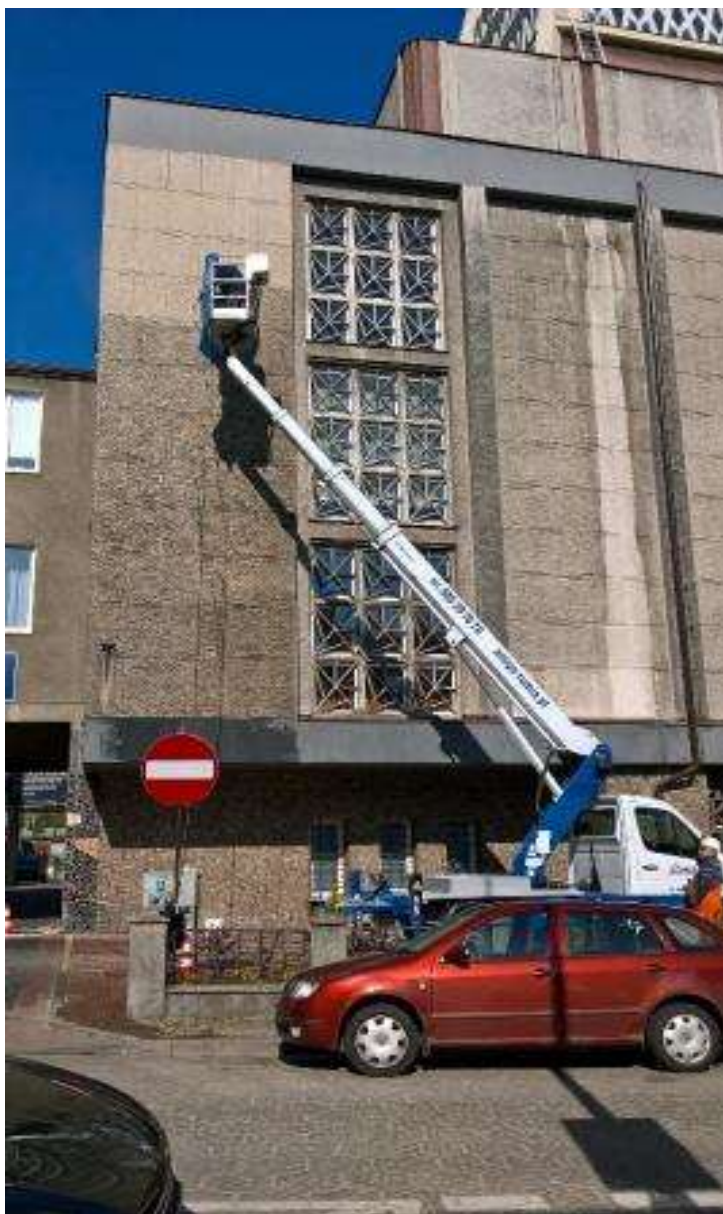
Photo 17. Comparison of the structure and color of the facade a) before and b) after its cleaning - on the example of the eastern facade (from the side of Monsignore Hilarego Jastaka Street) (street names as of 2023) (photo by Jacek Bramorski)

The next stage of the renovation works of the Church building was the cleaning of the elevation (Photo 16). All facades of the building were subjected to restoration works, which were cleaned using the hydromonitoring method (Photo 17), using hot water at a temperature of 30°C. As an addition to the purification, an agent with a neutral pH was used, containing surfactants, i.e. surfactants that lower the surface tension of water. Thanks to the emulsifying properties of the agent used, the washed dirt and impurities were bound, especially the layer of grease and dust accumulated over the years of operation on the surface of the plaster made as the so-called. scraper. After cleaning, the facades were not additionally secured with a protective paint coating with the addition of anti-algae and anti-fungal agents, it was assumed that the protection would be provided by preservatives used in the production of the detergent in order to obtain its durability.
