Assessment of Technical Conditions in Adapting a Historic Warehouse's Space Functionality

Maciej NIEDOSTATKIEWICZ^{*1}, Tomasz MAJEWSKI²

The aim of the paper is to present the results of the analysis of the technical condition of a historic Warehouse building located in the former shipyard area in connection with the planned construction in the place of the existing location of the production hall warehouse building.

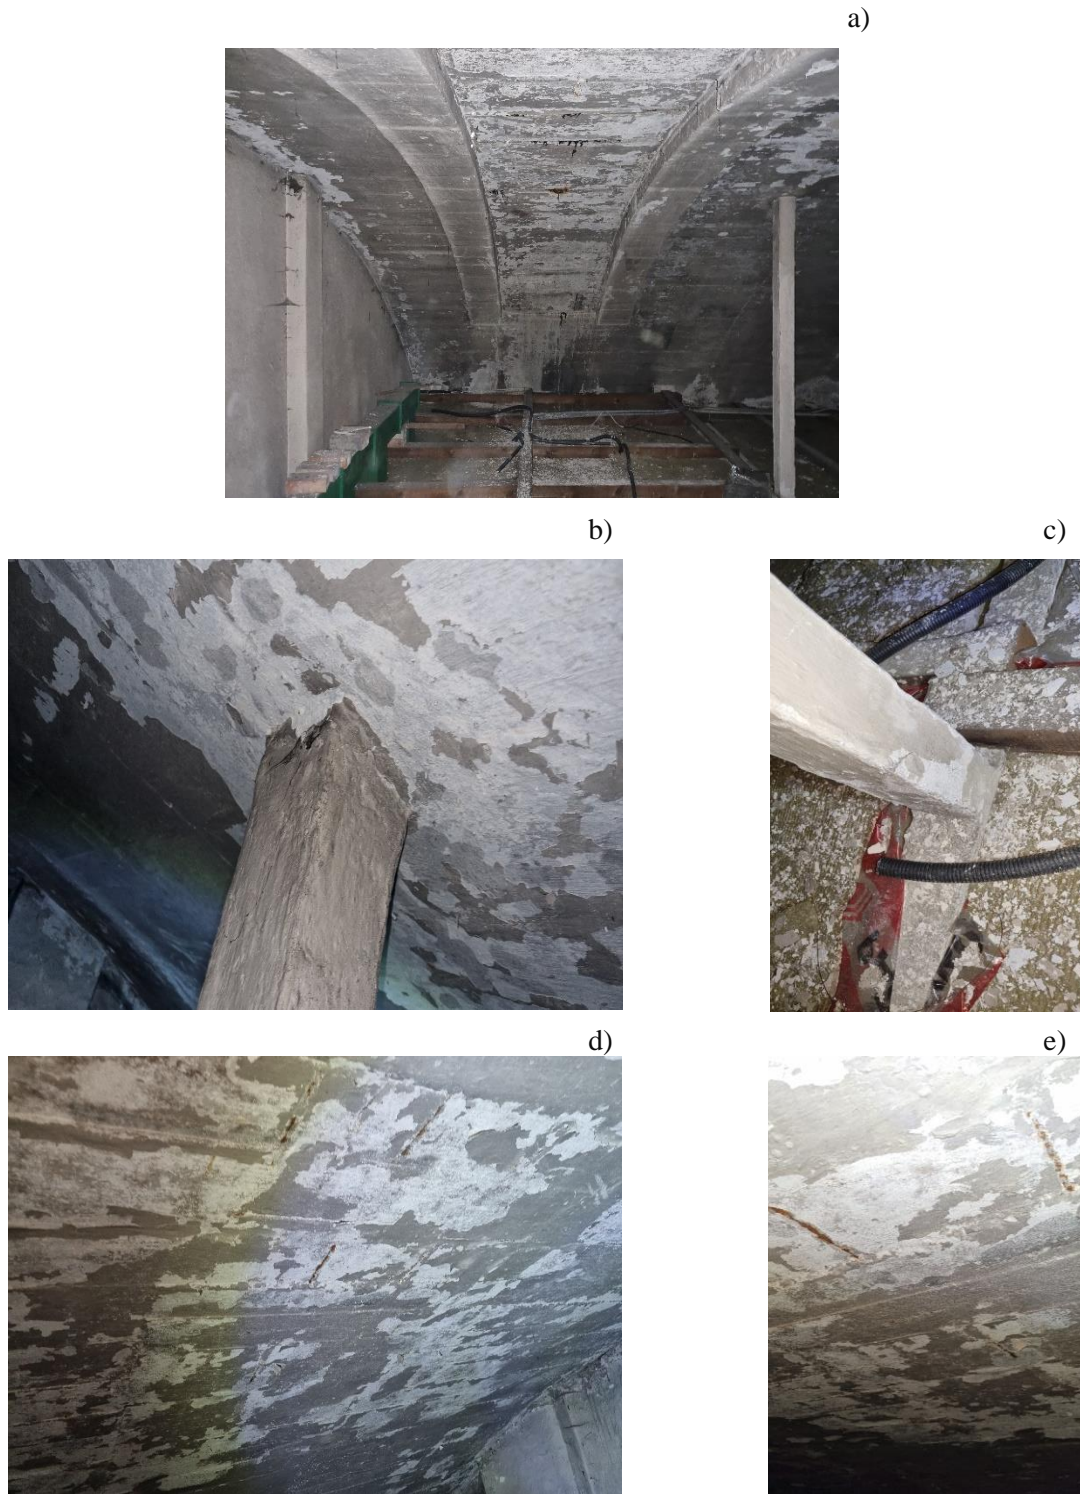
Photo 6. Warehouse building - attic space: a) stiffening ribs below the curvilinear covering slab, connection: b) post - curvilinear covering slab, c) post - horizontal tie, d), e) damage to the concrete cover of the reinforcing bars of the curvilinear covering slab

During the inspection, only part of the attic was possible (Photo 6a). The view from the bottom of the slab arch showed traces of moisture, the concrete cover was falling off locally, and corrosion of the reinforcing bars was visible (Photo 6a, d, e). The spacing of the reinforcing bars was on average 30 cm. There were no visible signs of damage where the posts were connected to the slab arch (Photo 6b), similarly to the case where the posts were connected to the tie (Photo 6c).

The curved surface of the arch, viewed from the bottom, showed traces of the reinforcing bar cover falling off, which was caused by swelling corrosion of the reinforcement resulting from the moisture of the concrete element.

There was no visible damage in the places of installation (suspension) of the reinforced concrete posts to the bottom of the slab arch surface - no detachment of the posts from the roof surface was observed. The connections of the posts with the tie rods were also undamaged - there were no visible scratches. During the inspection, no buckling of either the posts or the tie rods was found. In the place where the slab arch rests on the longitudinal walls, in the view from the bottom of the covering, no damage in the form of cracks or scratches was identified.

A completely technically and economically justified solution, and at the same time recommended from a technical and economic point of view, was the demolition of the existing roofing constructed as a slab arch with ties and the possible subsequent use of fragments of the original elements, in accordance with detailed conservation recommendations.

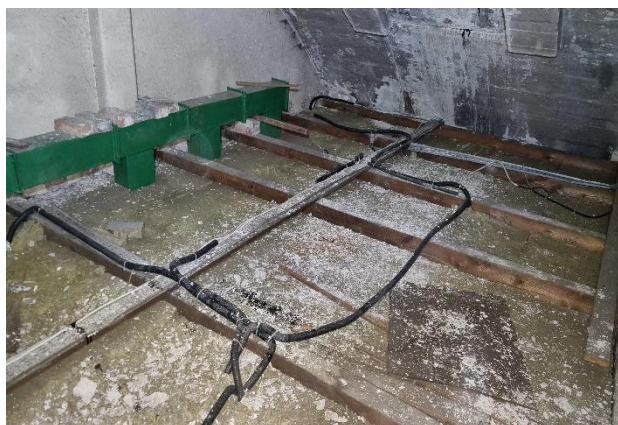
Photo 7. Warehouse building - attic space: a) arrangement of wooden ceiling beams of the covering structure above the ground floor, b) supporting wooden ceiling beams on a horizontal tie
