# Assessment of Technical Conditions in Adapting a Historic Warehouse's Space Functionality

The aim of the paper is to present the results of the analysis of the technical condition of a historic Warehouse building located in the former shipyard area in connection with the planned construction in the place of the existing location of the production hall warehouse building.

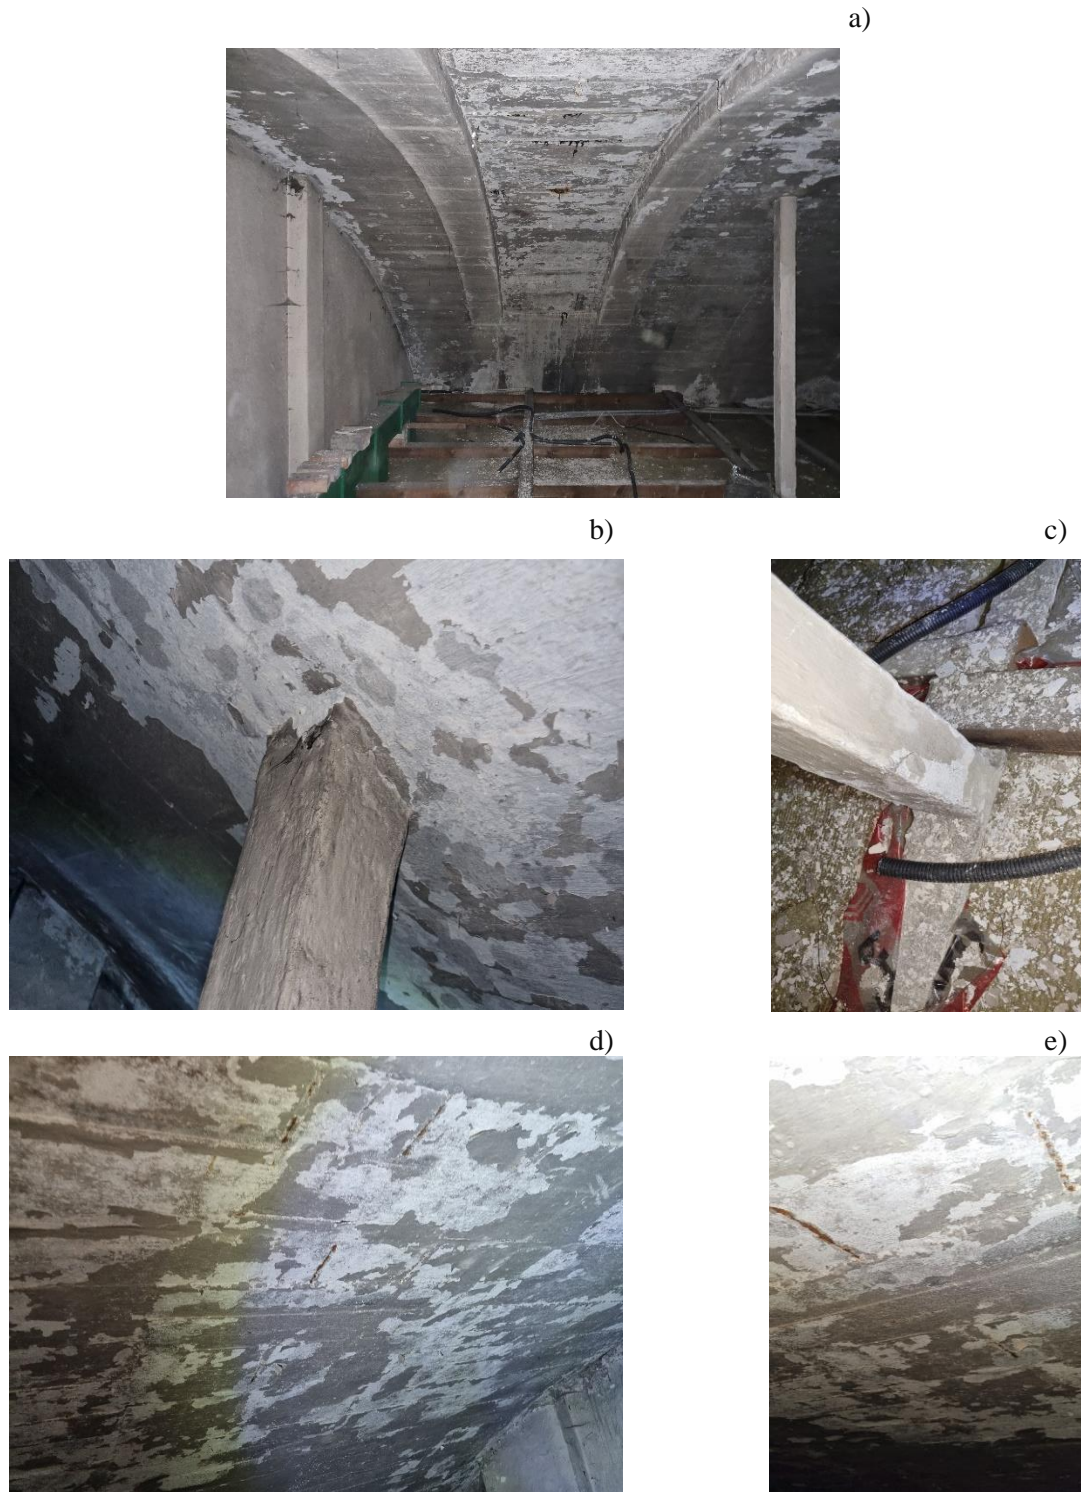
**Photo 6.** Warehouse building - attic space: a) stiffening ribs below the curvilinear covering slab, connection: b) post - curvilinear covering slab, c) post - horizontal tie, d), e) damage to the concrete cover of the reinforcing bars of the curvilinear covering slab

During the inspection, only part of the attic was possible (Photo 6a). The view from the bottom of the slab arch showed traces of moisture, the concrete cover was falling off locally, and corrosion of the reinforcing bars was visible (Photo 6a, d, e). The spacing of the reinforcing bars was on average 30 cm. There were no visible signs of damage where the posts were connected to the slab arch (Photo 6b), similarly to the case where the posts were connected to the tie (Photo 6c).

The curved surface of the arch, viewed from the bottom, showed traces of the reinforcing bar cover falling off, which was caused by swelling corrosion of the reinforcement resulting from the moisture of the concrete element.

There was no visible damage in the places of installation (suspension) of the reinforced concrete posts to the bottom of the slab arch surface - no detachment of the posts from the roof surface was observed. The connections of the posts with the tie rods were also undamaged - there were no visible scratches. During the inspection, no buckling of either the posts or the tie rods was found. In the place where the slab arch rests on the longitudinal walls, in the view from the bottom of the covering, no damage in the form of cracks or scratches was identified.

A completely technically and economically justified solution, and at the same time recommended from a technical and economic point of view, was the demolition of the existing roofing constructed as a slab arch with ties and the possible subsequent use of fragments of the original elements, in accordance with detailed conservation recommendations.
