Typology, current state and non-destructive testing of timber roof trusses of historic churches in the West Vistula Delta, Poland

Tomasz Zybała^{1*}, Monika Zielińska¹, Magdalena Rucka^{2,3}, Jarosław Przewłócki¹ and Karol Grębowski¹

Abstract

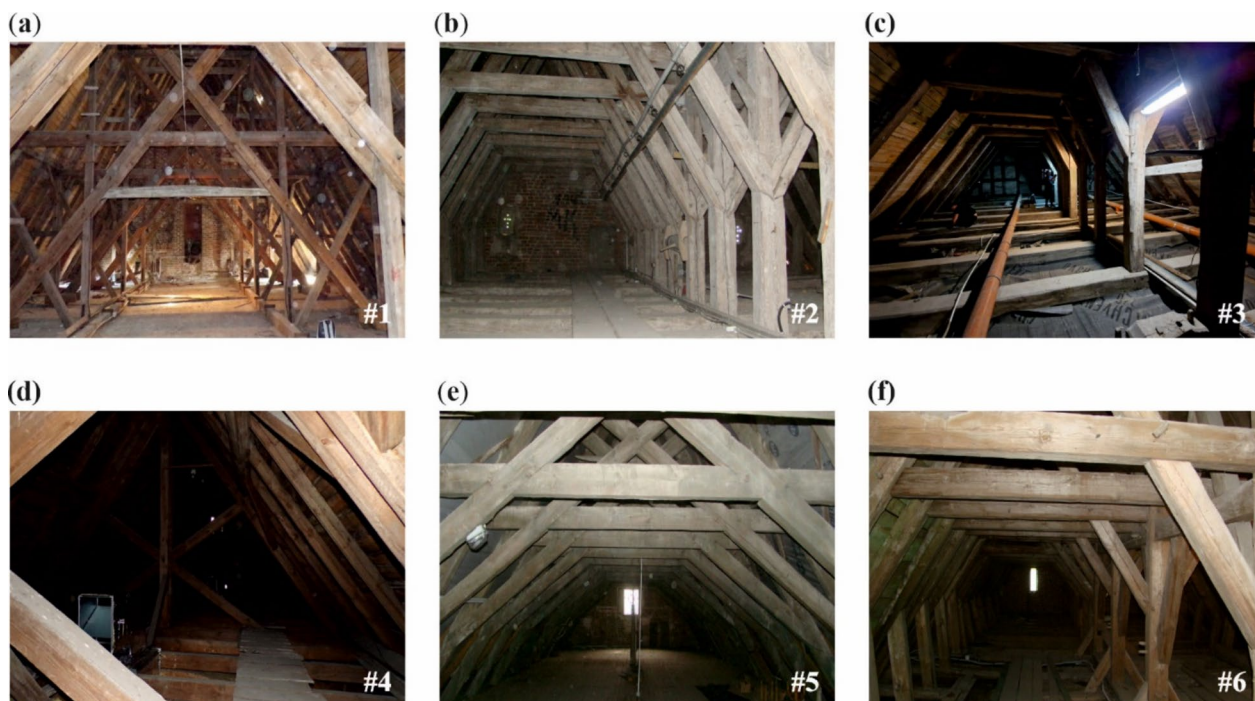
The analysis shows that the most common type of roof truss in the historic churches located in Żuławy is the king post truss (Figs. 4, 5b, c, f). In church #5 (Fig. 5e) there is a collar beam truss with struts, in church #4

(Fig. 5d) there is a scissor truss. In the church #1 (Fig. 5a) there is an attic truss shaped similar to that of the previous structure, that one from before the war damage.

Fig. 5 Roof trusses in: **a** Miłobądz (#1), **b** Pruszcz Gdański I (#2), **c** Kieźmark (#3), **d** Pruszcz Gdański II (#4), **e** Kozłiny (#5), **f** Trutnowy (#6)

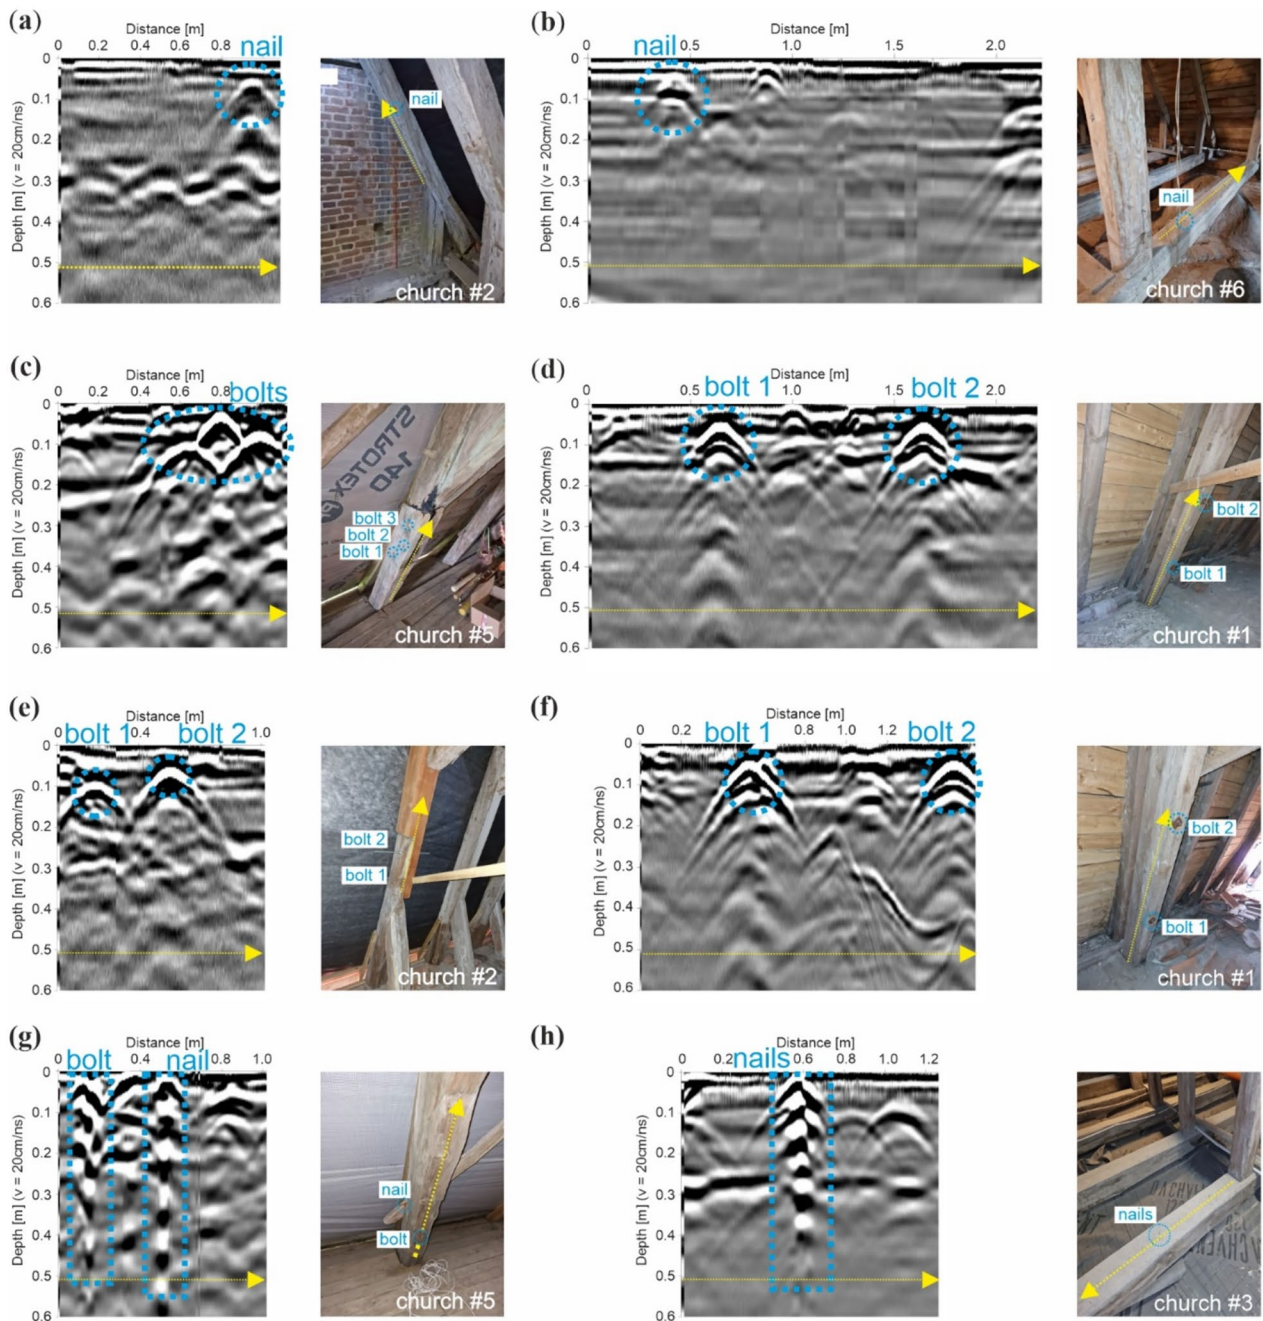
In the case of screws and nails, where the main axis is perpendicular to the direction of GPR movement, their location is marked on the B-scan in the form of several hyperbolas located one above the other (Fig. 8g, h). GPR

can therefore be used not only to locate a metal element but also to assess its orientation.

Fig. 8 GPR radagrams locating bolts and nails in timber beams a plane parallel (a–f) and perpendicular (g, h) to the moving GPR antenna

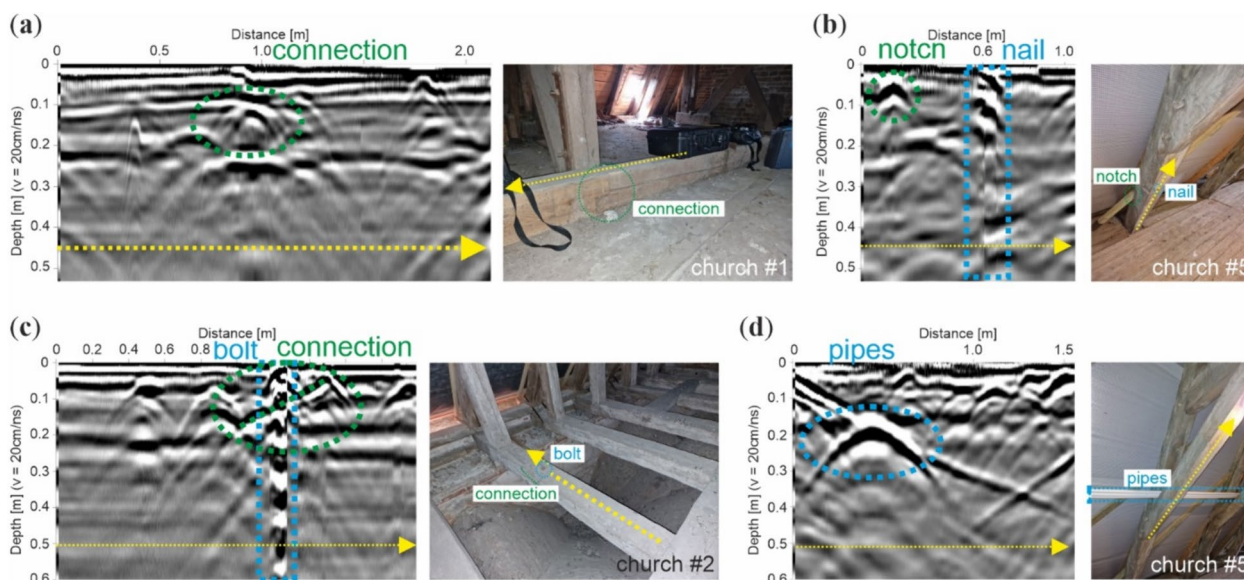
Fig. 9 GPR radagrams locating carpentry joints for electric cables in timber beams: **a**) Milobadz (#1); **b**) Koźliny (#5); **c**) Pruszcz Gdański I (#2); **d**) Koźliny (#5)

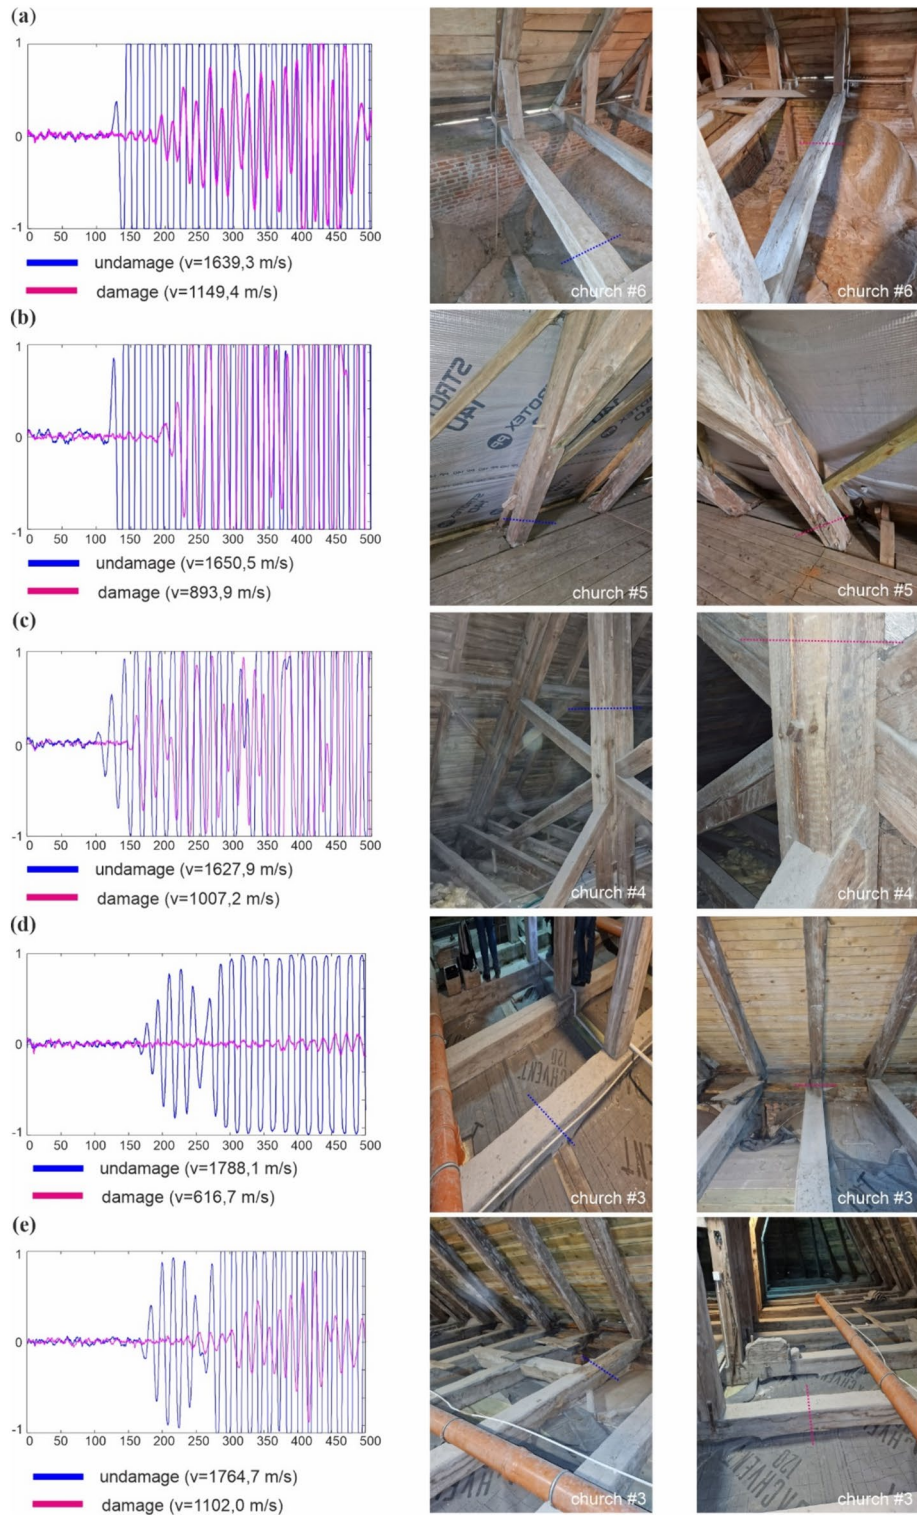
tested, the density of the material and the type of wood, the minimum velocity is 893.9 m/s, while the maximum is 2777.8 m/s. The fact that the tests were carried out on three similar roof beams in each church made it possible to compare the signals for the beams of the same type, geometry and significance. Figure 12 a–e show graphs of the signals from measurements performed on two beams. Photographs of both beams are shown alongside the diagram. One of the beams is undamaged, while the other one shows varying degrees of damage in the form of voids (Fig. 12a–c), cracks (Fig. 12d) and moisture (Fig. 12e). The location of the measurement is marked in the photographs with blue and pink lines, for the undamaged and damaged beams, respectively. The TOF (time of flight) of the damaged elements is longer than that of the reference elements. The undamaged elements have similar velocities, ranging from 1627.9 (Fig. 12d) to 1788.1 m/s (Fig. 12e). The velocities in the damaged elements decrease significantly and reach the values of only 616.7 m/s (Fig. 12e) to 1149.4 m/s (Fig. 12a). It is worth noting that the amplitude of the signal also decreases for the damaged elements.

Fig. 12 Ultrasonic wave signals in undamaged and damaged elements with photos of the tested beams: **a)** Trutnowy (#6); **b)** Koźliny (#5); **c)** Pruszcz Gdański II (#4); **d)** and **e)** Kiezmark (#3)
