Typology, current state and non-destructive testing of timber roof trusses of historic churches in the West Vistula Delta, Poland

Tomasz Zybała^{1*}, Monika Zielińska¹, Magdalena Rucka^{2,3}, Jarosław Przewłócki¹ and Karol Grębowski¹

Abstract

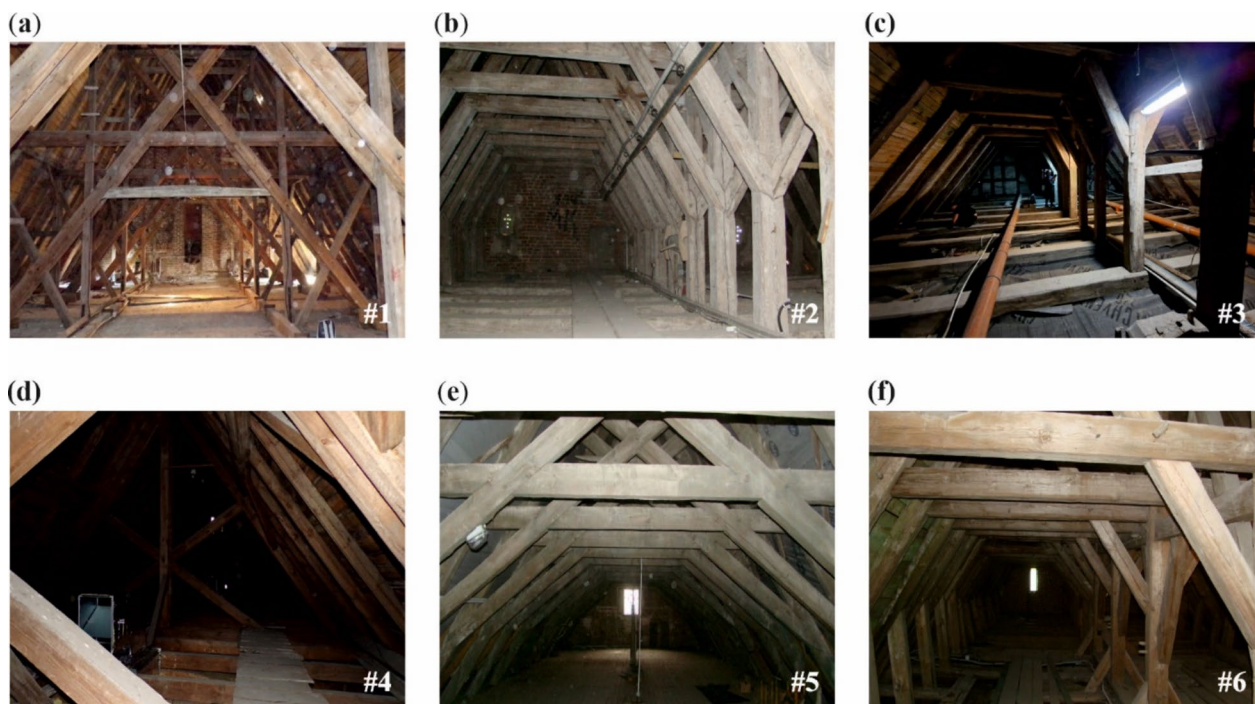
The analysis shows that the most common type of roof truss in the historic churches located in Żuławy is the king post truss (Figs. 4, 5b, c, f). In church #5 (Fig. 5e) there is a collar beam truss with struts, in church #4

(Fig. 5d) there is a scissor truss. In the church #1 (Fig. 5a) there is an attic truss shaped similar to that of the previous structure, that one from before the war damage.

Fig. 5 Roof trusses in: **a** Miłobądz (#1), **b** Pruszcz Gdański I (#2), **c** Kieźmark (#3), **d** Pruszcz Gdański II (#4), **e** Kozłiny (#5), **f** Trutnowy (#6)

(Fig. 2). The state of conservation of the trusses is good, the roofing is waterproof and the gravity ventilation of the attics is intact (Table 1). Only the roof trusses built before the twentieth century (churches #2, #3, #5, #6) have carpentry marks (Fig. 7).

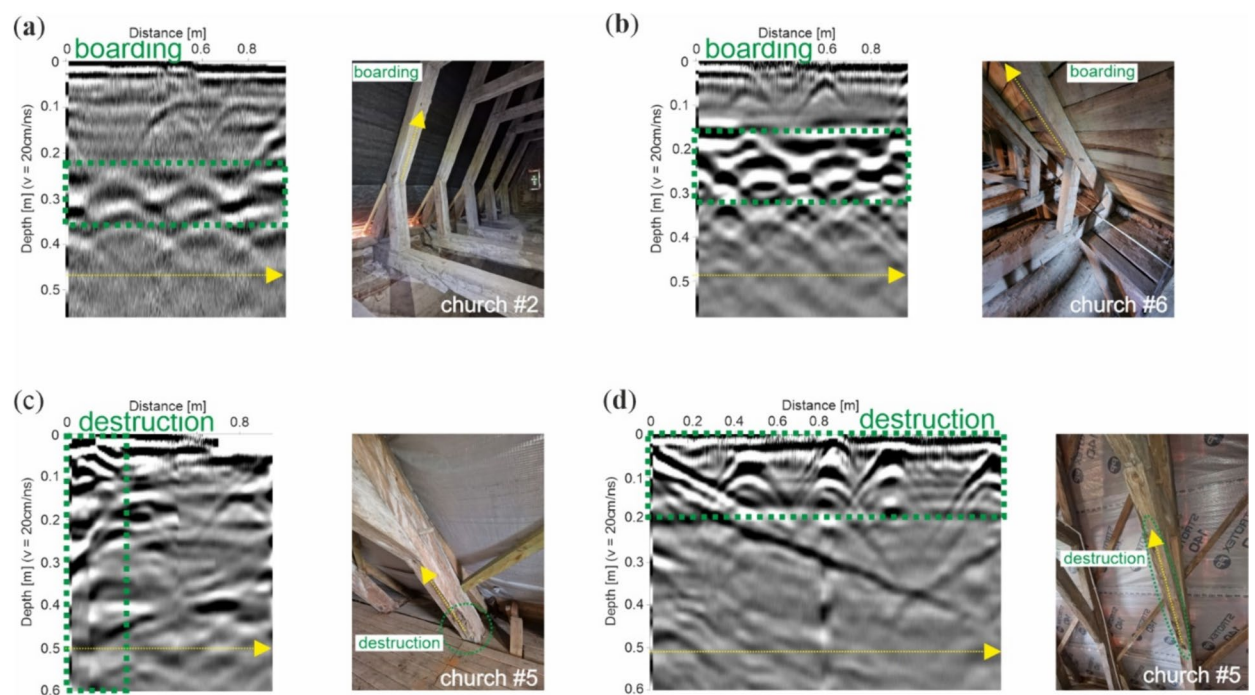
The reflections from the boarding are also characteristic and they form a sequence of evenly spaced hyperbolas on the radargrams, indicating the locations of board joints (Fig. 10a, b). Damage to timber elements causes disturbances in GPR radargrams. Figure 10c shows a local failure on the lower part of the beam. The beam shown in Fig. 10d is completely and shallowly damaged, causing numerous reflections. Figure 11 shows beams from three different girders from the churches in Trutnowy, Pruszcz Gdański I, Kiezmark, and Koźliny, respectively which show varying degrees of destruction. The scans prepared for undamaged beams can be considered as reference. The reflections from the bottom of these beams are visible here, which allows the thickness of the element to be assessed. The scans prepared for the damaged beams indicate a significant disturbance in the propagation of electromagnetic waves. This demonstrates high sensitivity of the GPR method to any defect in a timber element. The reference scan is not always feasible, but it makes the interpretation of the results much easier.

Fig. 10 GPR radagrams locating the boarding of the roof truss and decay of timber beams: **a**) Pruszcz Gdański I (#2); **b**) Trutnowy (#6); **c**) and **d**) Koźliny (#5)

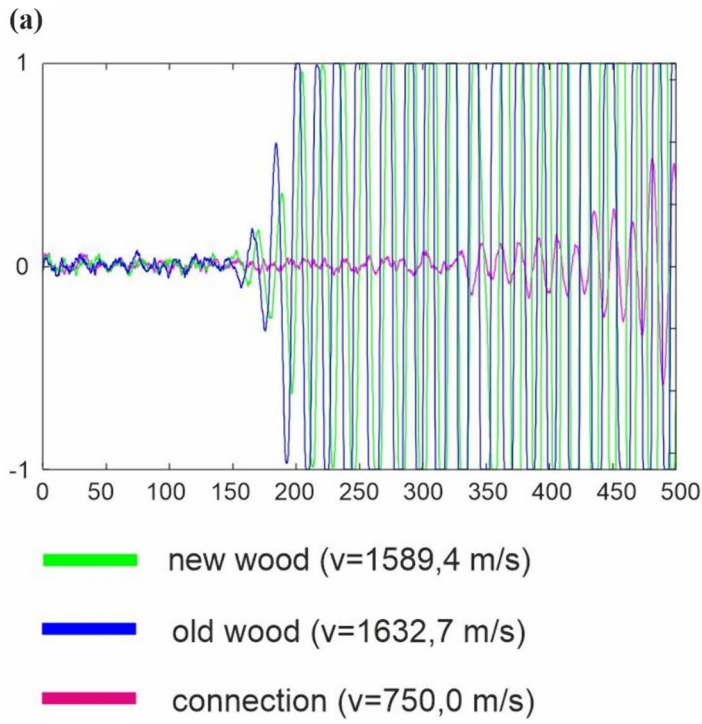
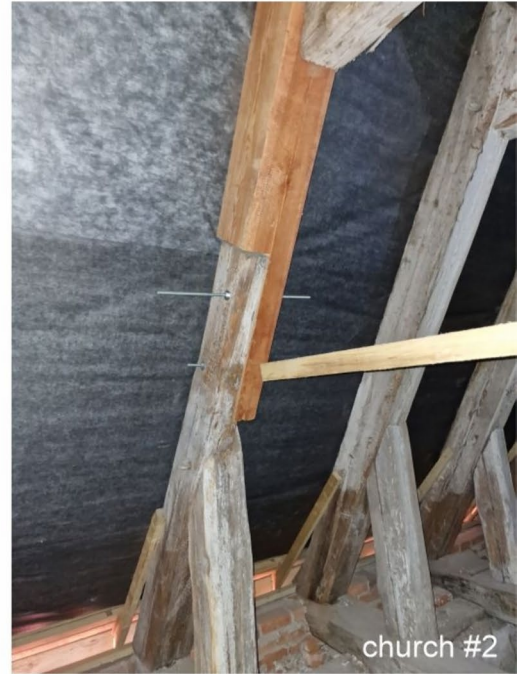
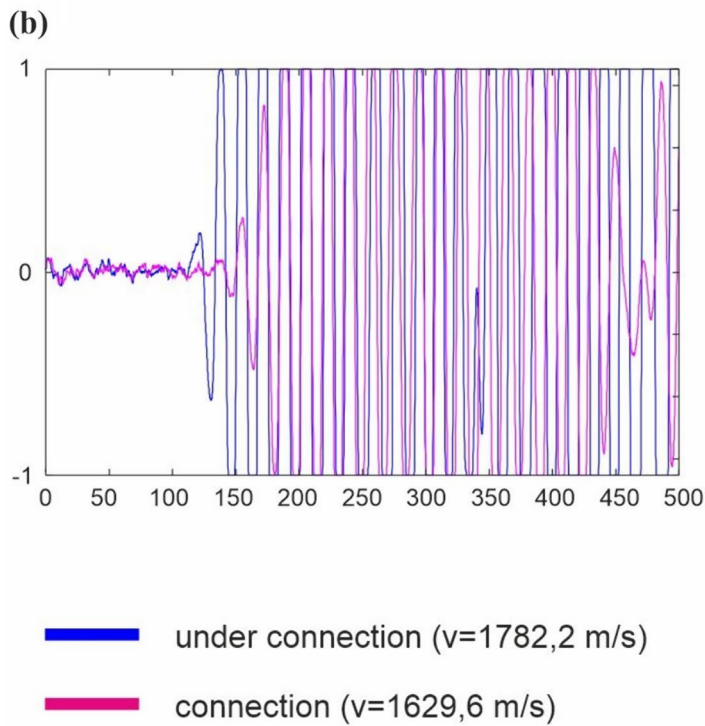
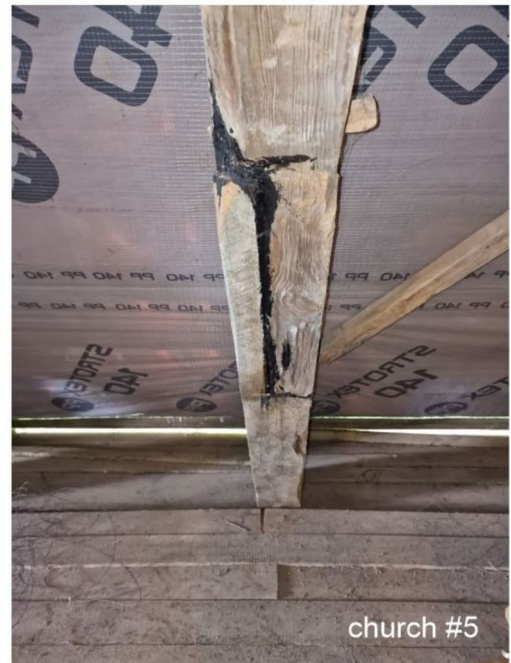
The ultrasonic wave signals propagating through the connections of the elements were analyzed. The measurements were made for straight overlap joints (Fig. 13). The first joint analyzed was in the church #2 and the second in the church #5. Both connections were bolted, and the second was additionally sealed with some adhesive. For the first analyzed joint, the measurements were taken at three levels: above the joint of the new beam, below the joint of the old beam, and at the level of the joint. The propagation velocities were 1589.4 m/s, 1632.7 m/s and 750 m/s, respectively. The signals obtained for the new

and old beams were similar. At the level of the connection, the signal weakened significantly and the propagation velocity decreased more than twofold. In the case of the second joint, where a sealing adhesive was used, the velocity of wave propagation decreased slightly from 1782.2 m/s for a full beam to 1629.6 m/s at the level of the connection. The results obtained prove high sensitivity of the ultrasonic method in the case of joints with air

Fig. 13 Ultrasonic wave signals in wooden beam connections: **a)** Pruszcz Gdański I (#2); **b)** Koźliny (#5)
