# Diagnosics and protection methods a residential building in connection with the reconstruction of a road located in its immediate neighborhood - case study

<sup>1</sup> *Department of Engineering Structures, Faculty of Civil and Environmental Engineering,  
Gdansk University of Technology, Gdansk, Poland*

The aim of the paper is to present the results of the analysis of the technical condition of a residential building located in the immediate vicinity of the road that was to be expanded.

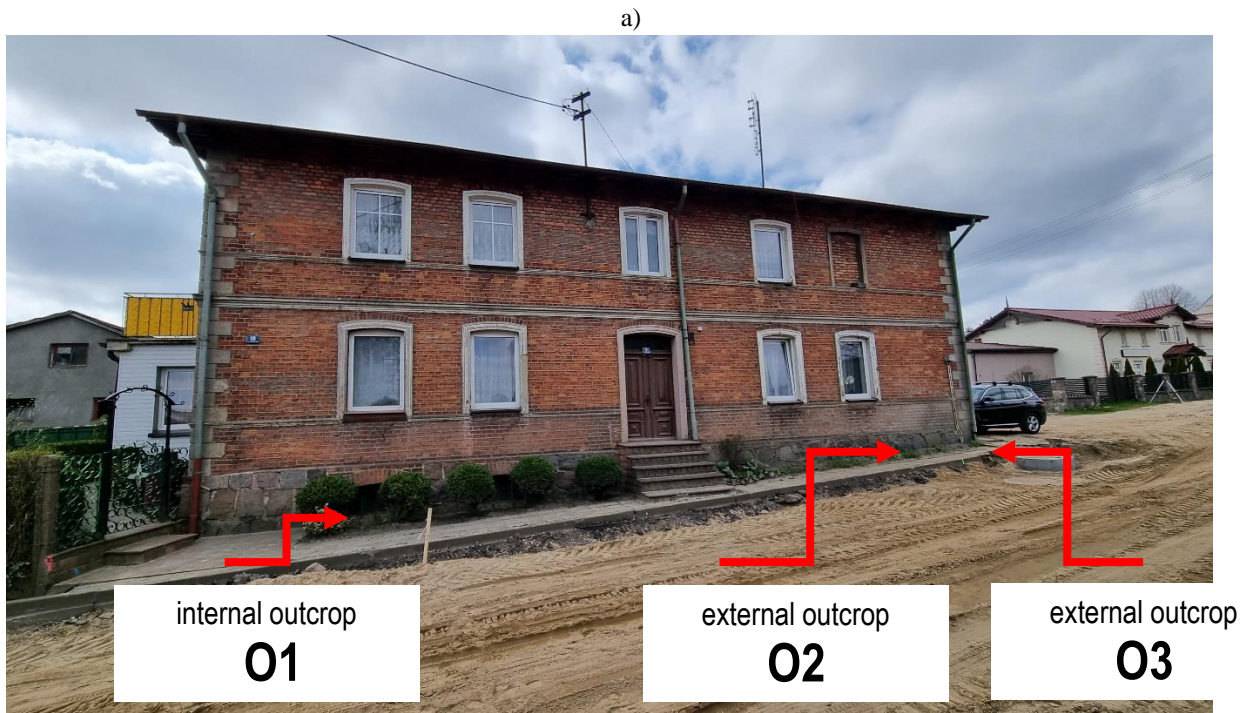
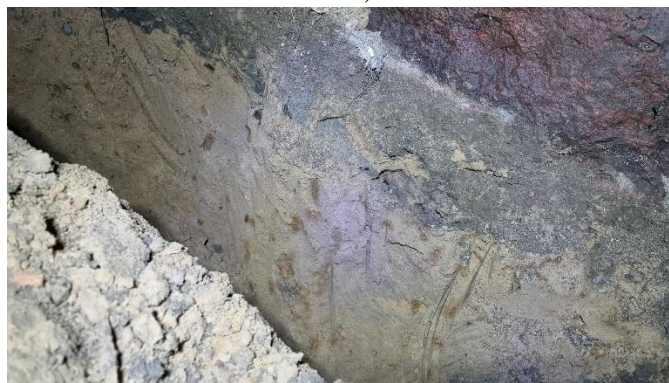
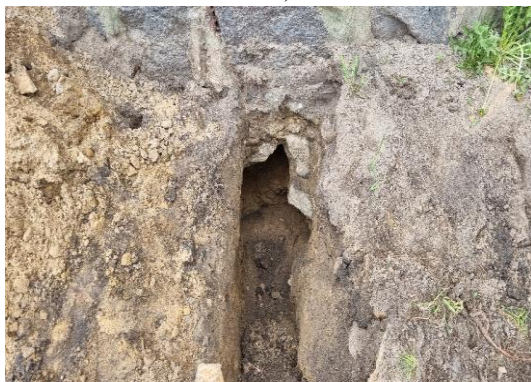
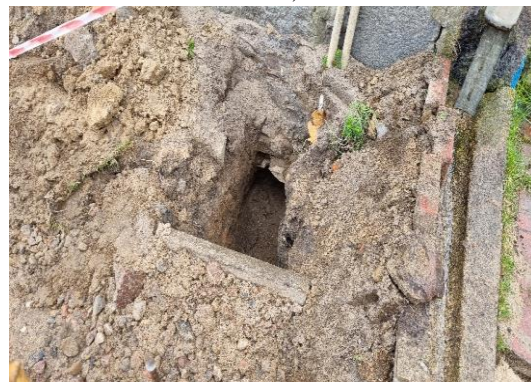
**Fig. 3:** Location of the outcrops in the residential building: a) view of the building from the street (front elevation), b) internal outcrop (in the basement): O1, external outcrops: c) O2 and d) O3

Based on the excavations made, it was determined that the building is founded on stone walls that do not have any offsets.

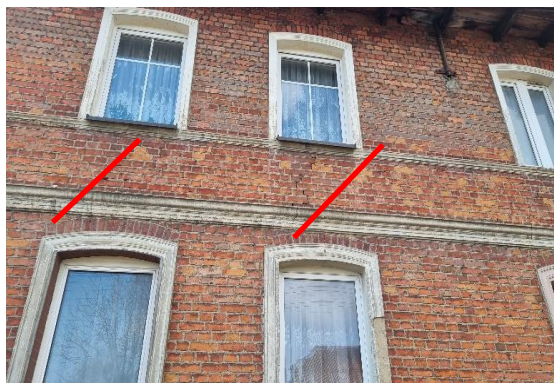
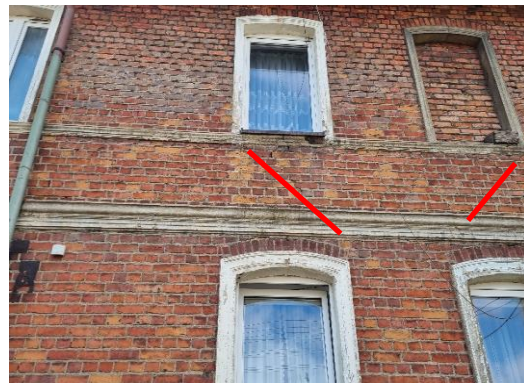
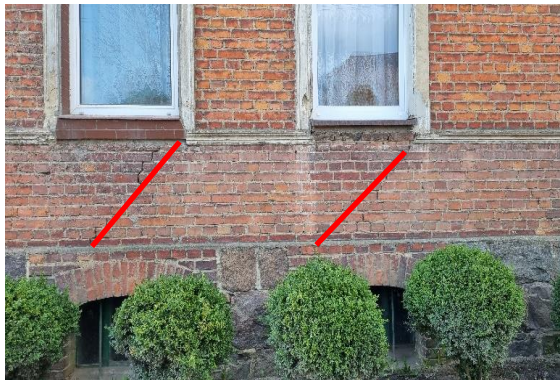
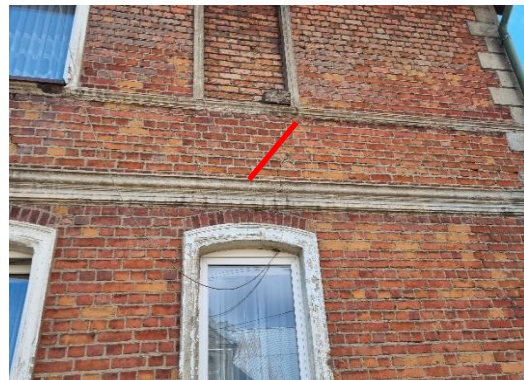
**Fig. 4:** Distribution of damages to the front wall (northern elevation) in the residential building: a) general view of the front elevation, b) left side (L) (basement part), c) right side (R) (non-basement part)

On the front, longitudinal wall (northern façade), damage to the brick wall of the longitudinal wall was visible: scratches to the strips under the windows occurred both on the ground floor and on the first floor, in the basement part (L) and in the non-basement part (R). The scope of damage in the basement part was greater: scratches and cracks in the brick strips under the windows were larger. The brick wall of the front wall was not plastered.

Scratches and cracks were visible on the front (northern) elevation (Fig. 4). Scratches were also visible on the garden (southern) elevation. The morphology of the above damage, especially that visible on the unplastered brick wall, i.e. on the front elevation, indicated that they were the result of uneven settlement of the building as a consequence of its partial basement. A similar picture of damage can be found in the literature on the subject (Fig. 5): in the case of the building in question, the analogy to the examples from the literature is that, similarly to Fig. 5, damage to the wall is visible, i.e. its cracks above the window arches that are tilted to the right, in the basement part (L) and to the left in the part without a basement (R). The inclination of the cracks is consistent in terms of direction

with the place of change in stiffness caused by the partial basement. The foundation of the part without a basement (R) in the ground freezing zone additionally contributed to the formation of damage to the wall - this method of foundation results in damage to the front elevation tilted to the right: in the winter, the corner of the building was uplifted upwards, and in the summer it settled excessively, which resulted in the formation of diagonal cracks tilted to the right. Unquestionably, the lack of tie beams between floors and the probable lack of frontal and side anchoring of the ceiling beams contributed to the extension of the damage to the wall. In practice, it was impossible to estimate quantitatively to what extent the previous traffic on the street contributed to the damage to the building's walls. Certainly, vibrations from moving vehicles had a negative effect, especially since the analyzed building had no foundations, which made it even more sensitive to vibrations from road traffic, propagating through the ground and affecting its structures - however, it was impossible to assess quantitatively the impact of traffic on the technical condition of the walls in practice.

- dismantle the entrance stairs to the building from the street side,
- perform sub-concreting of the front, longitudinal wall (northern elevation) according to the concept of solutions presented in Fig. 7 and Fig. 8,
- sub-concreting of the left side (L) (basement part) should be performed from the outside of the building with a control excavation of the wall foundation from the basement side in order to check whether the concrete introduced under the stone wall tightly fills the space under the wall across its entire width,
- sub-concreting of the right side (R) (non-basement part) should be performed from the outside of the building, paying particular attention to ensuring that the concrete is distributed across the entire width,

- sub-concreting at the place of change in the depth of the stone wall foundation, i.e. at the connection of parts L and P, should be performed from the outside of the building, maintaining far-reaching care in filling the space under the stone wall with concrete,
- as part of the works related to strengthening the front wall, strengthen parts of the gable and side walls (eastern elevation and western elevation) - the scope of reinforcement in accordance with the solution presented in Fig. 7,
- fill the joints of the stone wall from the outside and inside using cement mortar - it is recommended to use a system-based packaged (bagged) mortar characterized by low shrinkage,
- after completing the works related to strengthening the front wall, reconstruct the entrance stairs from the street side.
