# **Diagnostics and protection methods a residential building in connection with the reconstruction of a road located in its immediate neighborhood - case study**

Maciej NIEDOSTATKIEWICZ <sup>1\*</sup>

<sup>1</sup> *Department of Engineering Structures, Faculty of Civil and Environmental Engineering,  
Gdansk University of Technology, Gdansk, Poland*

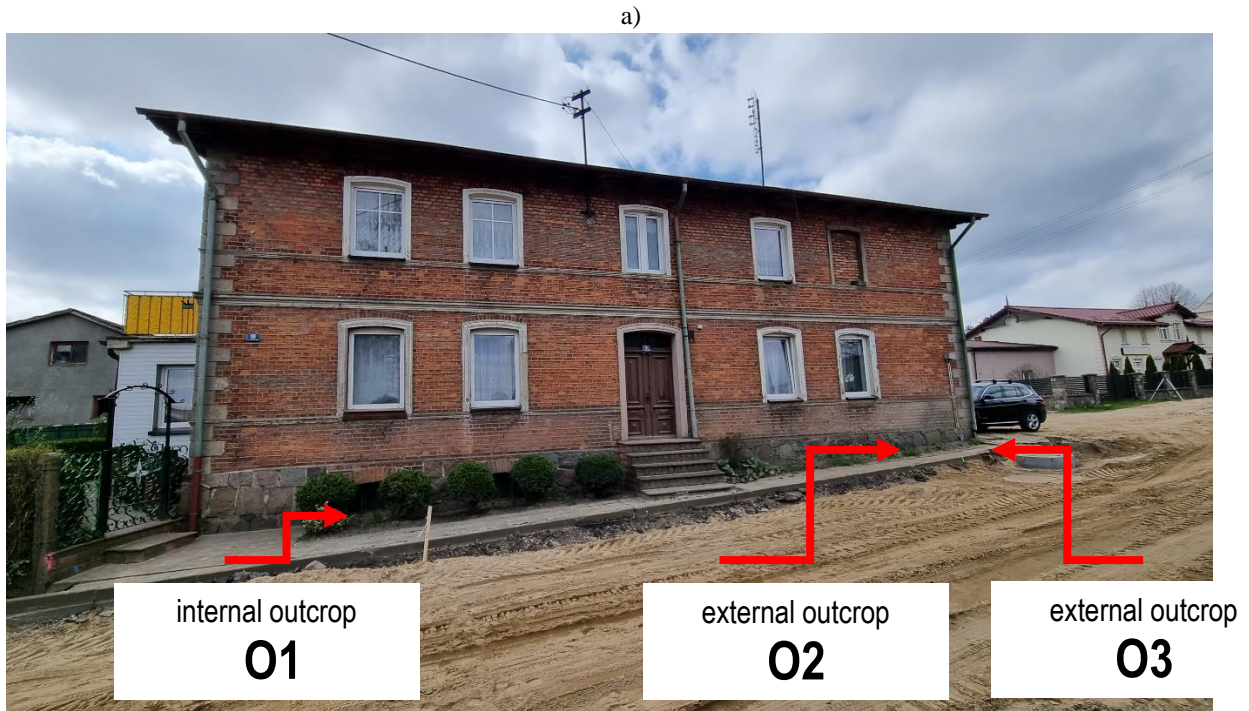
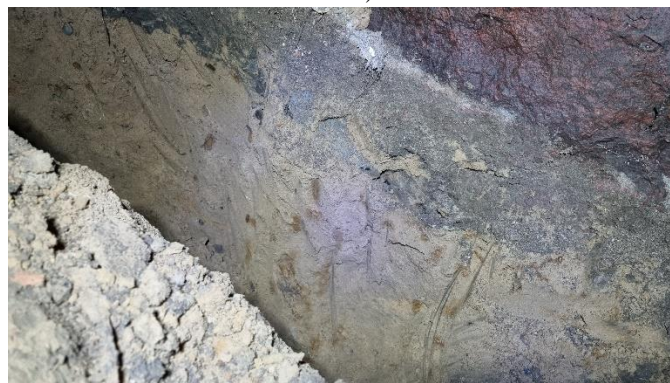
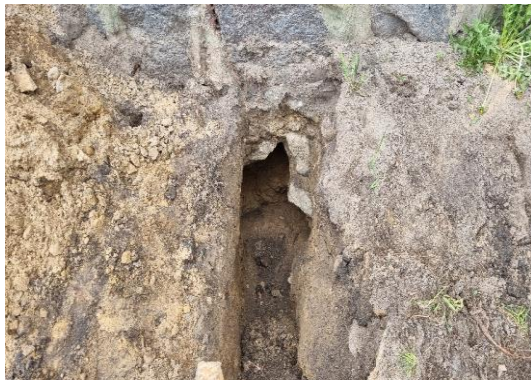
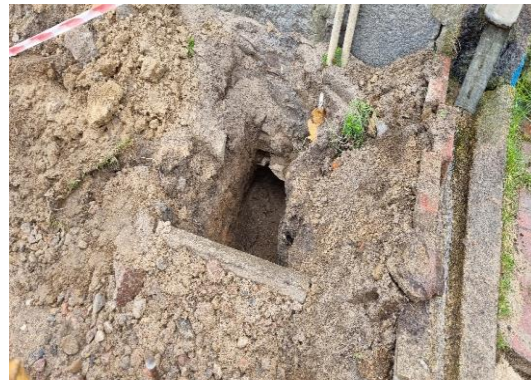
**Fig. 3:** Location of the outcrops in the residential building: a) view of the building from the street (front elevation), b) internal outcrop (in the basement): O1, external outcrops: c) O2 and d) O3

Based on the excavations made, it was determined that the building is founded on stone walls that do not have any offsets.

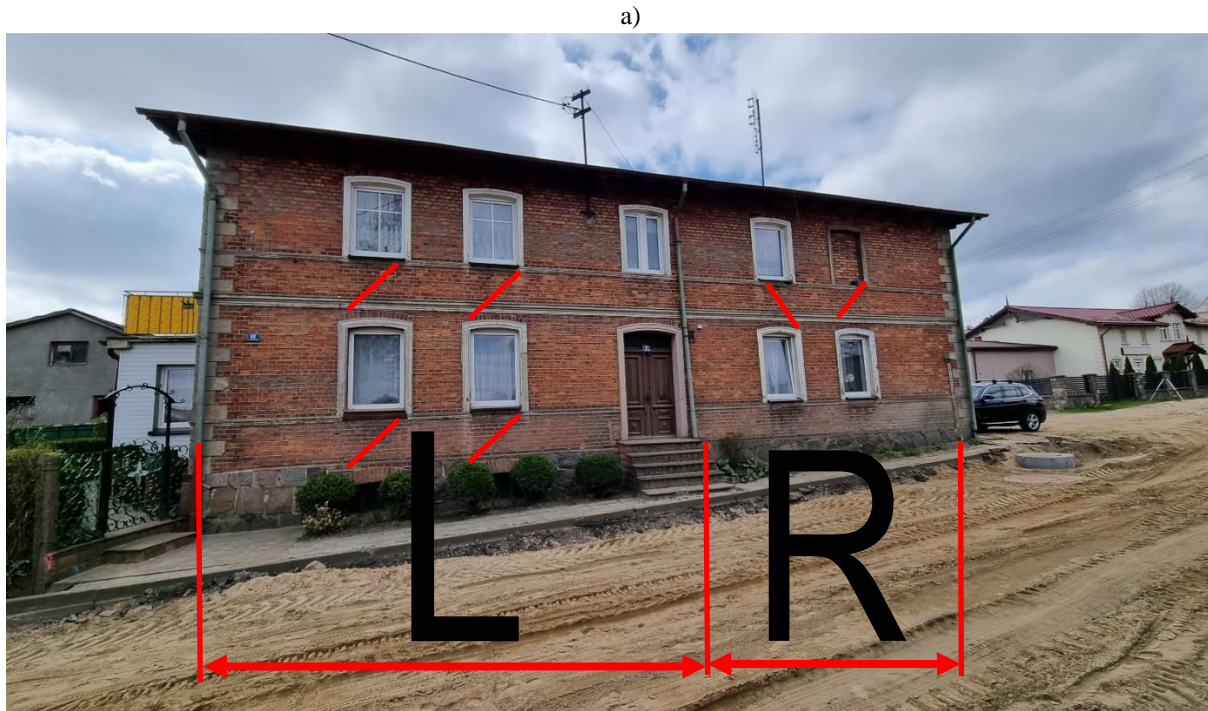
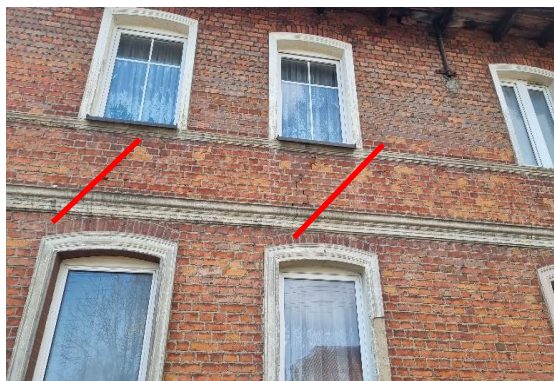
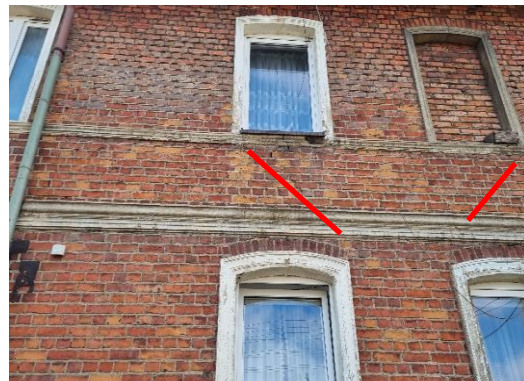
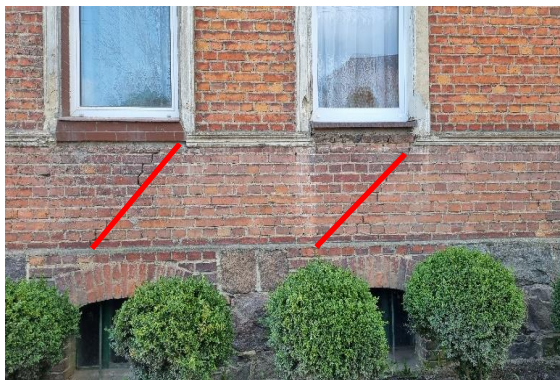
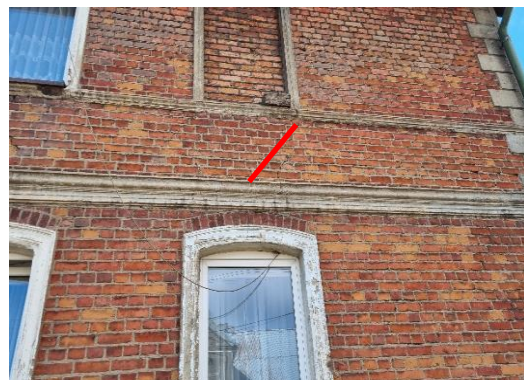
**Fig. 4:** Distribution of damages to the front wall (northern elevation) in the residential building: a) general view of the front elevation, b) left side (L) (basement part), c) right side (R) (non-basement part)

On the front, longitudinal wall (northern façade), damage to the brick wall of the longitudinal wall was visible: scratches to the strips under the windows occurred both on the ground floor and on the first floor, in the basement part (L) and in the non-basement part (R). The scope of damage in the basement part was greater: scratches and cracks in the brick strips under the windows were larger. The brick wall of the front wall was not plastered.

Scratches and cracks were visible on the front (northern) elevation (Fig. 4). Scratches were also visible on the garden (southern) elevation. The morphology of the above damage, especially that visible on the unplastered brick wall, i.e. on the front elevation, indicated that they were the result of uneven settlement of the building as a consequence of its partial basement. A similar picture of damage can be found in the literature on the subject (Fig. 5): in the case of the building in question, the analogy to the examples from the literature is that, similarly to Fig. 5, damage to the wall is visible, i.e. its cracks above the window arches that are tilted to the right, in the basement part (L) and to the left in the part without a basement (R). The inclination of the cracks is consistent in terms of direction

with the place of change in stiffness caused by the partial basement. The foundation of the part without a basement (R) in the ground freezing zone additionally contributed to the formation of damage to the wall - this method of foundation results in damage to the front elevation tilted to the right: in the winter, the corner of the building was uplifted upwards, and in the summer it settled excessively, which resulted in the formation of diagonal cracks tilted to the right. Unquestionably, the lack of tie beams between floors and the probable lack of frontal and side anchoring of the ceiling beams contributed to the extension of the damage to the wall. In practice, it was impossible to estimate quantitatively to what extent the previous traffic on the street contributed to the damage to the building's walls. Certainly, vibrations from moving vehicles had a negative effect, especially since the analyzed building had no foundations, which made it even more sensitive to vibrations from road traffic, propagating through the ground and affecting its structures - however, it was impossible to assess quantitatively the impact of traffic on the technical condition of the walls in practice.

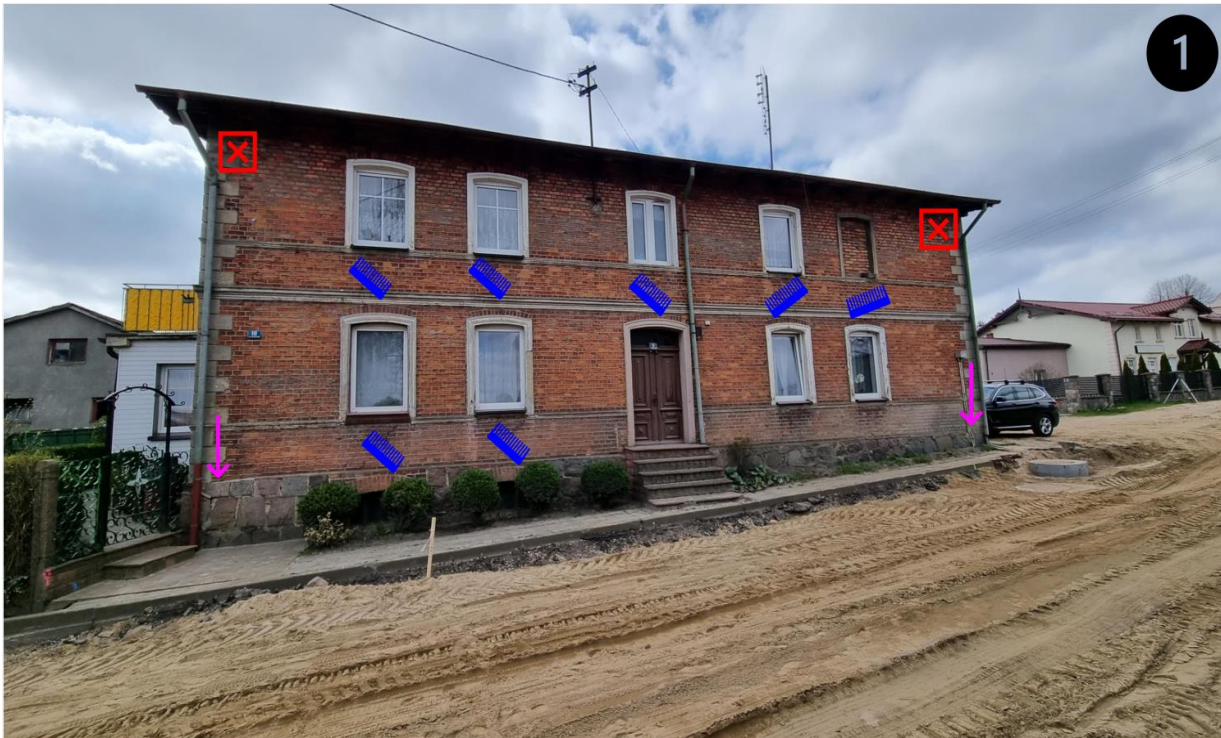
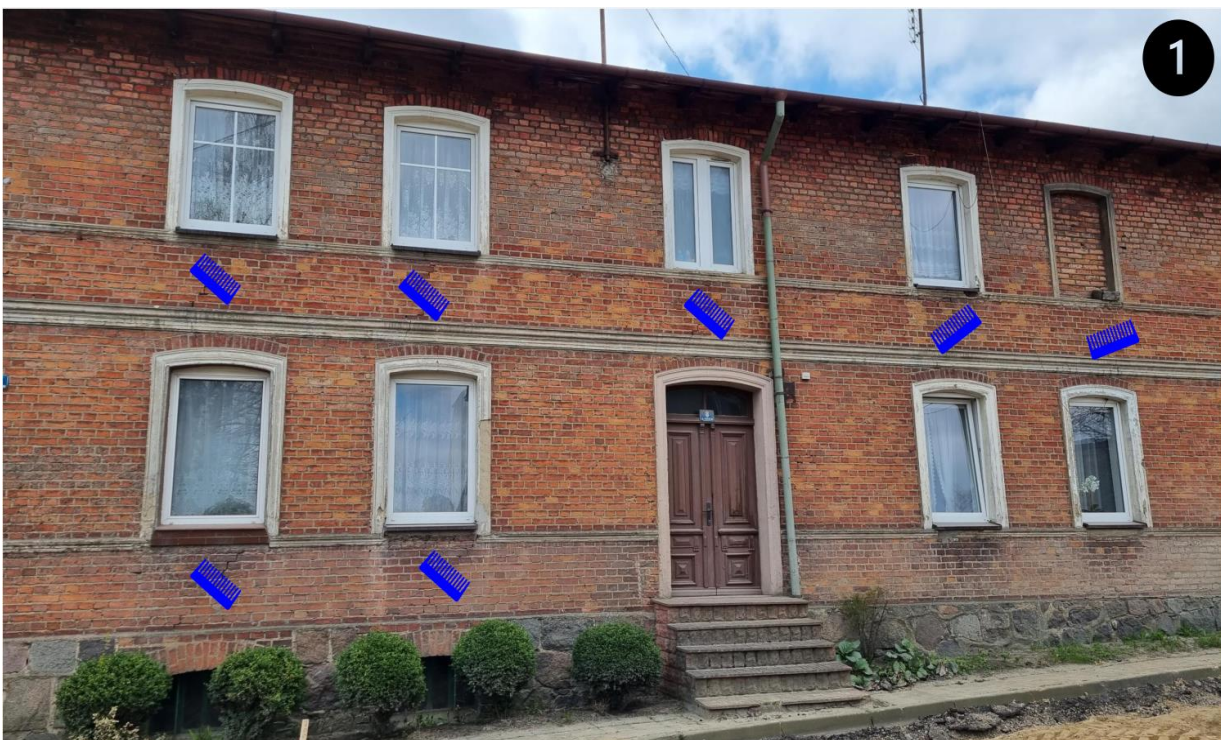
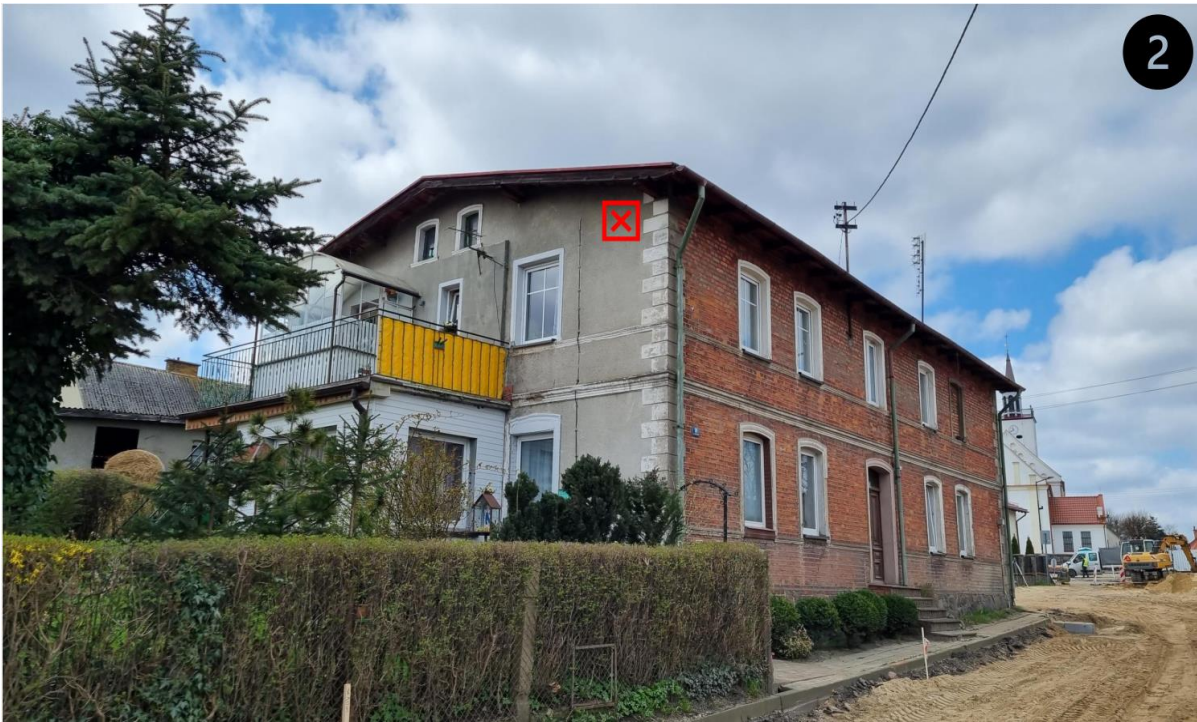
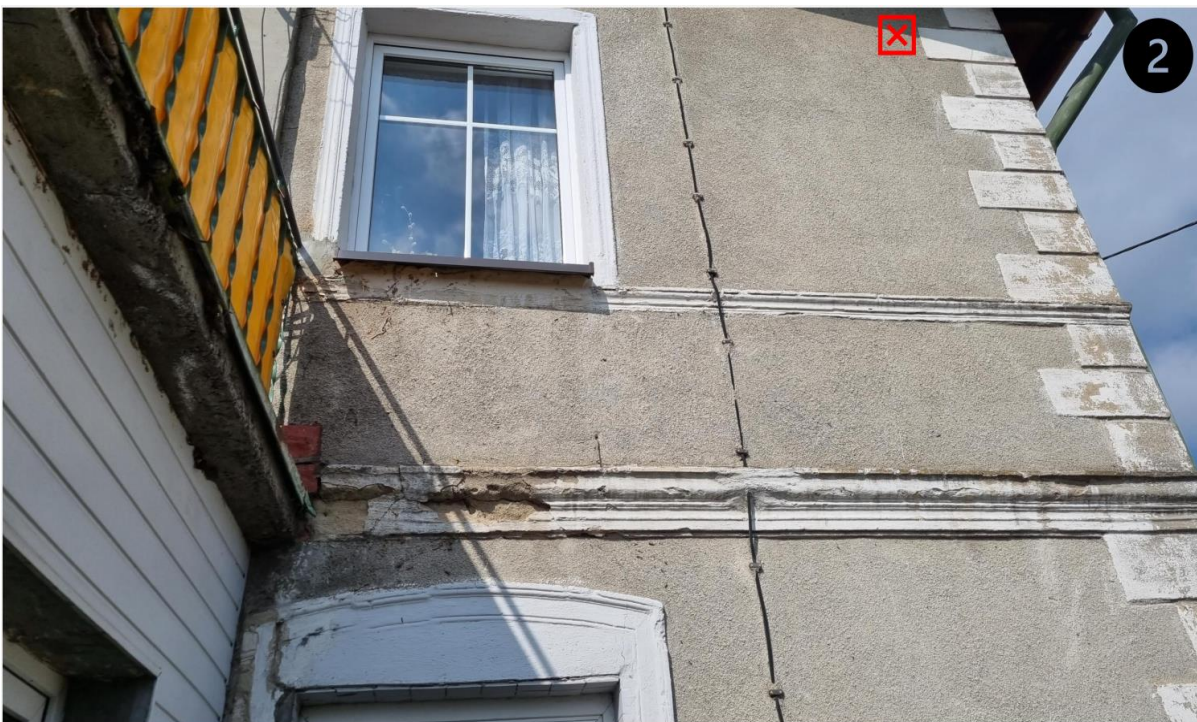
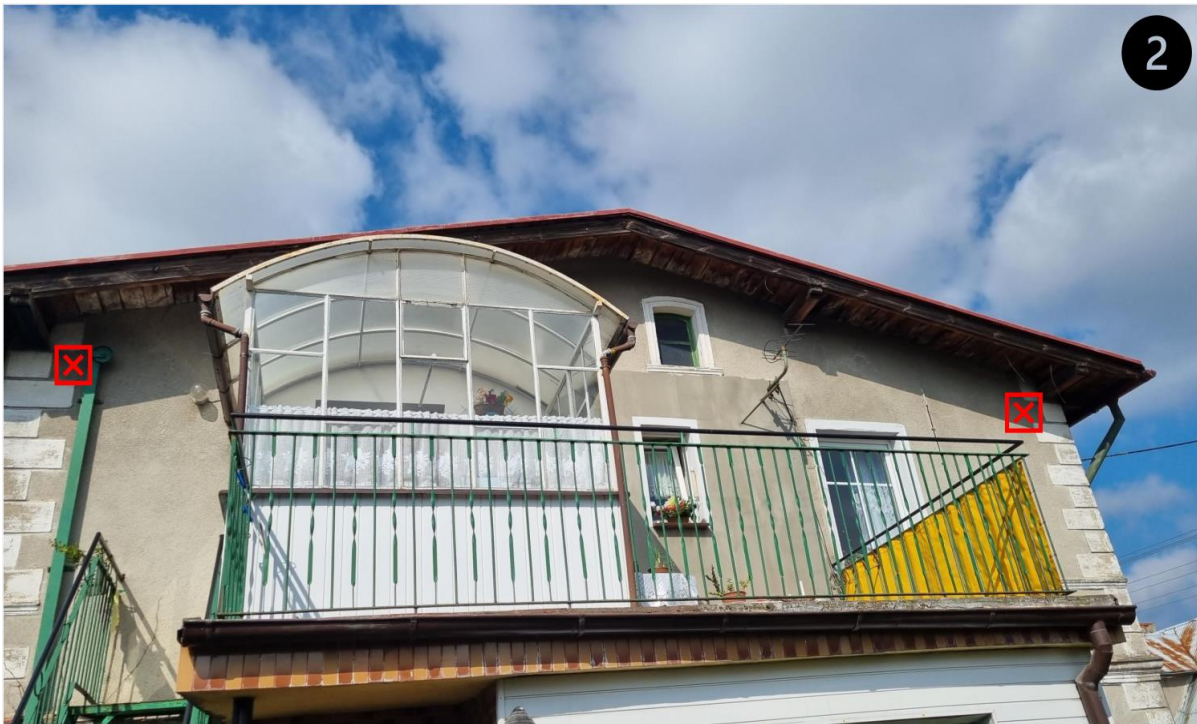
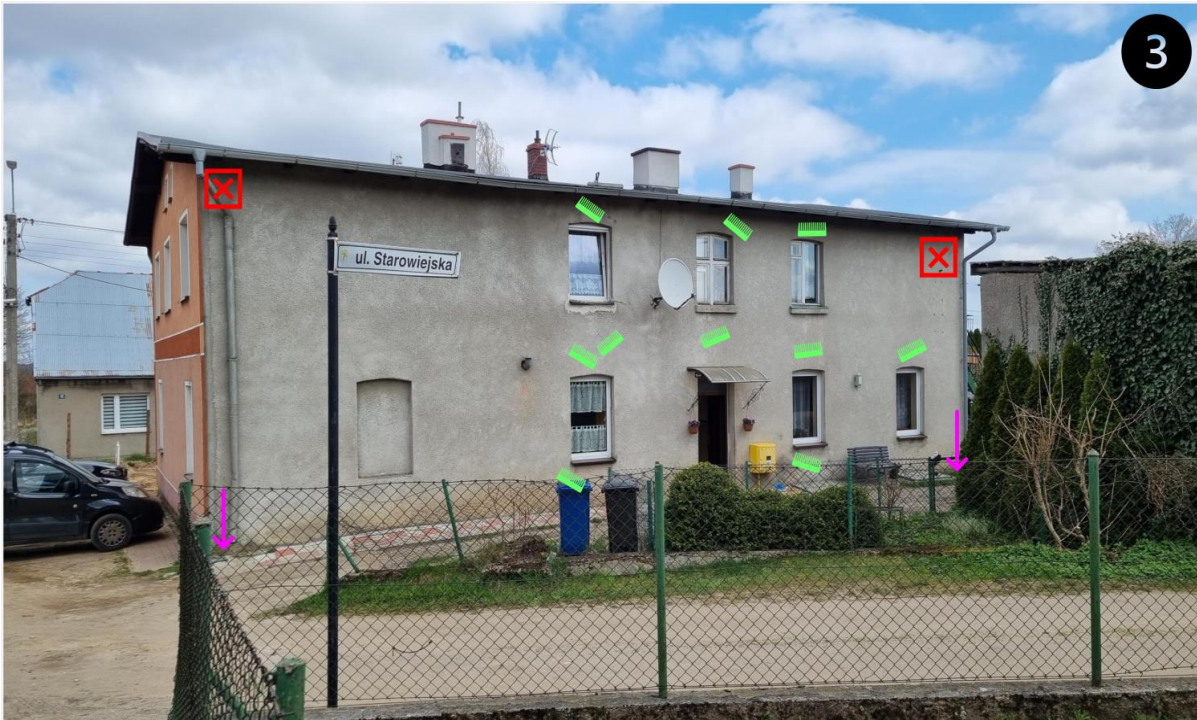
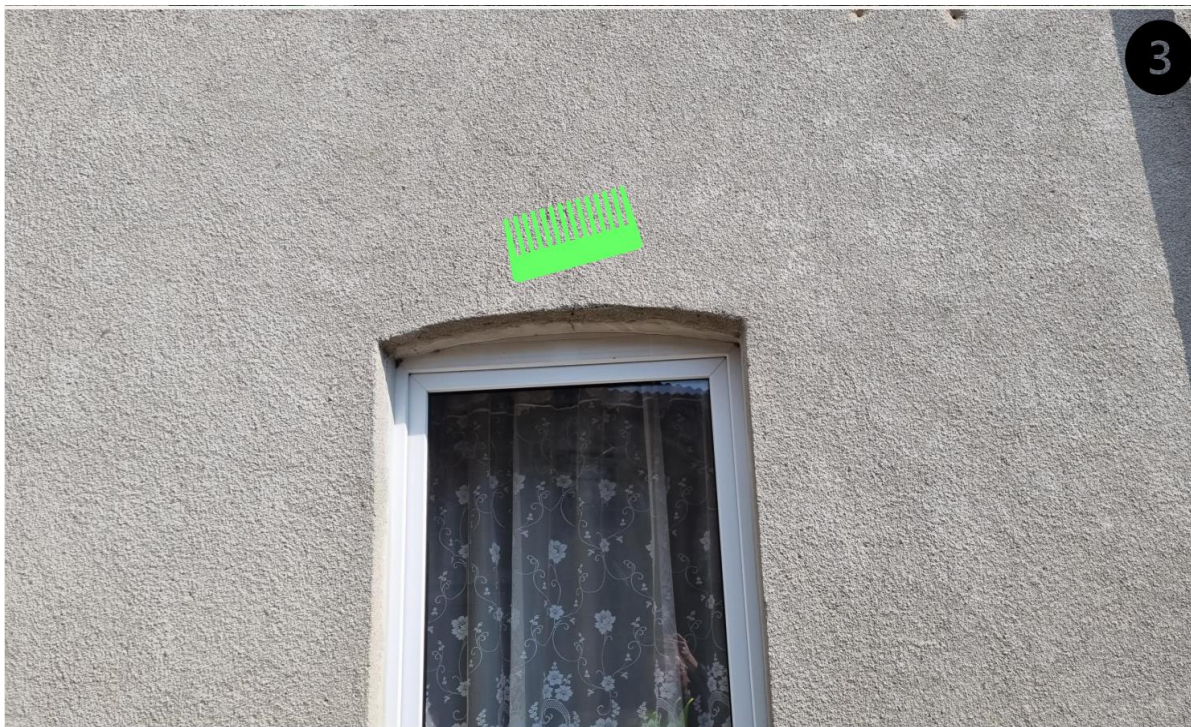
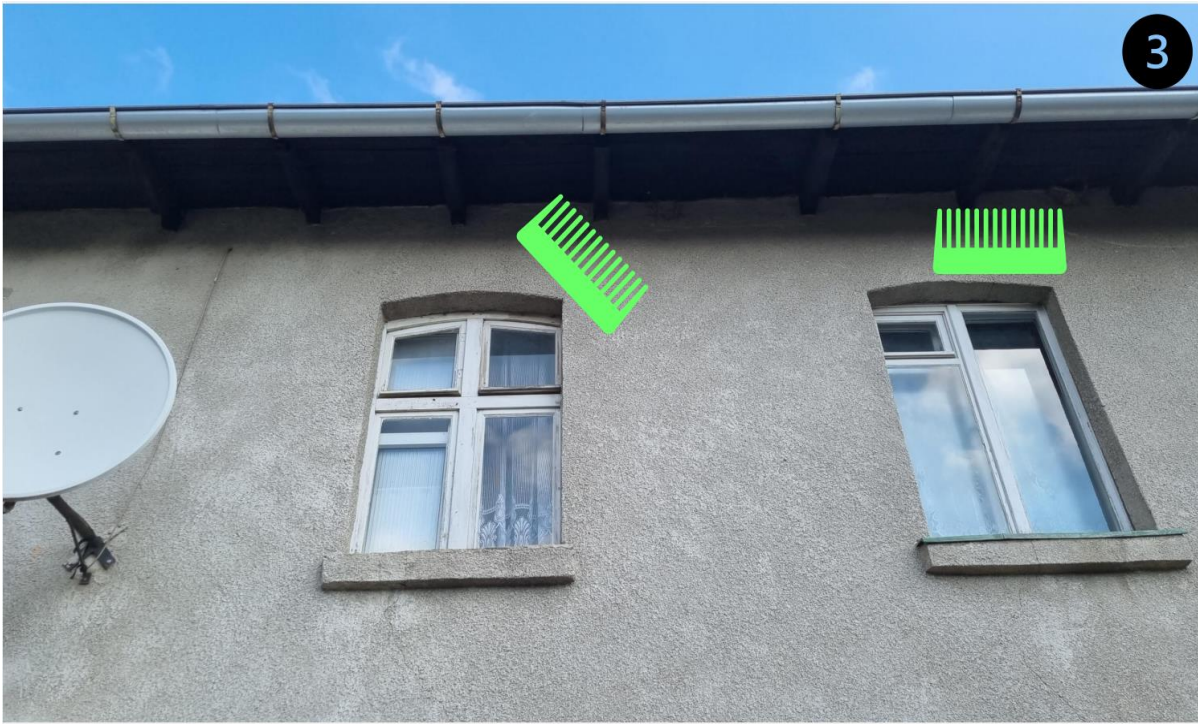
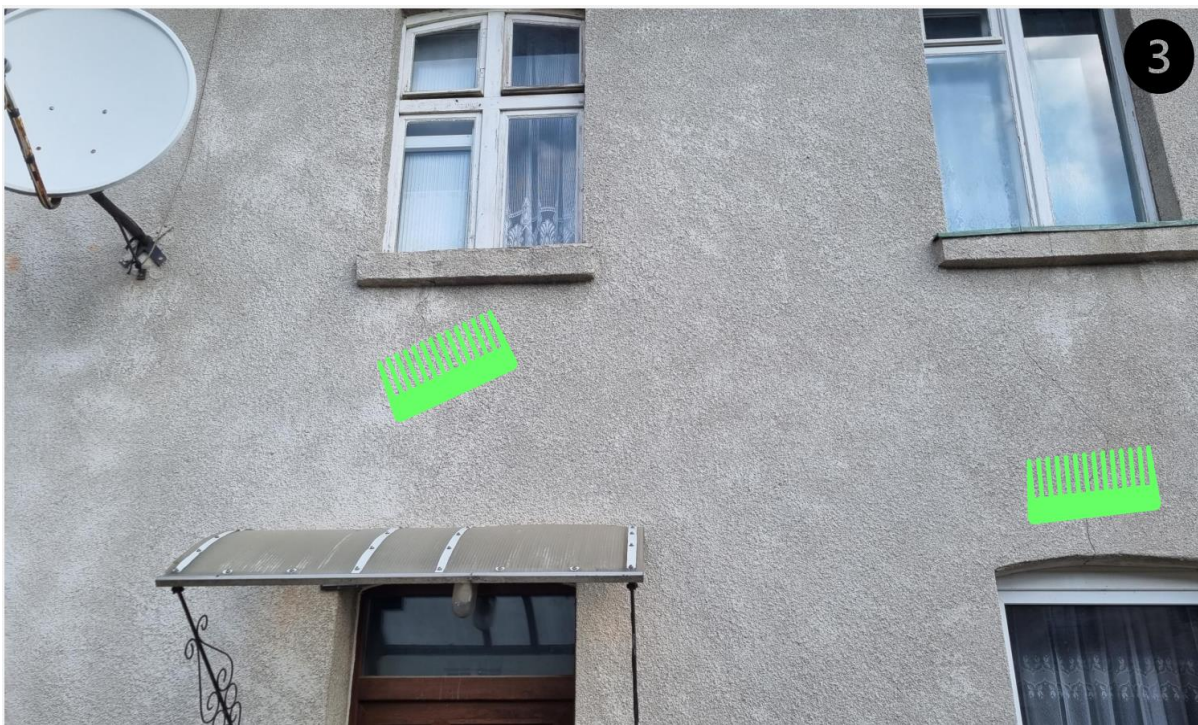
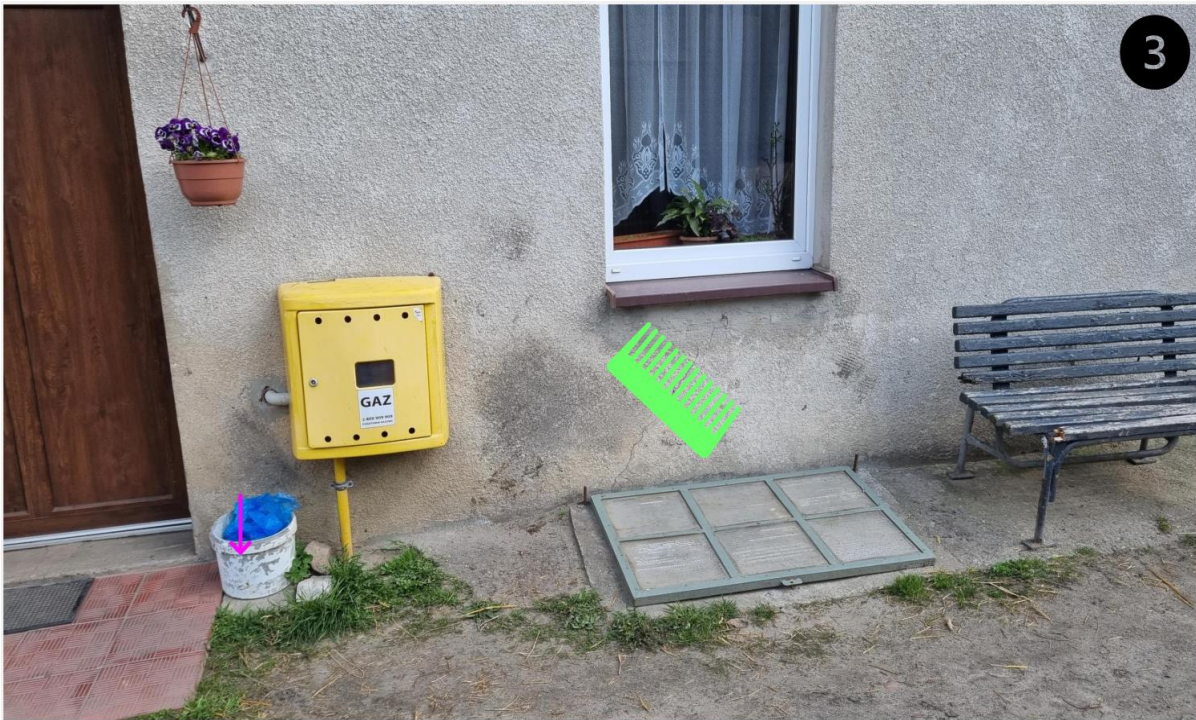
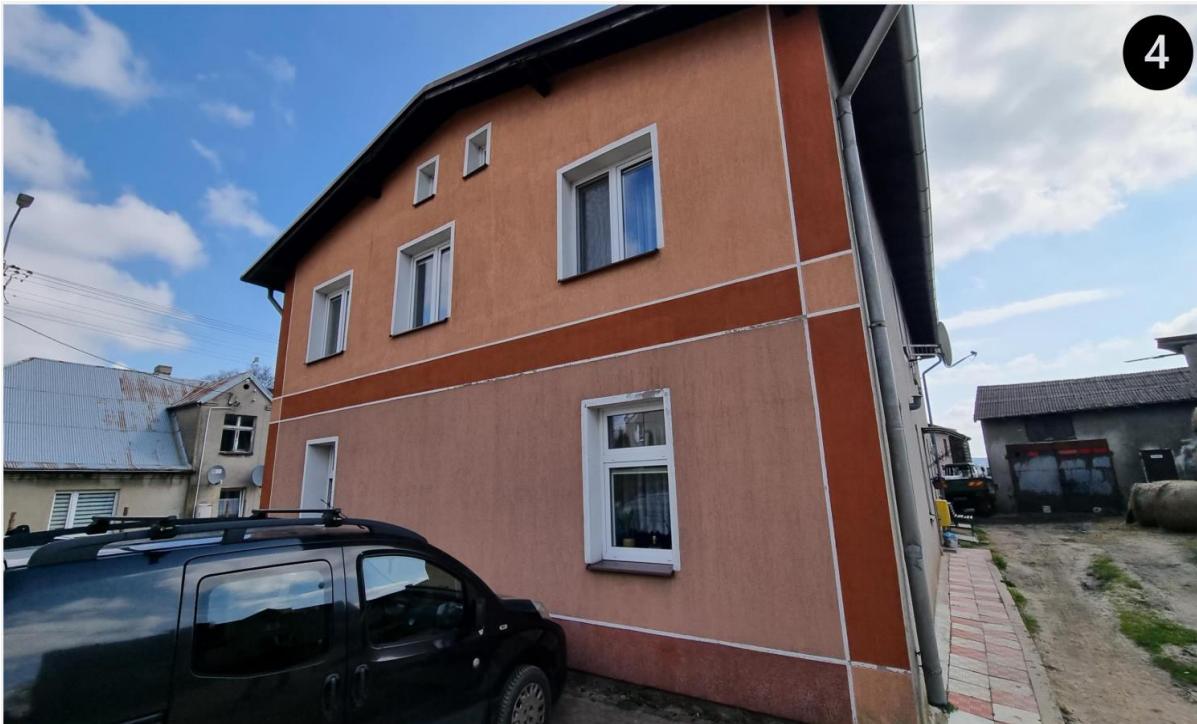
**Fig. 6:** Proposed location of target plates, benchmarks and feeler gauges on the external walls of a residential building: 1) front elevation (north), 2) side elevation (east), 3) garden elevation (south), 4) side elevation (west)

**STAGE 1** - to be carried out at the moment, enabling inspection of the technical condition of the building, during works related to the expansion of the road on the section along the building:

- ❖ when the works related to the reconstruction of the road are completely completed: every month for 6 months,
- after the completion of **STAGE 2** works, the feeler gauges may be destroyed. In such case, geodetic measurements should be limited to measurements of benchmarks and target plates, which are recommended to be carried out for a year at monthly intervals.

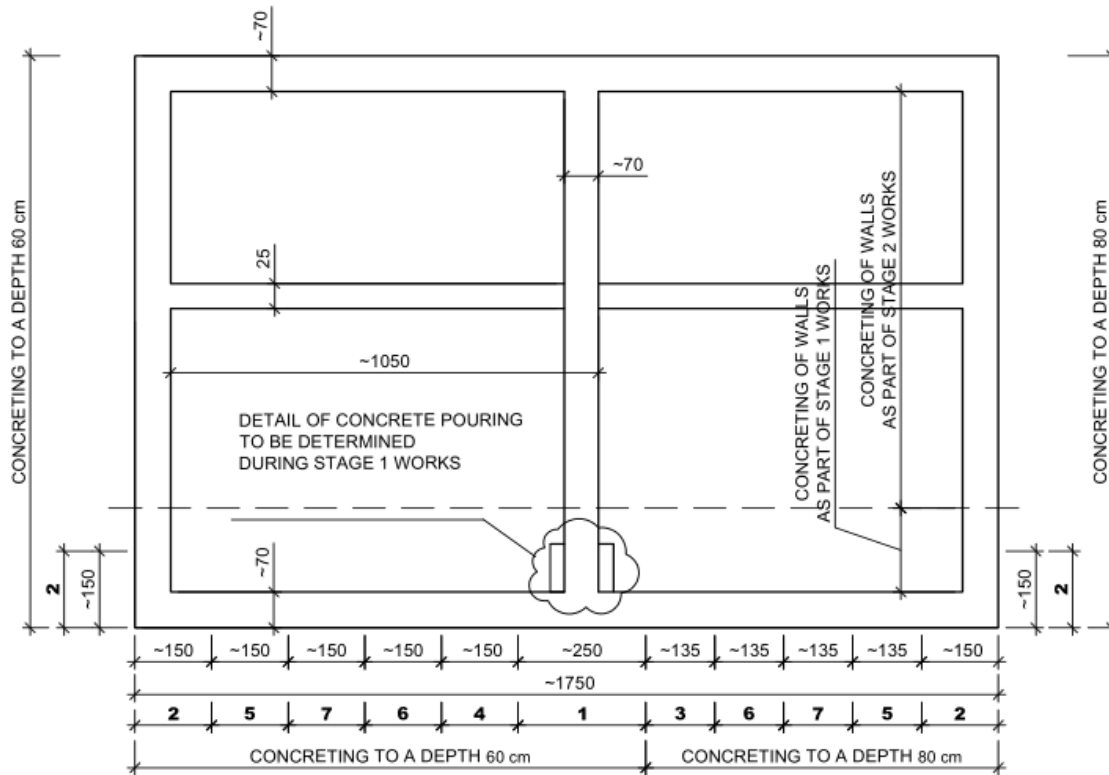
**Fig. 7:** The sequence of reinforcement of the front, longitudinal wall (northern elevation) in a residential building: a) general view of the front elevation, b) left side (L) (basement part), c) right side (R) (non-basement part)

- dismantle the entrance stairs to the building from the street side,
- perform sub-concreting of the front, longitudinal wall (northern elevation) according to the concept of solutions presented in Fig. 7 and Fig. 8,
- sub-concreting of the left side (L) (basement part) should be performed from the outside of the building with a control excavation of the wall foundation from the basement side in order to check whether the concrete introduced under the stone wall tightly fills the space under the wall across its entire width,
- sub-concreting of the right side (R) (non-basement part) should be performed from the outside of the building, paying particular attention to ensuring that the concrete is distributed across the entire width,

- sub-concreting at the place of change in the depth of the stone wall foundation, i.e. at the connection of parts L and P, should be performed from the outside of the building, maintaining far-reaching care in filling the space under the stone wall with concrete,
- as part of the works related to strengthening the front wall, strengthen parts of the gable and side walls (eastern elevation and western elevation) - the scope of reinforcement in accordance with the solution presented in Fig. 7,
- fill the joints of the stone wall from the outside and inside using cement mortar - it is recommended to use a system-based packaged (bagged) mortar characterized by low shrinkage,
- after completing the works related to strengthening the front wall, reconstruct the entrance stairs from the street side.

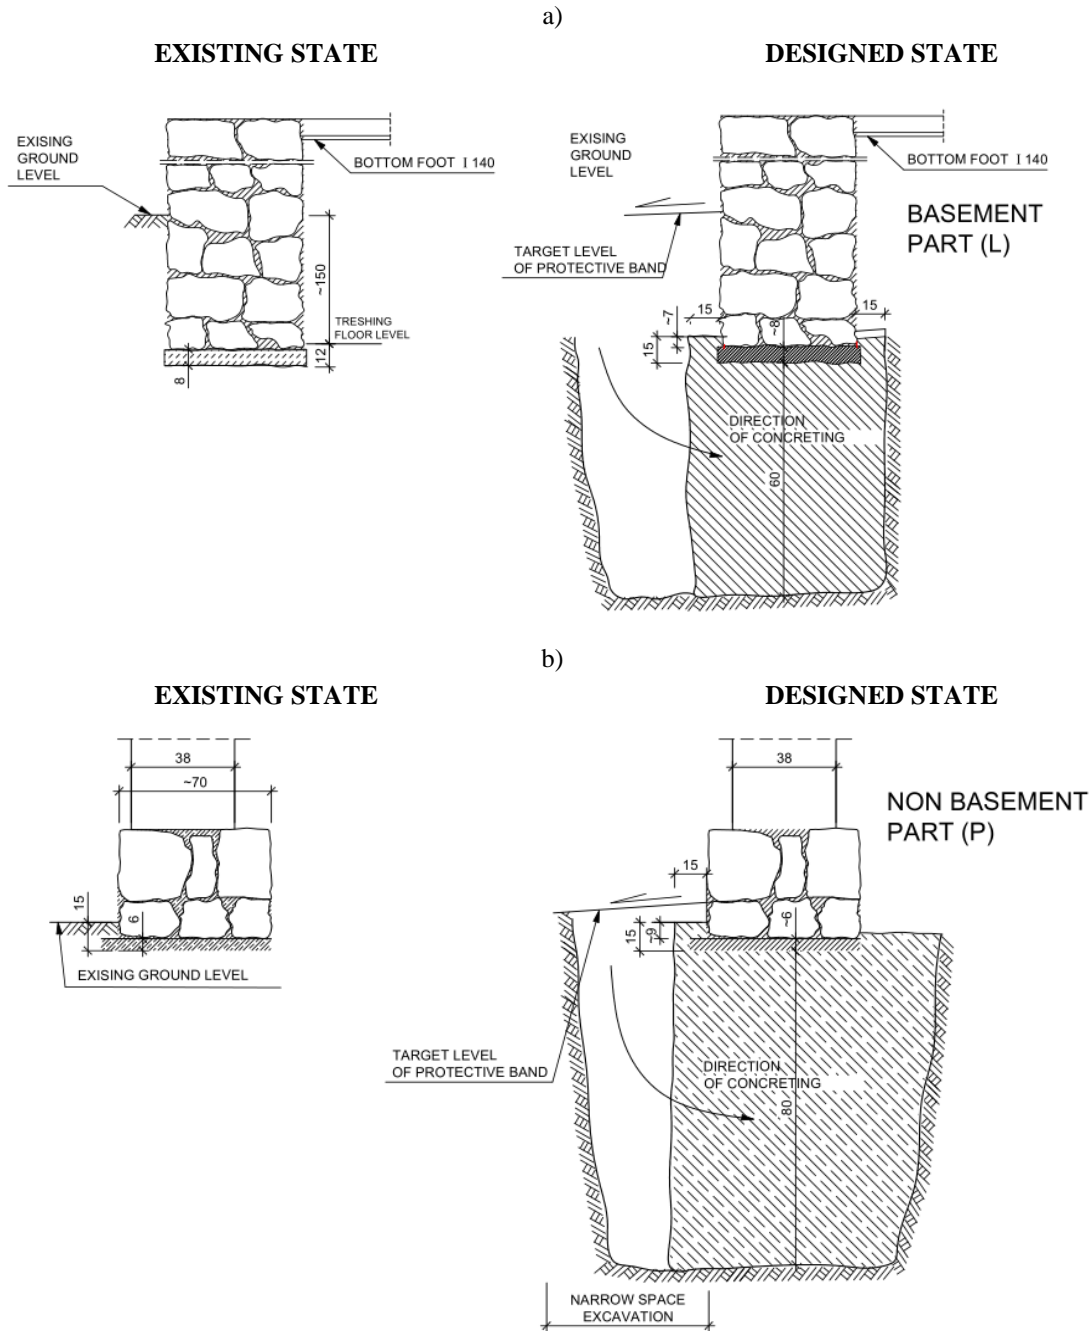
**Fig. 8:** Details of reinforcement of the front, longitudinal wall (northern elevation) in a residential building: a) left side (L) (basement part), c) right side (R) (non-basement part)
