Types of Surface Impurities versus the Quality of Brazed Joints

Keywords: brazing, brazing imperfections, radiographic tests, inclusions, non-destructive tests

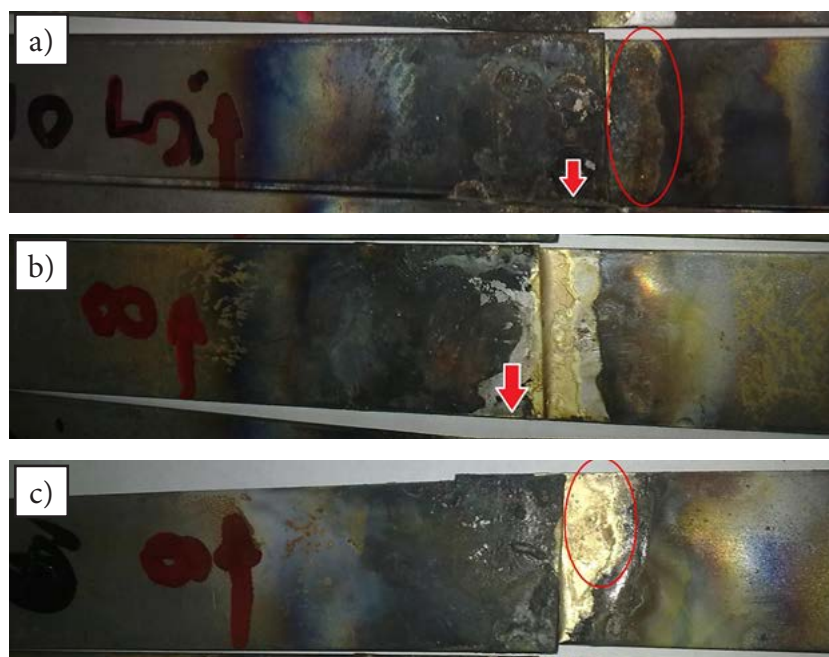
Fig. 2. Visual test results; a) specimen 5 – three copper inclusions, excessive spread of the brazing metal (ellipse), a crack of the braze and gas pores (arrow), the overlap on the upper edge not filled with the filler metal, b) specimen 8 – immersed in water, a crack of the braze (arrow), the overlap on the left edge not filled with the filler metal c) specimen 9 – provided with the flux used in the SAW method, excessive spread of the brazing metal (ellipse), gas pores, the overlap on the upper edge not filled with the filler metal

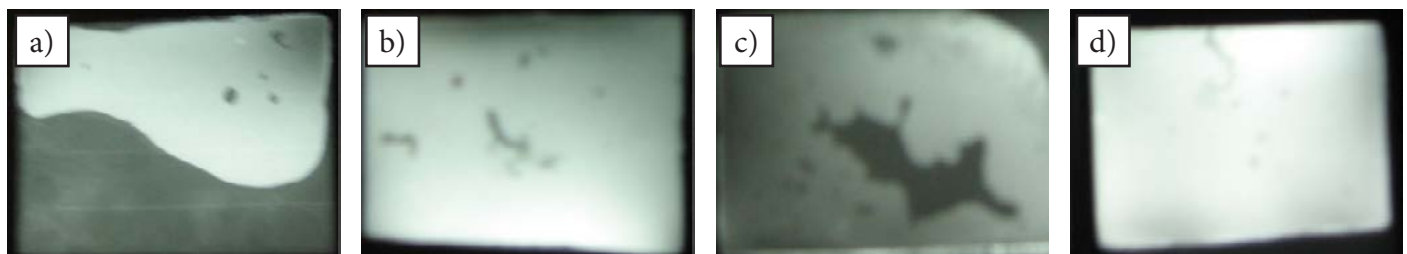
Fig. 3. Radiographic test results; a) specimen 1 – lack of the flux, a complete joint covering approximately 50% of the surface subjected to brazing, inclusions, oval gas cavities, b) specimen 3 – improperly cleaned surface, a longitudinal gas cavity having a length of 5 mm in its central part and oval gas cavities, c) specimen 8 – immersed in water, a gas cavity having a length of 20 mm and a width of up to 7 mm, oval gas cavities, d) specimen 10 – made properly, a longitudinal gas cavity having a length of 3 mm, small inclusions
