## Analysis and Risk Evaluation on the Case of Alteration, Revitalization and Conversion of a Historic Building in Gdańsk

To cite this article: Beata Grzyl *et al* 2017 *IOP Conf. Ser.: Mater. Sci. Eng.* **245** 082049

Beata Grzyl<sup>1</sup>, Adam Kristowski<sup>1</sup>, Emilia Miszewska-Urbańska<sup>1</sup>

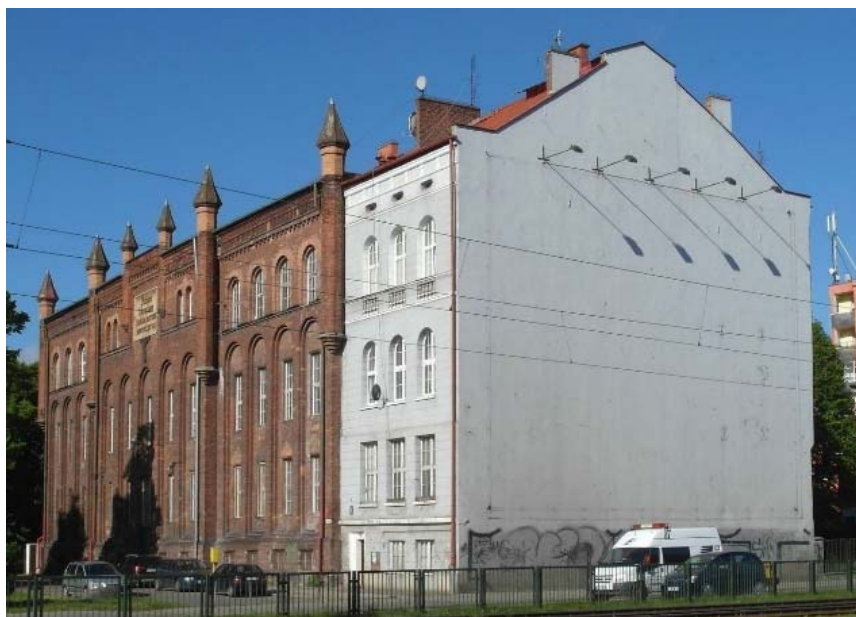
**Figure 1.** The building of the former Municipal Secondary School at 2 Lastadia Street and the dwelling building of 1 Lastadia Street

The dwelling house at 1 Lastadia Street was added to the former Secondary School at 2 Lastadia Street in about 1908. The results of performed expert technical evaluations [among others: 6-9] indicate that the dwelling building does not have a construction order which is independent and has expansion joints. It has been “tacked on” to the existing building of 2 Lastadia Street by joining of the foundations and the structural walls of both buildings. The dwelling house of 1 Lastadia Street, does not have its own gable from the side of the Secondary School building. The gable of the Secondary School building was used to lean the ceilings of the dwelling house (in the building of the Secondary School, the ceilings are leaned against the longitudinal walls). The findings of the expert opinions, which were carried out show, that these buildings were positioned in a different way. Taking the above-mentioned building actions and changing the external and surroundings conditions in which the buildings were erected, resulted in current catastrophic technical state of the building at 2 Lastadia Street [among others: 9]. No gable in the dwelling house results in the shifting of the centre of gravity of load combination in relation to the basement plan. As a result, there is uneven pressure on the stilts and subsiding of the building with an inclination of 25-30 cm [6]. The conclusions of the expert evaluations [6, 7] indicate that the ceilings of the dwelling house, originally leaning on the gable of the Secondary School building, lost their support as a result of the inclination of the building and are currently working on cantilevers. The joining of both properties results in subsiding and progressive degradation of the Secondary School building. In order to save the historic building at 2 Lastadia Street, “Gdańskie Melioracje Ltd.” has been considering a possibility (subject to a permission of Pomeranian Province Conservator of Monuments) of conducting demolition of the dwelling house situated at 1 Lastadia Street (private property, presently in the course of buyout by the Town of Gdańsk). This solution will allow to carry out the extensive reinforcement and repairs to foundations and protecting them against uneven sinking.
