**B. Świczko-Żurek<sup>1</sup>, M. Krzemiński<sup>2</sup>**

<sup>1</sup>Gdańsk University of Technology, Faculty of Mechanical Engineering, Department of Material Science and Engineering, Narutowicza 11/12, 80-952 Gdansk, Poland

## THE DEGRADATION OF METAL IMPLANTS

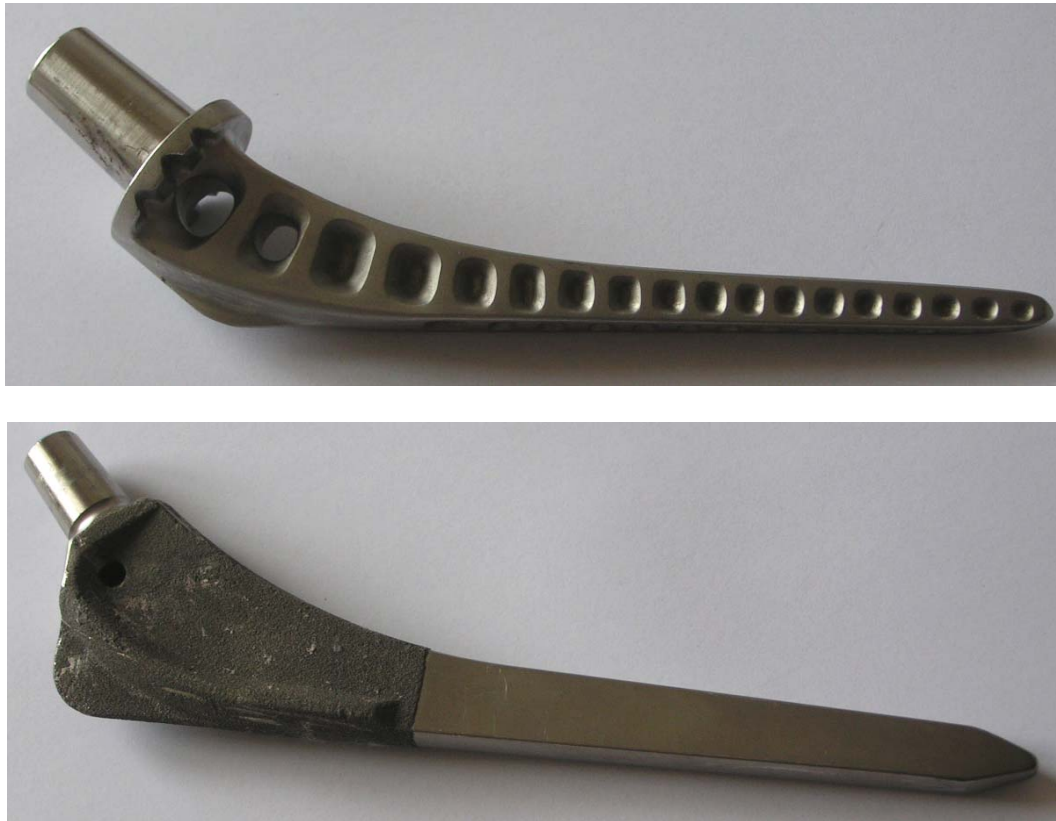
Two endoprothesis made of alloy steel - Ti6Al4V (pic.1). The chemical composition was as follows: Ti, 4,08%V, 6,39%Al, 0,17%Fe, 0,015%C, 0,185%O, 0,005%N, 0,0035%H

**Pic.1.** The endoprothesis made of titanium alloy (Ti-6Al-4V)

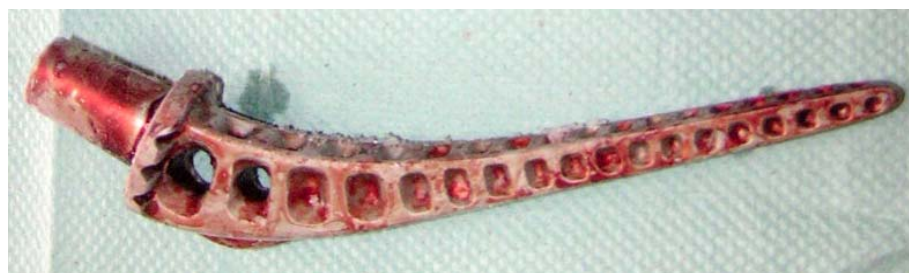
Picture 4 and 5 show degraded implants, after removed of human body.

**Pic.4.** The degraded implants from the first patient

1. The reason for removing implants was their degradation caused by improper conditions provided by the body – both patients suffered from *Poliarthritits Rheumatoidea*.
2. The bacteria *Staphylococcus Epidermidis* as well as the environment of the body

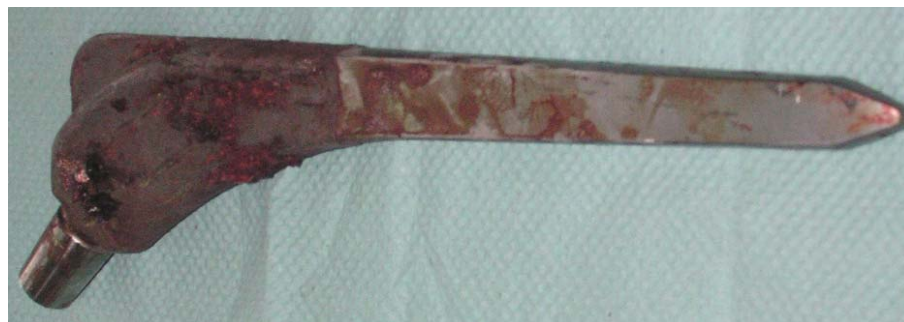
**Pic.5.** The degraded implants from the second patient
