## ANALYSIS AND ASSESSMENT OF THE ACOUSTIC EMISSION SUITABILITY FOR DETERMINATION OF THE ENERGY STATES OF A TRIBOLOGICAL SYSTEM IN THE FORM OF A FOUR-BALL TESTER FRICTION NODE

*Key words: tribological system, acoustic emission, energy state*

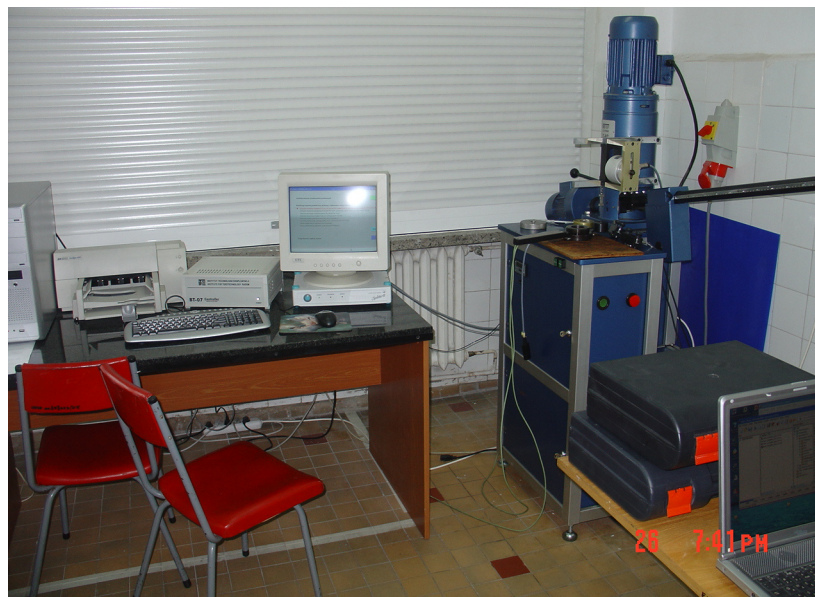
Fig.1 Schematic diagram of the ITeE Radom company four-ball tester and the Vallen-Systeme GmbH AMSY-5 apparatus measurement and control systems[1]

The energy release impact investigations [1] were carried out on the T-02 four-ball tester with Vallen piezoelectric gauges (Fig.1), in the conditions defined in Section 2.
