B. Świczko-Żurek¹, A. Szumlański², J. Zorn¹

¹Faculty Of Mechanical Engineering, Technical University of Gdansk, Narutowicza 11/12 Str., 80-952 Gdansk, Poland

ALLERGY TO IMPLANT COMPONENTS: CHROMIUM, NICKEL, COBALT AND TITANIUM

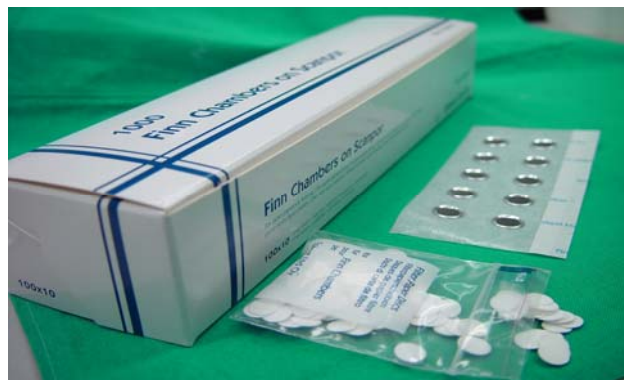
Fig.1. The patch tests were used for the research

The patch tests (Fig.1) were used for the research, which was carried on 6 selected patients, before and after surgical intervention.

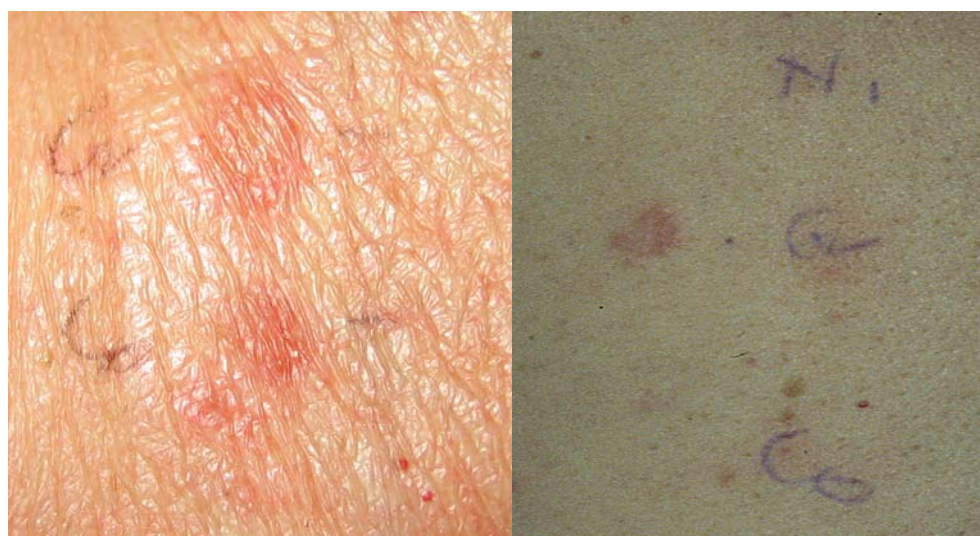
Fig.3. Skin changes after performing the tests

The patients (6) were subjected to the tests on the Ni, Cr, Co allergens (Fig.3).

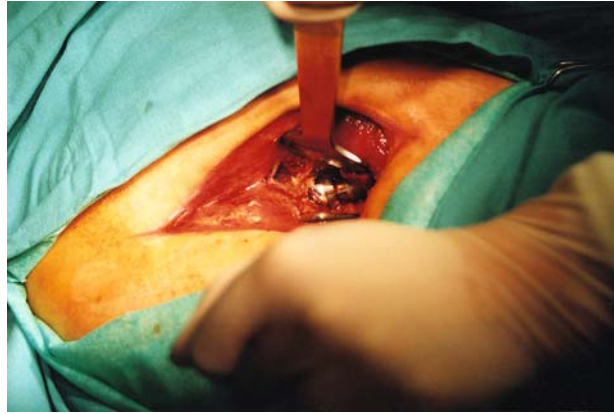
Fig.4. The hip implant removing caused by aseptic loosening

Two of them (1,2) had their implants removed due to aseptic loosening and intolerance of endoprosthesis. It resulted in pain, fistula serosa and edema. There were found to have oversensitiveness to Cr and Co. The allergic were not diminished by using antihistaminic drugs (Fig.4).

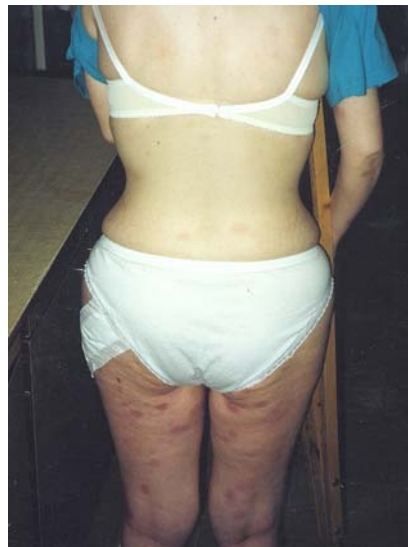
Fig.5. The patient with Ni sensitiveness after applying hip prothesis

The patient (3) with Ni allergy suffered from skin imperfections after introducing hip implant (Fig.5). The symptoms decreased after applying antihistaminic drugs.

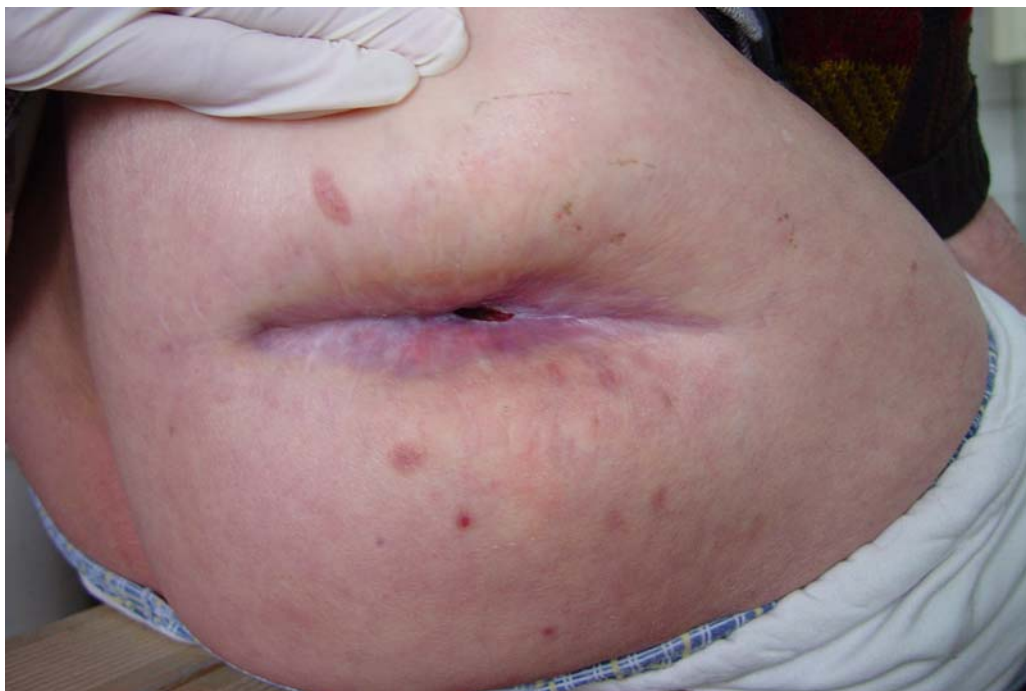
Fig.6. The fistula serosa in hip after implantation

Another is the case with the patient (4) allergic to Ni and Co, who had no symptom of oversensitiveness up to 2 weeks. Then fistula serosa aseptica occurred in the hip (Fig.6). Patch tests were repeated. They showed allergy to Ti. The histaminic drugs decreased the symptoms.

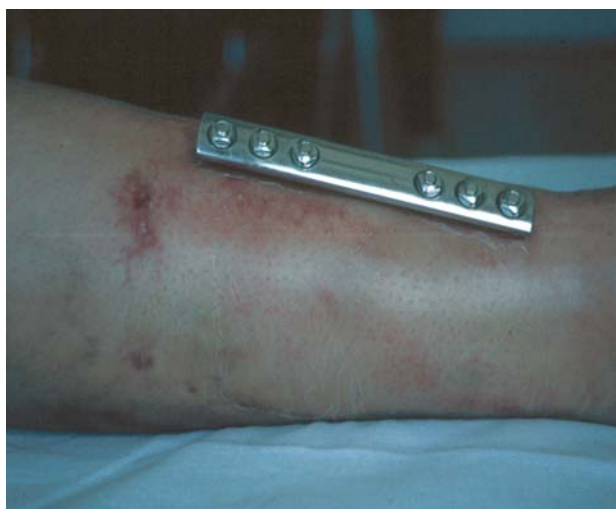
Fig.7. The contact dermatitis on the skin surface

The patients (5,6) whose bones were joint with ZESPOL method, positive reaction to Cr and Ni was found. It appeared as contact dermatitis covering a large area of the skin, not only in the implant-tissue area (Fig.7). Some disturbances in the bone growth was observed. Treatment with antyalergic drugs was ineffective. After 4 weeks the implants were removed and the patients were treated in cast.
