H. Smoleńska¹, W. Kończewicz²

¹Gdańsk University of Technology, Faculty of Mechanical Engineering, Department of Materials Science and Engineering, Gdansk, Poland

MICROSTRUCTURE AND PROPERTIES OF THE COBALT BASE CLAD LAYERS AFTER LONG TIME SERVICE

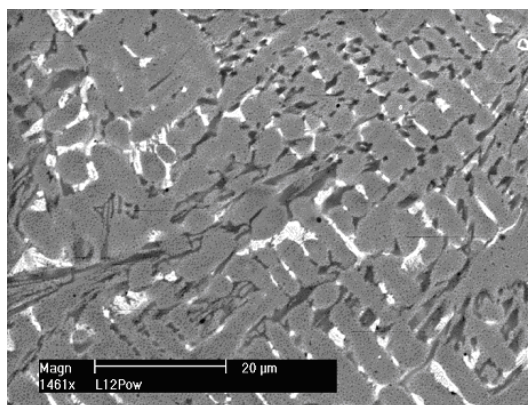
Fig. 1. SEM photograph of the cross-section of the clad layer close to the surface. The grey regions are dendritic while light and dark domains are placed in inter-dendritic regions, respectively

The laser deposited layers presented a typical surface welding solidification structure which is presented in the Fig. 1.

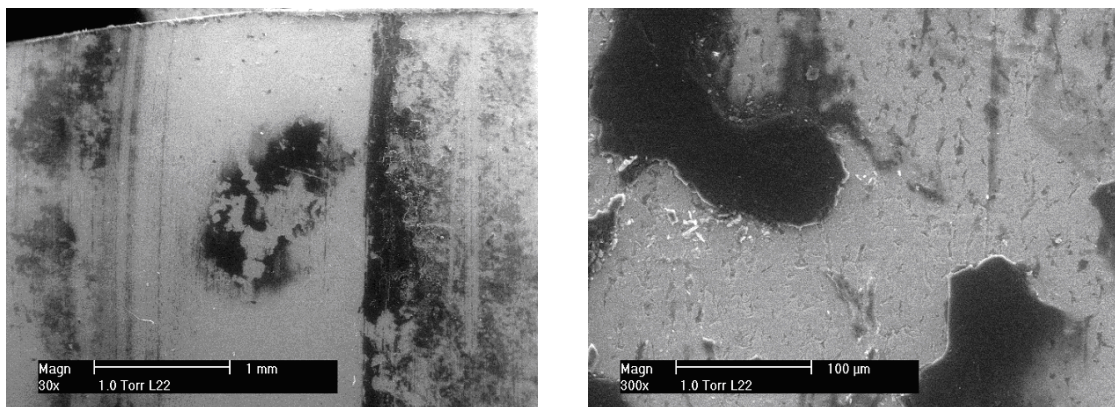
Fig.3. SEM of the vale face after two years of service; valve head from L22 engine – dark “spot” region under different magnification

After service the surface of the faces of the both valve heads presented shining surfaces (Fig. 2) in the great deal but some dark “spots” on them were noticed (Fig. 3, 4). There were no visible damages. However SEM observations showed some results of wear. There were small amount of wear pits which were fill up with wear debris and possible the scale (Fig. 4).

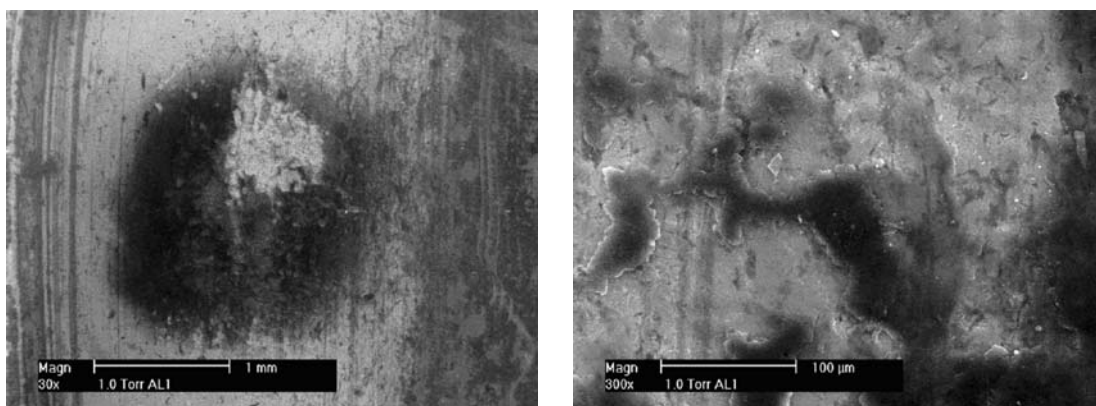
Fig.4. SEM of the vale face after two years of service; valve head from 3AL25 engine - - dark “spot” region under different magnification

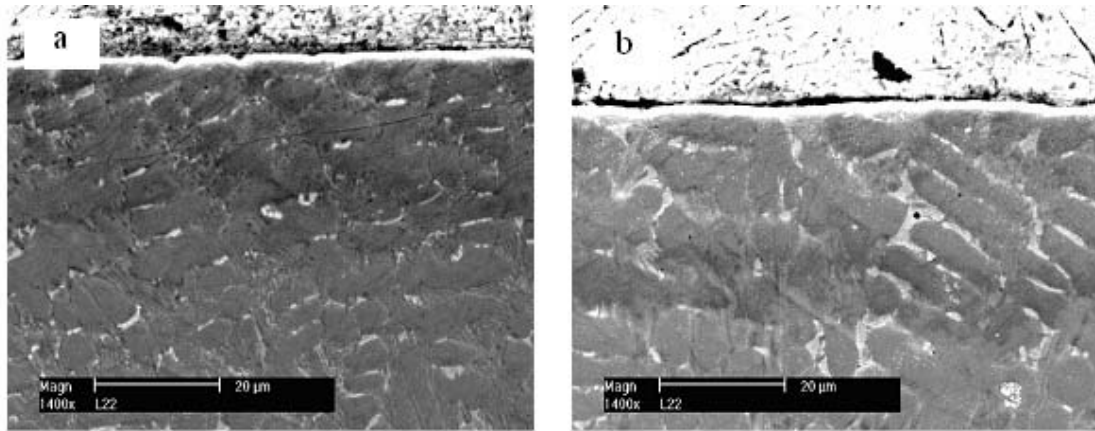
Fig. 5. SEM of the cross-section of the clad; valve head from L22 engine; a- region where the small pits were observed; b- typical structure for the most of the faces

On the cross section of the clad layers general visible changes in microstructure were not found (Fig. 5). On the surface some small pits were observed (Fig. 5a) but in the great deal the surface was smooth (Fig. 5b).

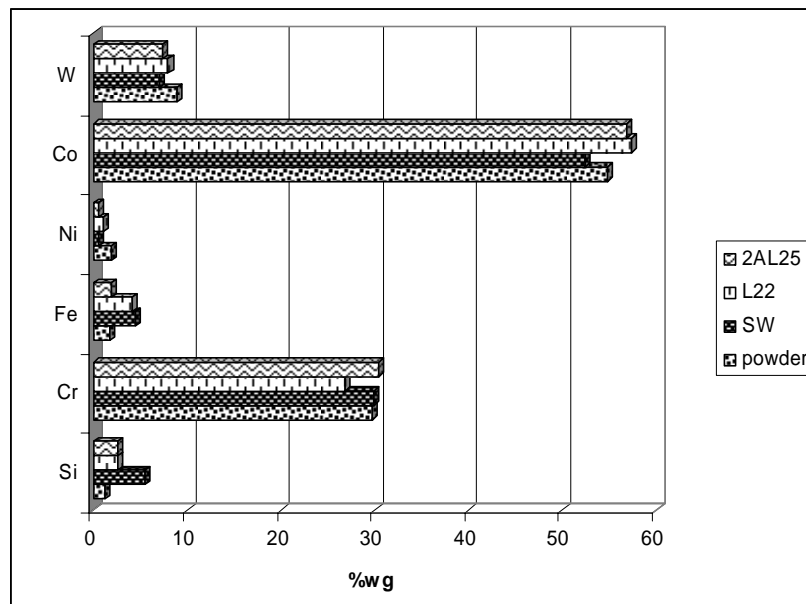
Fig. 6. Chemical composition of the powder and composition of the surface region for: SW – as clad state, L22 – surface region of the face from L22 engine, 2AL25 - surface region of the face from 2AL25 engine

The chemical analysis EDS in the micro region on different part of the clad layer allowed establish the trends of chemical changes. Fig. 6 presented result of chemical analysis on the cross section of the clad layers, close to the surface for faces from the both engines after service in comparison to clad state and powder composition

The small changes in the composition corroborated earlier metallographical results about not significant structural changes. Different service conditions resulted with differences in diffusion of some elements. Lower amount of chromium for L22 engine indicated more intensive oxidation and building a chromia scale. For less demand condition the “use” of chromium was less intensive.
