NON-DESTRUCTIVE DIAGNOSTICS OF CONCRETE CANTILEVER BEAM AND SLAB BY IMPACT ECHO METHOD

Magdalena RUCKA¹, Krzysztof WILDE^{1,2}

¹ Department of Structural Mechanics and Bridge Structures, Faculty of Civil and Environmental Engineering, Gdansk University of Technology

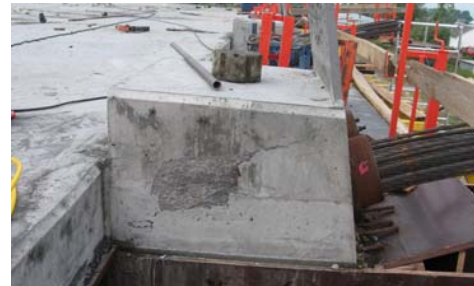
The object of the study is the road bridge (Fig. 2) in Nowy Dwór Gdański over the road no. 7 Gdańsk-Warsaw. During construction process the cantilevers of transverse beams were prestressed according to the plan (this state is referred here as 'state 0'). After prestressing process, cracks and cavities appeared on the cantilever surfaces (Fig. 3). Therefore repair operation was undertaken in the form of additional reinforcement and new gunite parts, but the cracks were not injected before gunite process. The aim of performed diagnostics was assessment of technical condition of cantilevers after repair (this state is referred here as 'state 1'). The impact-echo method was applied to non-destructive testing of the considered structure.

Fig. 3. Damaged cantilever no. 4 after prestressing

As results, a map of distribution of wave speeds in 59 measurement points was plotted in Fig. 7a for the cantilever no. 4 at 'state 1'. The average value of P-wave speed in cantilever no. 4 was 4352 m/s. There are several points in which wave speeds are significantly smaller than average value. Points in which wave speed was smaller than 90% of average values were indicated as damaged areas (points 5, 7, 11, 12, 22, 23, 36, 37, 54). They are marked in Fig. 5 and they cover with localization of cracks observed at 'state 0' (c.f. Fig. 3).

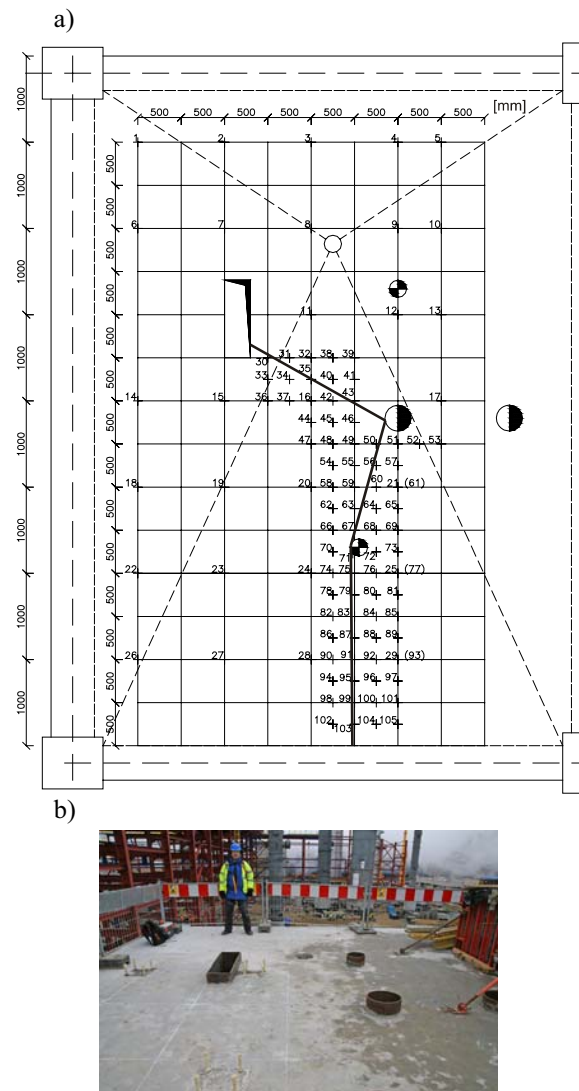
The object of the research was the concrete floor slab (Fig. 8). Due to disturbances in concrete delivery during the slab casting, the homogeneity of the concrete became in question. The non-destructive test was performed with the use of the impact-echo method to determine presence of discontinuities.

The geometry of the slab is shown in Fig. 8a. The number of measurement points was 105. They were distributed along the line of potential discontinuity, depicted as thick solid line in Fig. 8a. The hardware equipment was the same, as in the case of bridge measurements (c.f. Section 3.2). In this experiment, one-side measurement was performed, i.e. both mechanical impact and acceleration measurements were realized on the upper side of the slab only. The slab height, varied from 17 to 19 cm, was calculated in the measurement points based in known slab slopes.

Fig. 8. Concrete floor slab: a) geometry and measurement points; b) the photo
