SURVEY FOR NEWLY BUILT SPORT FACILITIES

Zygmunt Kurałowicz
Politechnika Gdańska

Eugeniusz Lepacki, Jacek Śmierzchalski
FU-H DIAZ Gdańsk

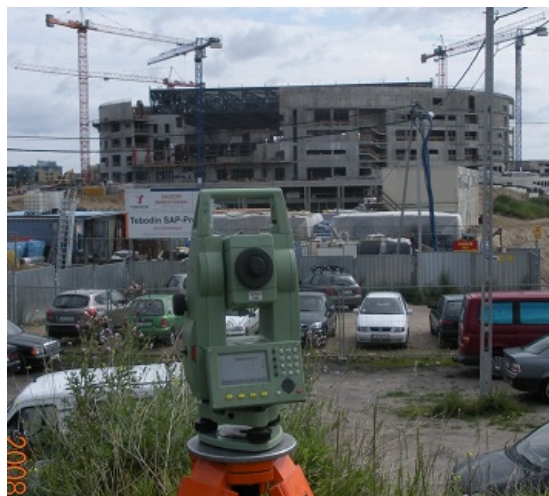
Fig. 2. View of Hall ERGO-ARENA under construction on the administrative border of Gdańsk and Sopot.

Hall consists of two parts, the bottom is partially sunk into the ground, while the upper part is entirely visible in the form of a simple cylinder (Fig. 2). In the building of Hall, Main Arena with surrounding auditorium of approximately 11.000 seats, and back-up facilities is located. The sport hall serving as a place for warm-up, equipped with a movable rostrum adheres to the main building.

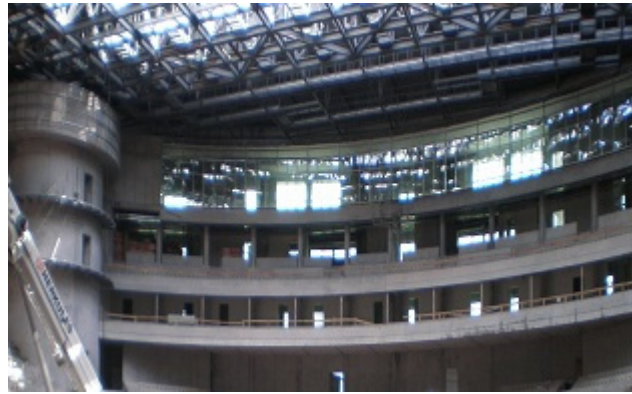
Fig. 3. View of the pylon and the girder of Hall.

Load-bearing structure of auditorium is a monolithic reinforced concrete slab made of concrete B37 and steel AIII N, based on the walls and pillars and binding joists. Whereas load-bearing structure roof of Hall constitutes a set of four pillars - the pylons with a diameter of 10.800 m and height of 25.000 m (Fig. 3), each of them is rigidly fixed in the pile foundation, articulated to the roof structure, and dilated from the rest of the structure of the object. A roof consists of spatial system of steel truss, supported on reinforced concrete columns, monolithically poured, covered with corrugated metal sheet. The spatial structure is characterized by dimensions of the axes: 70.600 m (length) x 66.600 m (width) x 5.600 m (height) and the axial distances of girders are 6.460 m and 6.060 m, with the technological platforms, attached to their lower flanges.

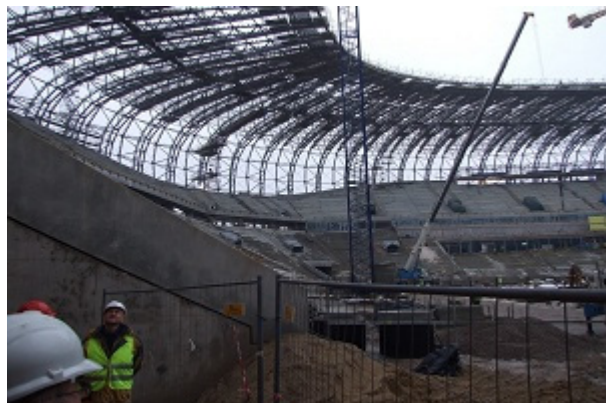
Fig. 4. View of the girders from the side of the pitch - the second stage of assembly.

The sport facility takes about 3.3 hectares, while the dimensions of the stadium are: length 236.000 m, width 203.000 m, height 45.000 m. The roof of the stadium consists of 82 girders weighing 66 tons each (Fig. 4 and 5), supported on independent bearings fixed in the ground parts of the object - a reinforced concrete structure by means of 8 anchors.

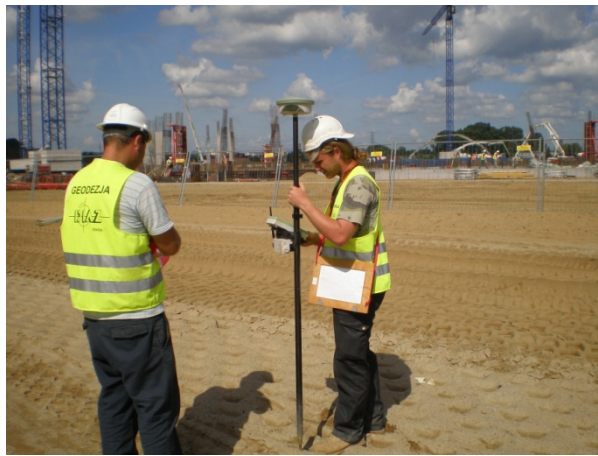
Fig. 8. Staking out axis of heads of reinforcing subsoil piles by means of GPS.

there were 6 - 7 teams. Used instruments are: TCR400 and TCR800 and TCR1201 of Leica. In staking out the axis of the reinforcing subsoil piles GPS was used (Fig. 8).

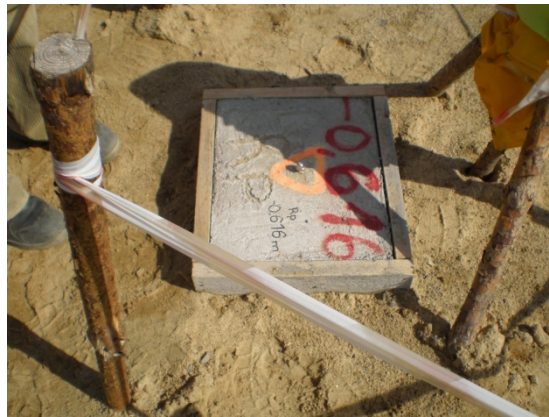
Fig. 10. The central geodetic mark - located in the middle of the stadium plate.

Elements of network connected to the national network of 3rd class: 6 points - a geodetic prism affixed to the slab roof of surrounding tall buildings, 15 points - reflective targets on facades of buildings, a ground point - stainless steel bar settled in a concrete block in the middle of the pitch (Fig. 10). Deviations (dx and dy) of newly-assigned points do not exceed 4 mm with a maximum length of 800 m. Detailed geodesic network was the development and densification of the basic realization network and consisted of 80 points signaled by reflective targets. The accuracy of alignment of points is 1 - 2 mm.

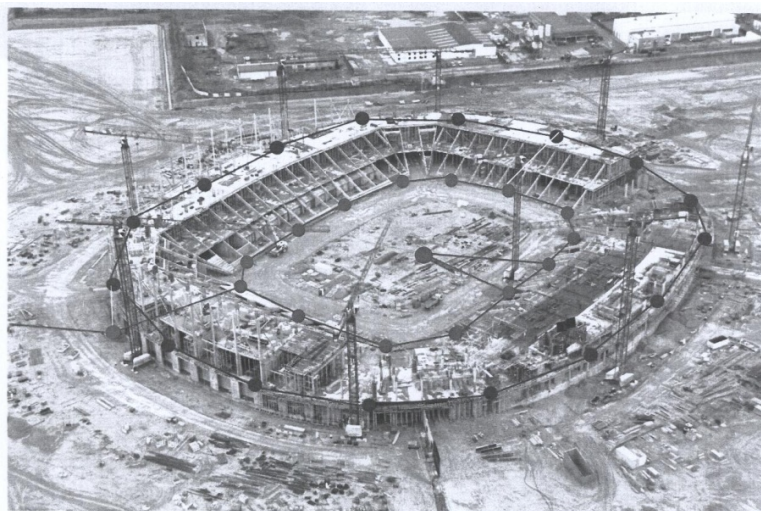
Fig. 11. Vertical geodetic network on the construction site of the stadium.

Vertical geodetic network was designed as two ovals at two levels of the object with the height difference of 6.000 m (Fig. 11): horizontally at the base of foundation, vertically in reinforced concrete of roof and was connected to the national vertical geodetic network (three bench-marks at a distance of about 800 meters from the stadium). The construction project assumed that the settlement of construction should not exceed 100 mm, and the differences of settlement should not exceed 10 mm.
