# Experimental Study on Ultrasonic Monitoring of Splitting Failure in Reinforced Concrete

Magdalena Rucka · Krzysztof Wilde

**Abstract** This paper investigates inspection of reinforced concrete elements sensitive to the splitting failure. The behaviour of a reinforced concrete specimen subjected to a tensile stress is considered. The damage detection procedure is based on the ultrasonic wave propagation technique. The piezoelectric transducers are located on both ends of the specimen and the measurements are taken periodically during the incrementally increased loading. The features of measured signals in time and frequency domains as well as wavelet transforms before and after the splitting failure are studied. The experimental results show that proposed method can be used for monitoring of damage evolution in concrete elements. The method makes possible detection of the moment just before the splitting failure occurs.

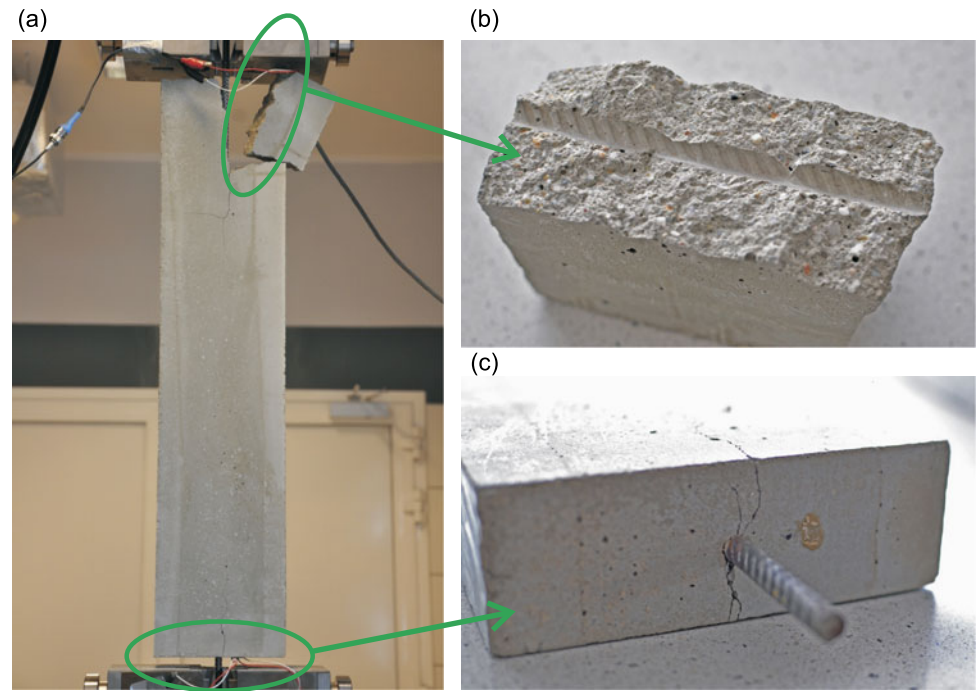
**Fig. 7** Specimen no. 3 after damage: (a) the view of the specimen; (b) interface between steel and concrete; (c) splitting cracks on the bottom part of the specimen

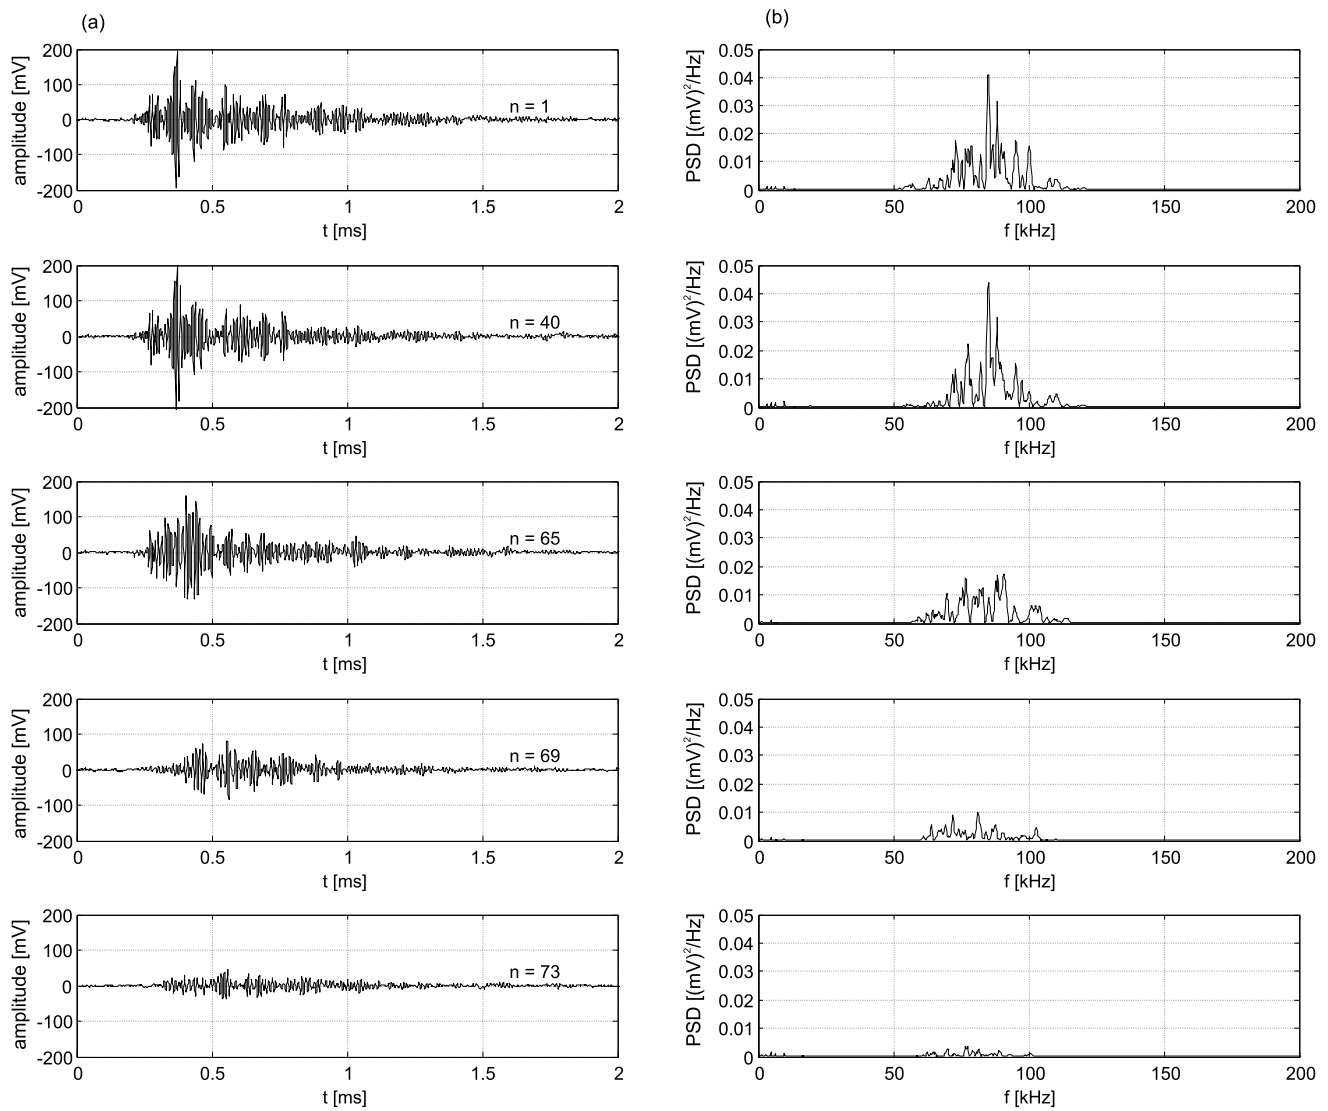
**Fig. 8** Ultrasonic signals registered at point B in specimen no. 1 for different load levels: (a) A-scan signals in time domain; (b) power spectral densities of time waveforms

The interpretation of measured signals in the frequency domain was performed by the power spectral density (PSD). The PSD function was used since it shows the signal power that better displays the changes in the wave propagation signals due to material degradation than Fourier transform. The PSD was computed using MATLAB<sup>®</sup>. The examples of the ultrasonic signals acquired at point B for specimen no. 1 and their power spectral densities are shown in Fig. 8. It can be seen that at the initial stage, no significant differences were visible in the measured time signals (e.g.  $n = 1$  and  $n = 40$ ).

The maximum amplitudes of the signals acquired at point B (on the opposite side then the PZT actuator) were practically the same for the signals from  $n = 1$  to  $n = 65$  and, then they decreased with the increase of the external tensile loading.

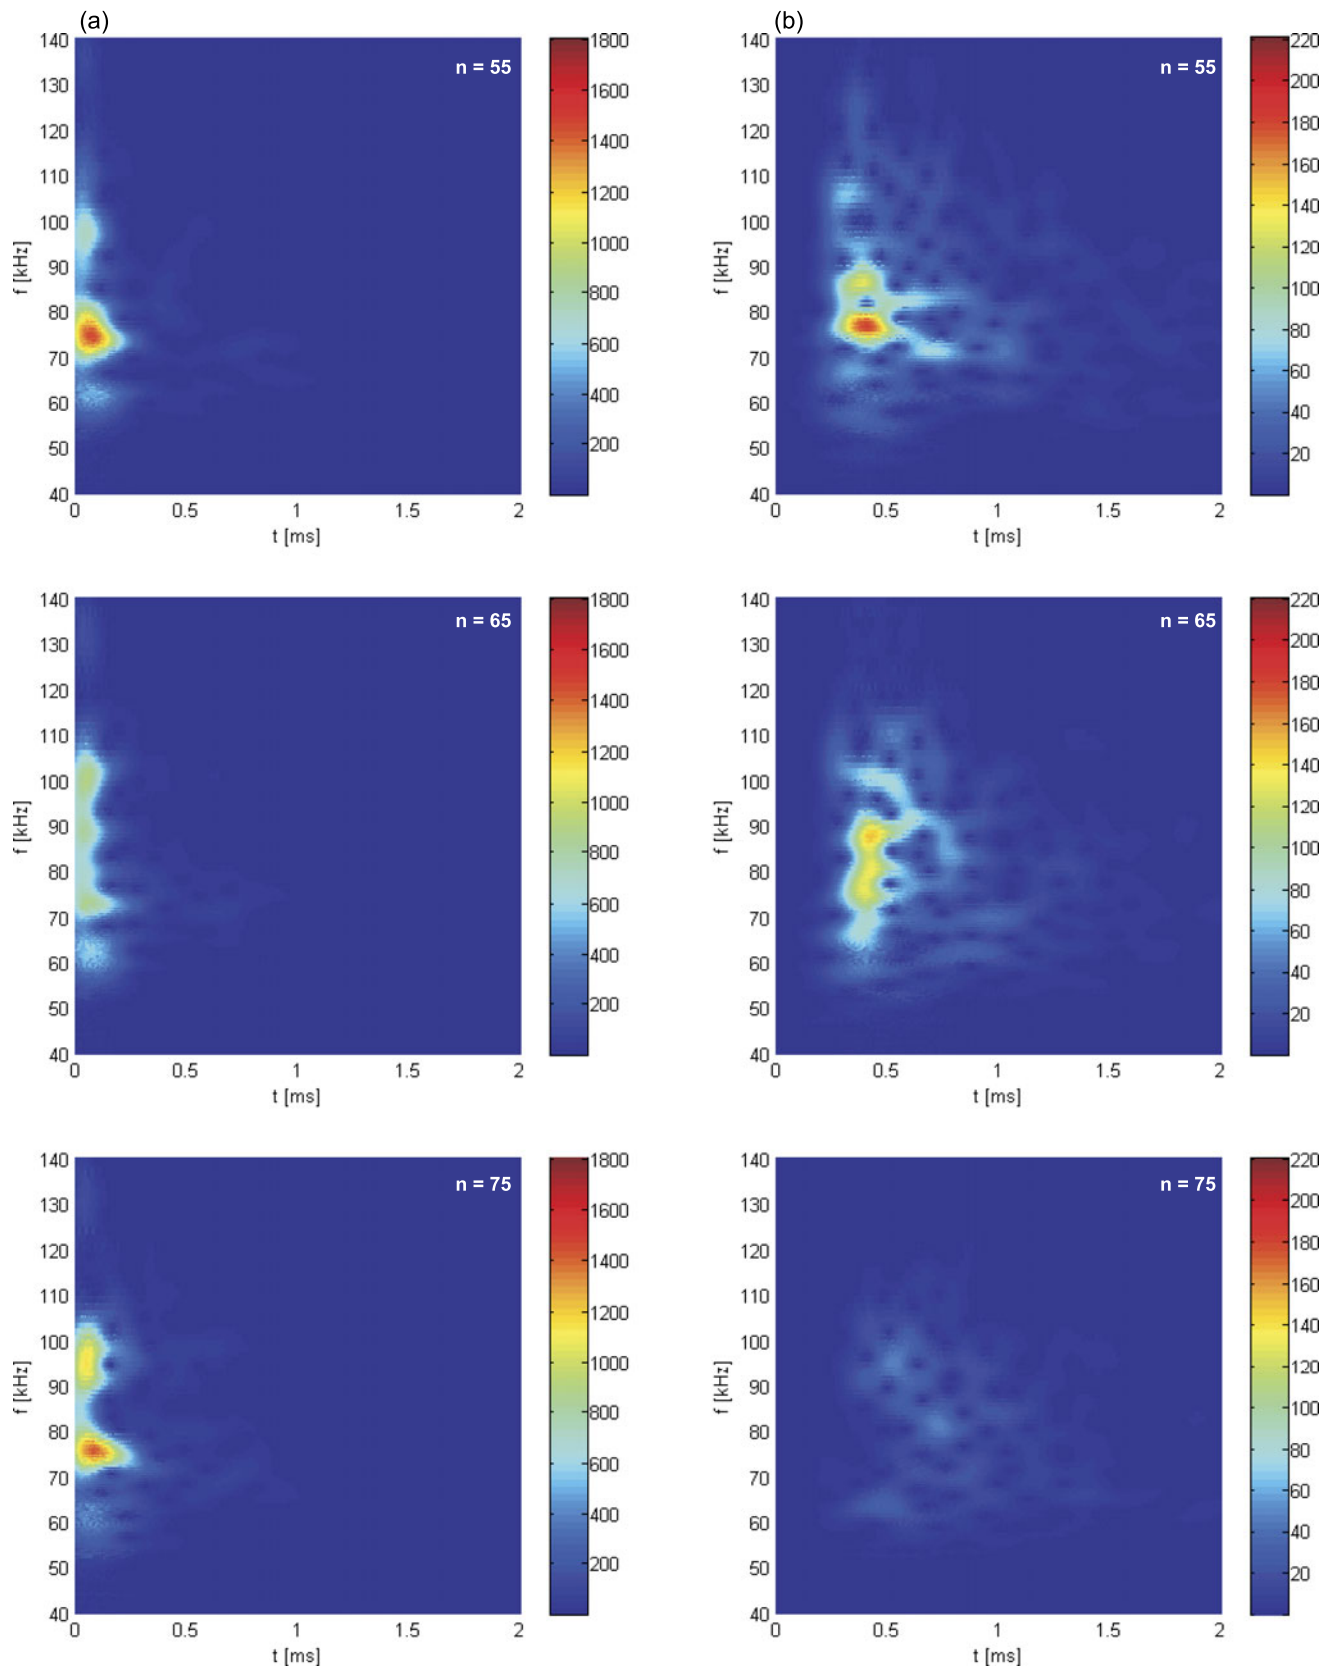
**Fig. 11** Wavelet transforms for specimen no. 1 for different load levels: (a) signals registered at point A; (b) signals registered at point B (wavelet transforms are in units of mV)

The wavelet transform results for the selected A-scan signals for specimen no. 1 are presented in Fig. 11. The left column of Fig. 11 shows the wavelet coefficients of the signals registered at point A and the right column depicts the wavelet coefficients of signals registered at point B for time steps corresponding to  $n = 55$  (stage before splitting),  $n = 65$  (appearance of the first vertical splitting crack) and  $n = 75$  (after the splitting failure). For  $n = 55$ , the elastic waves of frequency 76 kHz travelled through the concrete specimen and they can be observed in both signals measured at points A and B. At the beginning of development of the first splitting crack ( $n = 65$ ), the micro-crack zones were the biggest, causing a significant reduction of the amplitudes of ultrasonic waves at points A and B. Wave packets had frequency range from 70 kHz to 100 kHz. Further increase of

the external loading (e.g.  $n = 75$ ) resulted in the appearance of several large splitting crack and yielding of the steel bar. Plastic deformation of the bar near the notch changed the longitudinal load distribution. Largest deformations were in the areas near the notches. The internal forces in the specimen in the region from its top (the location of point A) to the first horizontal splitting crack were reduced. Therefore, the micro-crack zone became smaller and the waves generated in the neighbourhood of the measurement point A could travel with relatively small damping. Figure 11a (left column) shows large wavelet coefficients at frequency 76 kHz and 96 kHz for the specimen after splitting failure ( $n = 75$ ). The right column of Fig. 11b shows the wavelet coefficients of the signals at point B ( $n = 75$ ). There are no large values of the wavelet coefficients since the specimen have been destroyed by the horizontal splitting cracks that prevented propagation of ultrasonic waves from point A to point B through the concrete.
