Experimental Study on Ultrasonic Monitoring of Splitting Failure in Reinforced Concrete

Magdalena Rucka · Krzysztof Wilde

Abstract This paper investigates inspection of reinforced concrete elements sensitive to the splitting failure. The behaviour of a reinforced concrete specimen subjected to a tensile stress is considered. The damage detection procedure is based on the ultrasonic wave propagation technique. The piezoelectric transducers are located on both ends of the specimen and the measurements are taken periodically during the incrementally increased loading. The features of measured signals in time and frequency domains as well as wavelet transforms before and after the splitting failure are studied. The experimental results show that proposed method can be used for monitoring of damage evolution in concrete elements. The method makes possible detection of the moment just before the splitting failure occurs.

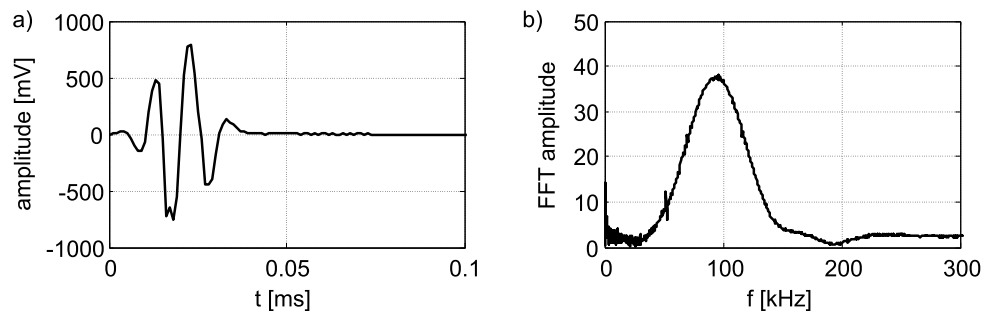
Fig. 4 Excitation signal: (a) in time domain; (b) in frequency domain

The excitation signal considered in this study was chosen as a single-frequency smoothed tone burst (also known as a wave packet) obtained from the multiplication of a sinusoidal function of established frequency by a Hanning function. The Hanning window provides smoothed tone burst in order to reduce the excitation of side frequencies [17]. This aspect of excitation of coherent single-frequency waves is important in the context of ultrasonic diagnostics. The number of cycles in the tone burst has a strong influence on the bandwidth of the input signal. For the established frequency of the sine wave, a large number of cycles is advantageous to obtain a narrow band in the frequency domain. On the other side, too many cycles causes increasing of wave packet length in the time domain. In this study, a four-peak sinusoidal signal with a central frequency of 96 kHz modulated by the Hanning window (Fig. 4) was chosen as a compromise between acceptable level of resolution in the time and frequency domains.

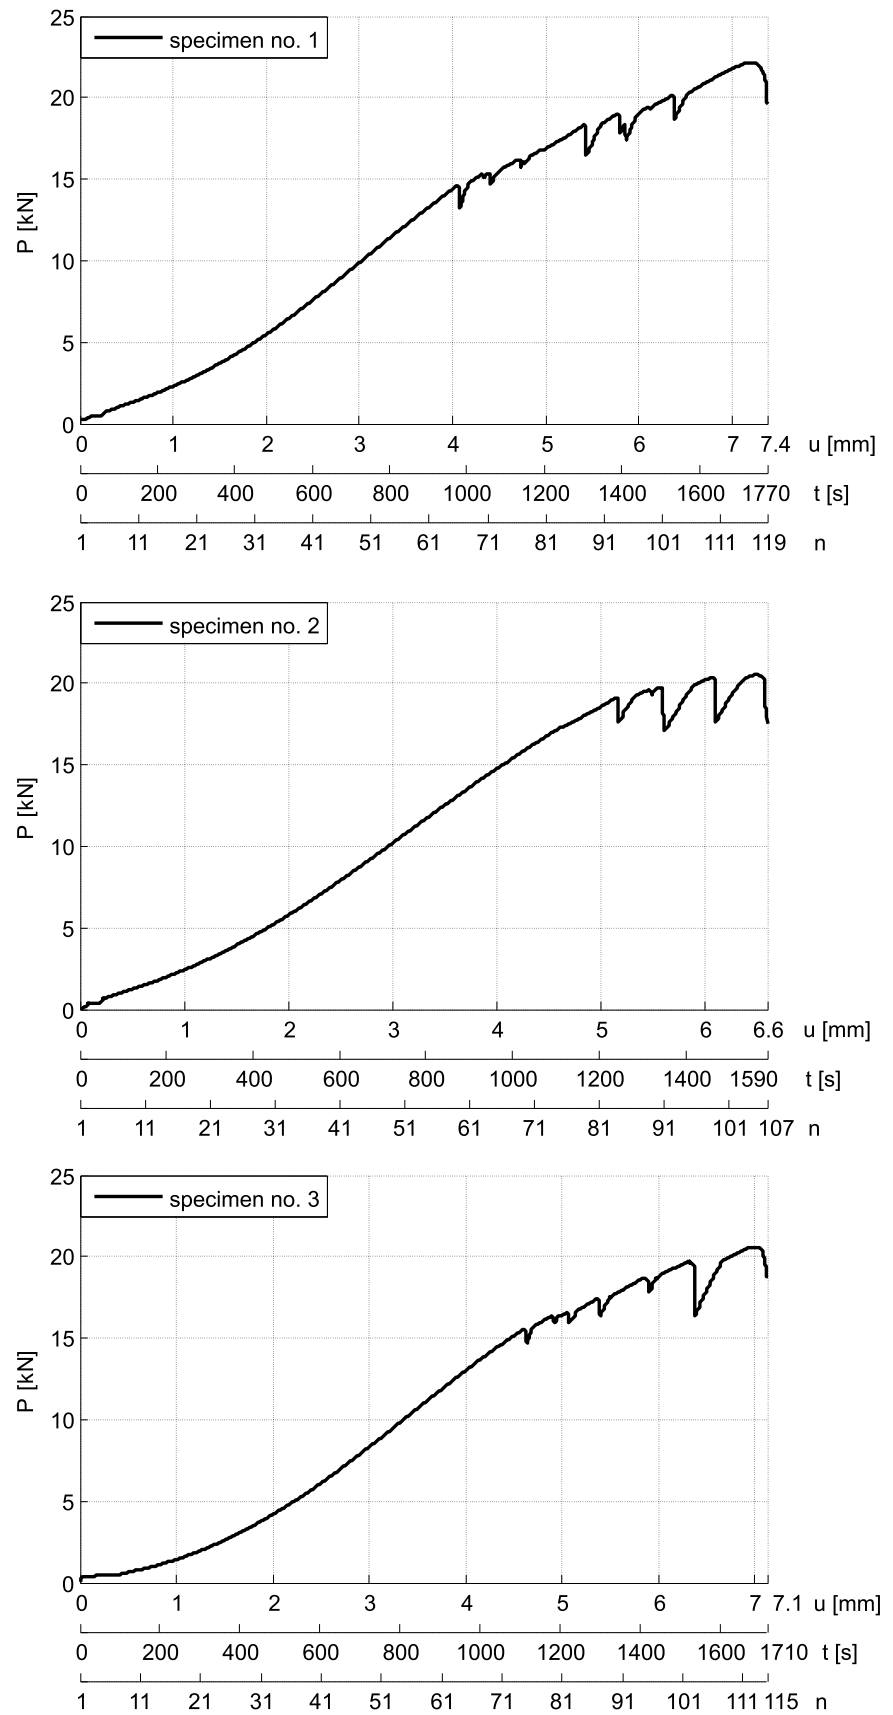
During the tensile tests, the displacement of the cross-head and the force level were recorded. Figure 5 shows the force-displacement ($P-u$) and the force-time ($P-t$) curves for the tested specimens. There are sudden drops of the force at the moments when the major splitting cracks appear and the load distribution within the specimen alters in time. It was noted that the sizes of the notches were not identical within the given element since they were cut by hand. The time of duration of the tensile test was 1770 s, 1590 s and 1710 s for specimen no. 1, no. 2 and no. 3, respectively. The maximum displacement u_{max} of the cross-head in the longitudinal direction was 7.38 mm, 6.6 mm and 7.12 mm for specimen no. 1, no. 2 and no. 3, respectively. During the tensile test, wave propagation measurements were conducted. Time signals were taken each 15 seconds and each signal was assigned ordinal number n . Parameter n started from $n = 1$

Fig. 5 Experimental load-deflection ($P-u$) and load-time ($P-t$) curves of three reinforced concrete specimens

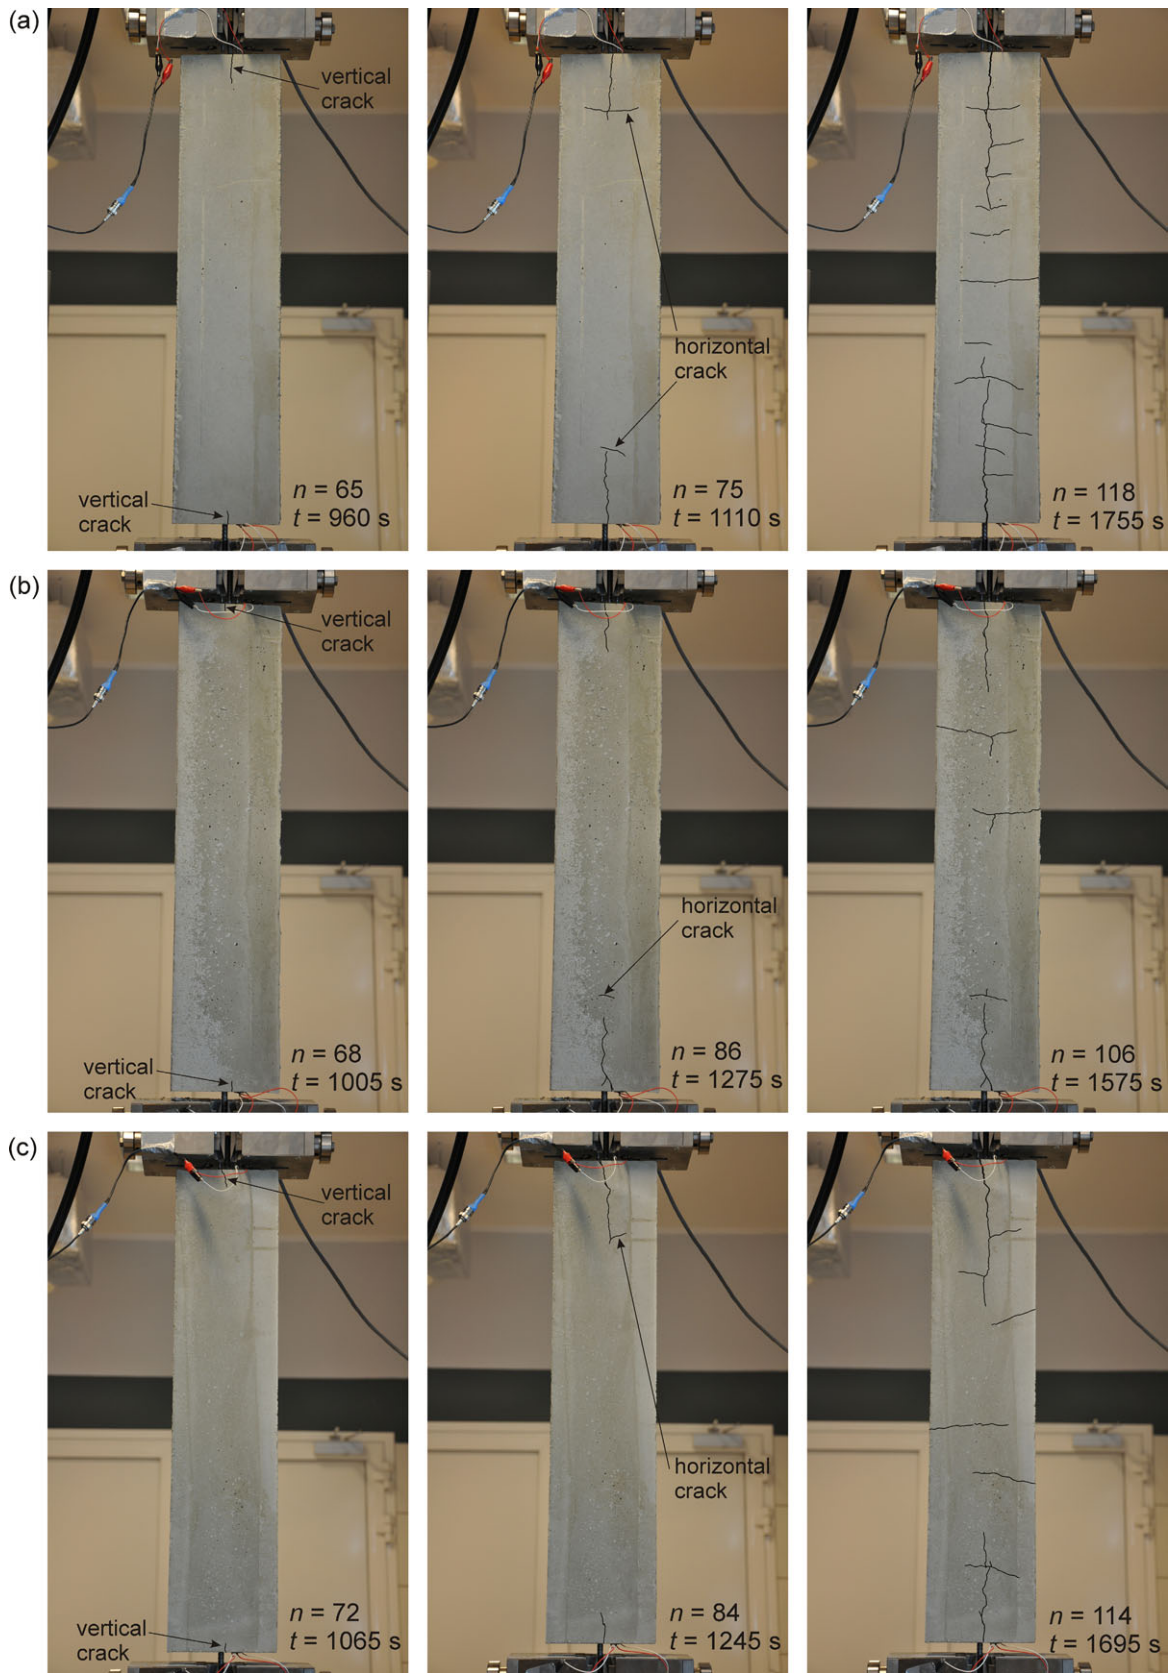
Figure 6 presents the crack formation and damage evolution in the tested specimens at the increasing load levels. At the first stage of the fracture process, two vertical cracks started to develop at the top and the bottom of the specimen. These cracks were initiated at $t = 960$ s ($n = 65$, $u = 0.54u_{max}$) for specimen no. 1, at $t = 1005$ s ($n = 68$, $u = 0.63u_{max}$) for specimen no. 2 and at $t = 1065$ s ($n = 72$, $u = 0.62u_{max}$) for specimen no. 3 (the first column of photographs in Fig. 6). Next the horizontal splitting of the concrete prism appeared at $t = 1110$ s ($n = 75$, $u = 0.62u_{max}$) for specimen no. 1, at $t = 1275$ s ($n = 86$, $u = 0.80u_{max}$) for specimen no. 2 and at $t = 1245$ s ($n = 84$, $u = 0.73u_{max}$) for specimen no. 3. This stage of damage is illustrated by the second column of photographs in Fig. 6. The penultimate stage of damage is given in the third column in Fig. 6. It occurred at $t = 1755$ s ($n = 118$, $u = 0.99u_{max}$) for specimen no. 1, at $t = 1575$ s ($n = 106$, $u = 0.99u_{max}$) for specimen no. 2 and at $t = 1695$ s ($n = 114$, $u = 0.99u_{max}$) for specimen no. 3. The tensile tests were stopped as a result of the tension failure of the steel bar. Figure 7 shows the details of the concrete specimen after the splitting failure. The prints of the lugs of the reinforcing bar are clearly seen on the piece of damaged concrete. Therefore, the slipping of the steel bar and damage of the bar surrounding concrete by the tips of the rebar lugs did not take place.

Fig. 6 Experimental damage evolution and crack patterns of three tested specimens (state of initiation of vertical cracks, state of initiation of horizontal cracks, penultimate stage of damage): (a) specimen no. 1; (b) specimen no. 2; (c) specimen no. 3

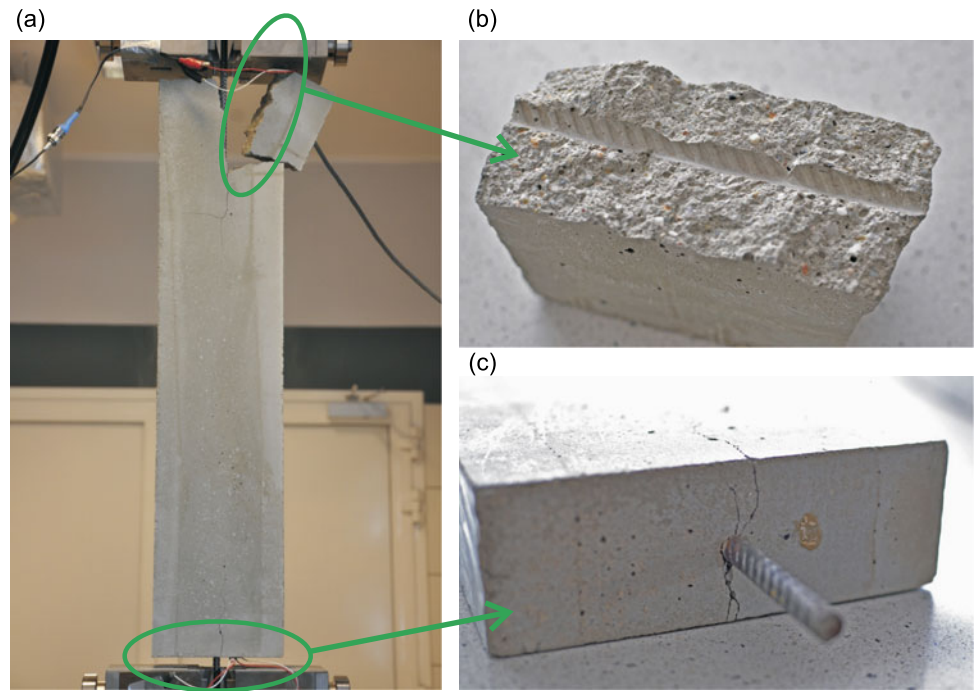
Fig. 7 Specimen no. 3 after damage: (a) the view of the specimen; (b) interface between steel and concrete; (c) splitting cracks on the bottom part of the specimen

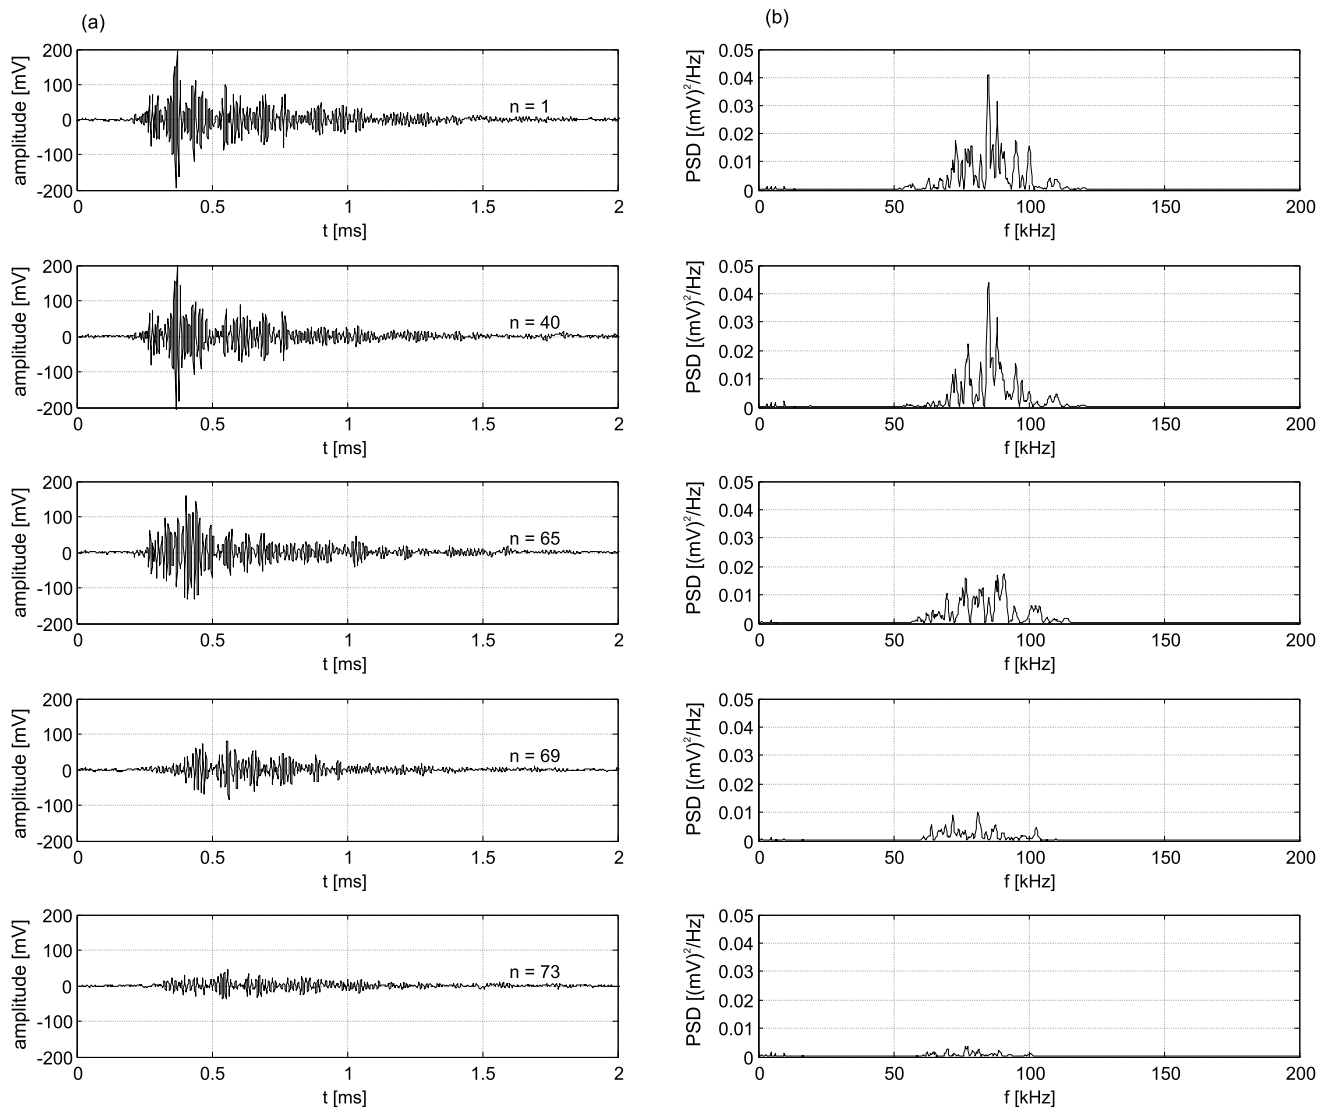
The maximum amplitudes of the signals acquired at point B (on the opposite side then the PZT actuator) were practically the same for the signals from $n = 1$ to $n = 65$ and, then they decreased with the increase of the external tensile loading.

Fig. 8 Ultrasonic signals registered at point B in specimen no. 1 for different load levels: (a) A-scan signals in time domain; (b) power spectral densities of time waveforms

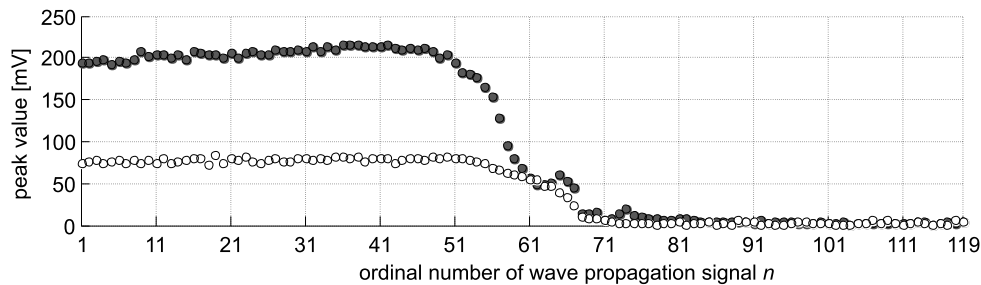
Figure 9 shows the peak values of the signals registered at point B for the specimen no. 1. Data in Fig. 9 are taken from the time signals (so called A-scans) for consecutive measurements of propagating ultrasonic waves. Peak values of the first incoming wave packet for the signals from $n = 1$ to $n = 119$ were plotted with white dots (Fig. 9). The first wave packet corresponds to the first pressure wave traveling in the specimen. The initial value of the peak was of about 80 mV. The first wave packet can be clearly seen for signal numbers from $n = 1$ to $n = 40$ (Fig. 9a). For the time records corresponding to higher signal numbers, the peak values of the first wave packet were determined for the time range $t = 0.27$ – 0.28 ms. The peak values of the second wave packet that can be seen at $t = 0.37$ – 0.38 ms were plotted in Fig. 9 with grey dots. The initial peak value of the second waveform was of about 200 mV. The second wave packet was associated with interference of shearing and pressure waves reflected from the specimen cross-section boundaries. The recognition which wave packet in the registered signal corresponds to pressure and shear waves was done based on wave velocities.

The amplitudes of the first wave packet were similar for the signal numbers from $n = 1$ to $n = 55$ (Fig. 9). From $n = 56$ to $n = 67$ the amplitudes started to decrease and from $n = 68$ they became close to zero. Small micro-cracked

zones did not significantly affect the first pressure wave, and therefore, the significant drop of the maximum amplitudes was noticed when the first vertical crack appeared (at $n = 65$). The amplitudes of the second wave packet were constant for signal numbers from $n = 1$ to $n = 51$ and the relatively rapid decrease of the amplitudes took place till $n = 61$. At signal number $n = 75$ the maximum amplitudes of the second wave packet became very small. It seems that the change of the peak values of the second wave packet indicated the development of the micro-crack zone before splitting takes place. The vertical splitting cracks were observed for $n = 65$ while the reduction of the amplitudes starts at $n = 51$. Formations of micro-crack zones had relatively large influence on the reflected shear and pressure waves resulting in large attenuation of the second wave packet.

Fig. 9 Peak values of wave propagation signals registered at point B in the specimen no. 1: the first wave packet corresponding to the first pressure wave traveling in the specimen (white dots) and the second wave

packet associated with interference of shearing and pressure waves reflected from the specimen cross-section boundaries (grey dots)

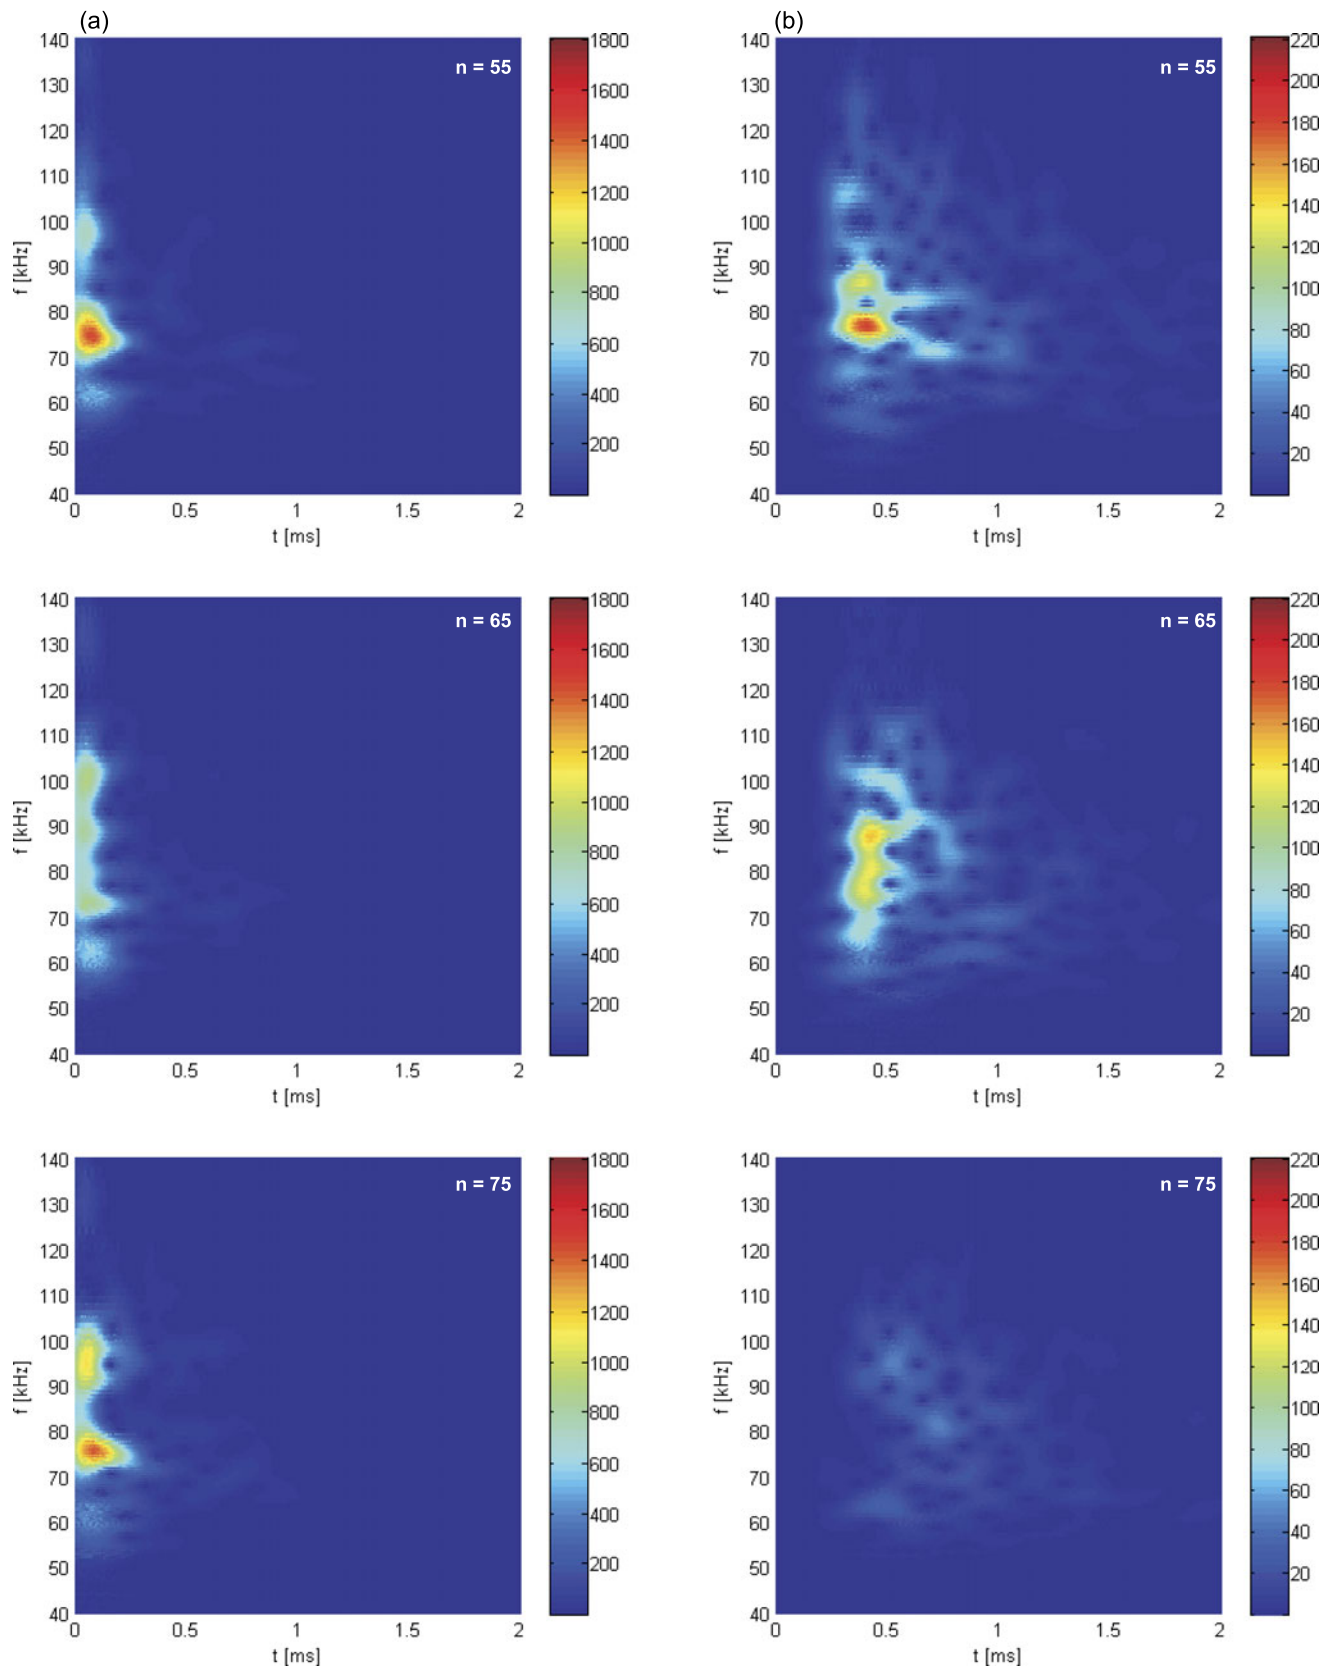
The wavelet transform results for the selected A-scan signals for specimen no. 1 are presented in Fig. 11. The left column of Fig. 11 shows the wavelet coefficients of the signals registered at point A and the right column depicts the wavelet coefficients of signals registered at point B for time steps corresponding to $n = 55$ (stage before splitting), $n = 65$ (appearance of the first vertical splitting crack) and $n = 75$ (after the splitting failure). For $n = 55$, the elastic waves of frequency 76 kHz travelled through the concrete specimen and they can be observed in both signals measured at points A and B. At the beginning of development of the first splitting crack ($n = 65$), the micro-crack zones were the biggest, causing a significant reduction of the amplitudes of ultrasonic waves at points A and B. Wave packets had frequency range from 70 kHz to 100 kHz. Further increase of

Fig. 11 Wavelet transforms for specimen no. 1 for different load levels: (a) signals registered at point A; (b) signals registered at point B (wavelet transforms are in units of mV)

the external loading (e.g. $n = 75$) resulted in the appearance of several large splitting crack and yielding of the steel bar. Plastic deformation of the bar near the notch changed the longitudinal load distribution. Largest deformations were in the areas near the notches. The internal forces in the specimen in the region from its top (the location of point A) to the first horizontal splitting crack were reduced. Therefore, the micro-crack zone became smaller and the waves generated in the neighbourhood of the measurement point A could travel with relatively small damping. Figure 11a (left column) shows large wavelet coefficients at frequency 76 kHz and 96 kHz for the specimen after splitting failure ($n = 75$). The right column of Fig. 11b shows the wavelet coefficients of the signals at point B ($n = 75$). There are no large values of the wavelet coefficients since the specimen have been destroyed by the horizontal splitting cracks that prevented propagation of ultrasonic waves from point A to point B through the concrete.
