APPLICATION OF INFRARED THERMOGRAPHY TO NON-CONTACT TESTING OF VARISTORS

Stanisław Galla, Alicja Konczakowska

Gdansk University of Technology, Faculty of Electronics Telecommunications and Informatics, Gabriela Narutowicza 11/12, 80-233 Gdańsk, Poland (✉ galla@eti.pg.gda.pl, +48 58 347 2140, alkon@eti.pg.gda.pl)

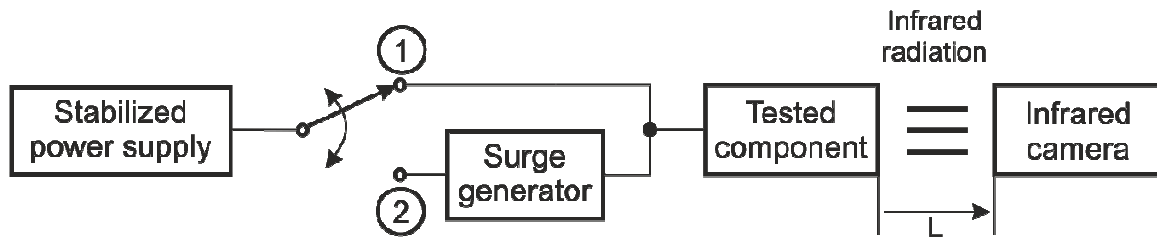
Fig. 1 presents the measurement circuit of varistors, during testing with a constant load (position 1 of the switch) and during testing with a surge generator (position 2 of the switch).

Fig. 1. Measurement circuit of varistors during testing, $L = 0.75$ m; position 1 of switch – measurement with constant load, position 2 of switch – measurement during surges.

The varistors were submitted to load testing in the circuit with a stabilized supply unit (Fig. 1, position 1 of the switch), enabling to obtain the following current values (flowing through the varistors):

First, testing of 10 varistors (5 of each type) with a surge generator was performed (Fig. 1, position 2 of the switch). The varistor thermograms were obtained during application of surges (every 20 s.) for 3 voltage levels: 500 V, 760 V and 1000 V; for each voltage level and each varistor every 5 s. The testing procedure is in accordance with the EN61000-4-5 standard. $N = 41$ measurements (thermograms) were performed with the infrared camera. The varistors were submitted to surges at different voltage levels; the interval between applying successive levels was 24 hours. The test results are compiled in Table 5 (P22Z1 type varistors) and Table 6 (S07K14 type varistors).

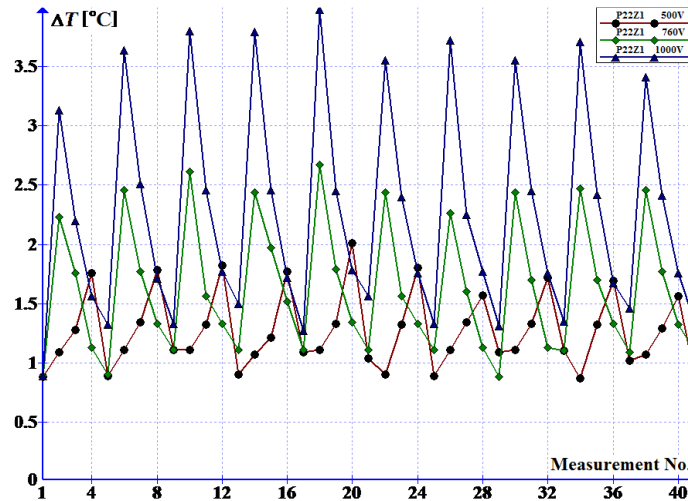
Fig. 2. Temperature increments ΔT recorded in successive measurements with an infrared camera during application of surges at 3 voltage levels: 500 V, 760 V and 1000 V for varistor No. 5 of P22Z1 type.

On the basis of recorded temperature increments, average values (for tested varistors) were assessed. The values were not exceeding 2°C, 3°C and 4°C for P22Z1 and S07K14 type varistors, for voltage surge levels of 500 V, 760 V and 1000 V (Fig. 2 and Fig. 3), respectively.

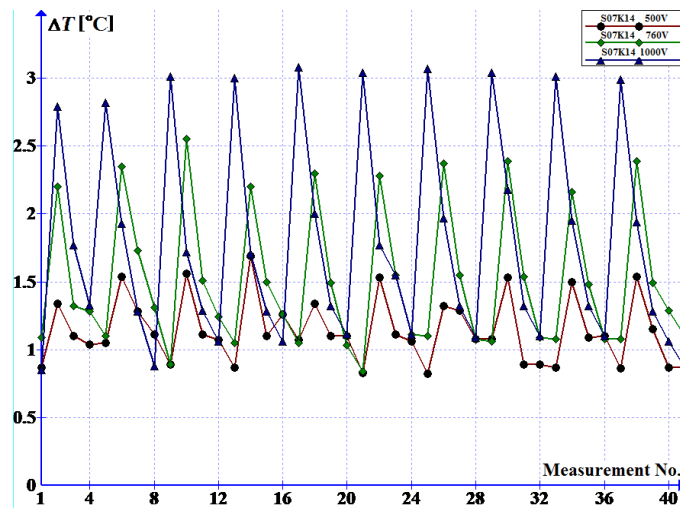
Fig. 3. Temperature increments ΔT recorded in successive measurements with infrared camera during application of surges at 3 voltage levels: 500 V, 760 V and 1000 V for varistor No. 5 of S07K14 type.
