Types of wear and tear of biomaterials used in orthopaedic surgery

Purpose: Purpose of this paper is presentation of observations on different kinds of wear and tear of biomaterials used in contemporary orthopaedic surgery.

Design/methodology/approach: Types of prosthesis damage, encountered in medical practice, and their causes have been described. Results of many clinical studies were analysed to review prosthesis damage from the stage of implanting (such as intrusion of a foreign object between its components) to their natural wear and tear after many years of use (abrasive wear, biological corrosion).

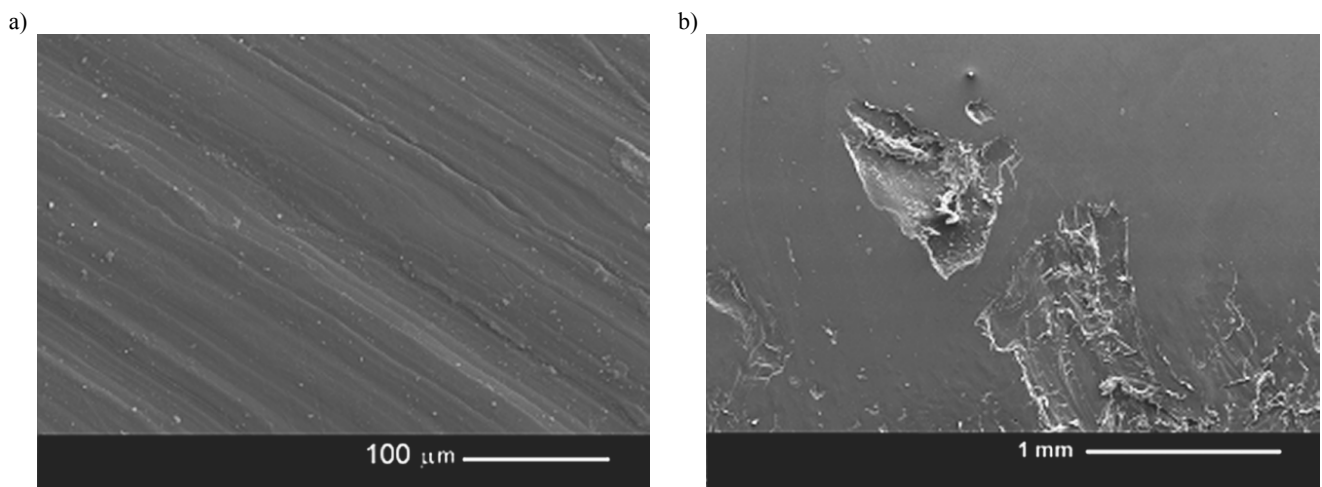
Fig. 4. Examples of different types of wear of hip joint prostheses sockets: a) abrasive wear, b) chipping the sockets material

Some socket surface has been seen to crack (Fig. 5a). However, abrasive wear has been the most common type of damage to their surface (Figs. 4 a, b). This may have been caused by elements of the socket material which have chipped off during the joint use (Fig. 4) or foreign bodies (Fig. 5 b) which entered the "prosthesis socket - head" contact zone. This has been confirmed by authors of other publications [2,35], whose studies have shown that parts of prostheses made of hard metals, which are in contact with polyethylene, do not show signs of significant wear even after more than ten years of use. Only hard products of wear, e.g. chips of bone cement, which enter the friction zone, can scratch the smooth surface of the metal element.

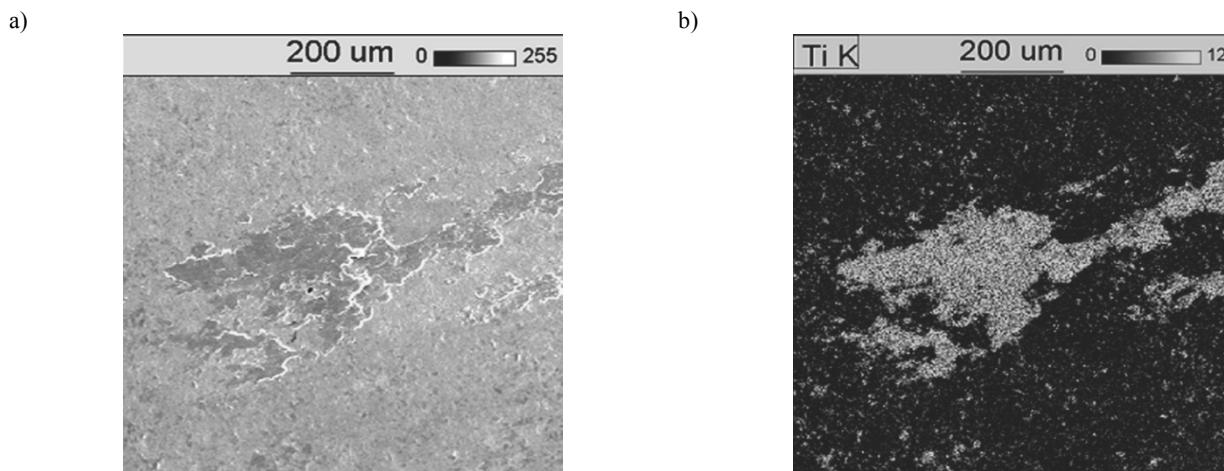
An analysis of the chemical composition has shown that certain titanium elements appeared on the prosthesis head, made of Co-Cr-Mo alloy (Vitalium). As the map of titanium distribution (Fig. 9) shows, its presence exactly coincides with the eruption. Titanium is not as hard as the Vitalium alloy, so those are not particles stuck into the surface; rather they are spread on the surface. Therefore, its presence here has different reasons. As the socket casing was made of titanium, the eruption on the surface may originate from it. This indicates that apart from typical wear processes by friction, a process of dissolving titanium by body fluids and transporting it to other places takes place.

Fig. 9. Foreign material on the surface of the head of a hip joint prosthesis: a) image of the intrusion, b) surface distribution of titanium.

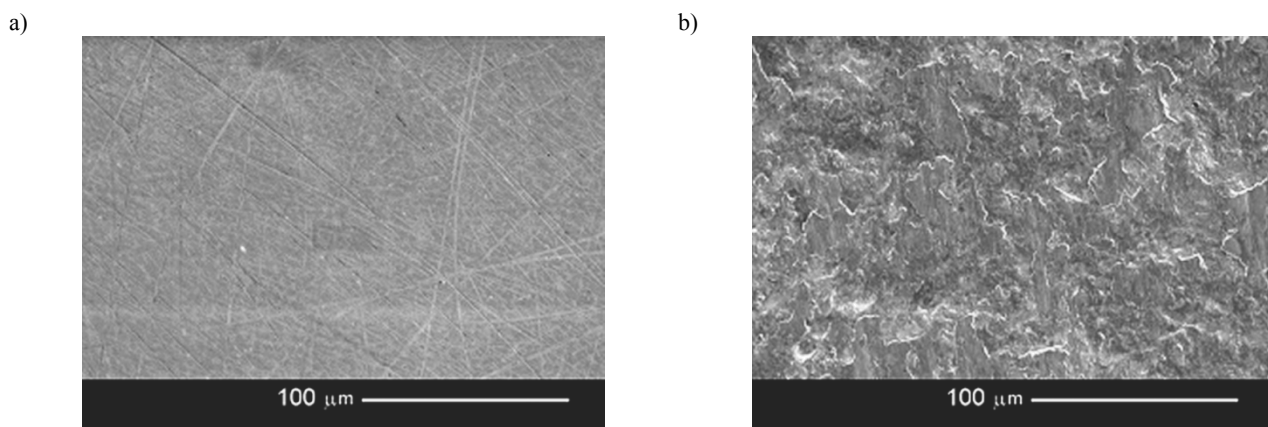
Apart from intrusions, there are also other types of wear observed on the surface of a prosthesis head. The surface of a non-worn head, shown in Fig. 10, is relatively smooth and there are only scratches on it caused by mechanical processing. A worn prosthesis head looks completely different (Fig. 10b). This is typical wear observed in cutting elements. Material defects and traces of its plastic flow are visible.

Fig. 10. Examples of different types of wear of heads of hip joint prostheses: a) non-worn surface, b) surface worn by friction
